Re: Building 3008 – Hanger 2 Structural Evaluation

Special Inspection

To:	Fort Wainwright Directorate of Public Works (DPW), File	Field Visit Date:	February 28, 2011
Date:	March 3, 2011	Location:	Hanger 2, Fort Wainwright
Time:	1330-1630	Weather:	-10°F, light wind, clear skies
Project:	FTWW Bldg. 3008 – Hanger 2 Structural Evaluation	Present at Site:	Michael Dean, Billy Brookins, Janet Matheson – Design Alaska; Scott Smith – FTW DPW; Shaw Contracting Crew

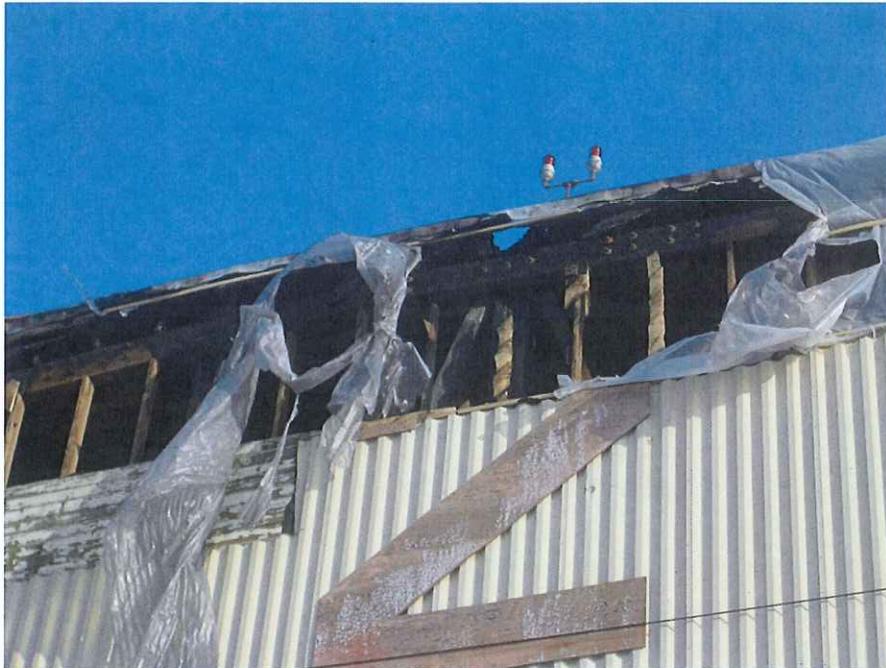
Visqueen sheeting had been partially attached to help seal the facility from the elements where appropriate (see photo 1). The Shaw crew stated that more Visqueen sheeting was going to be placed in the next 48 hours on this facility.

Photo 1: West Exterior Face

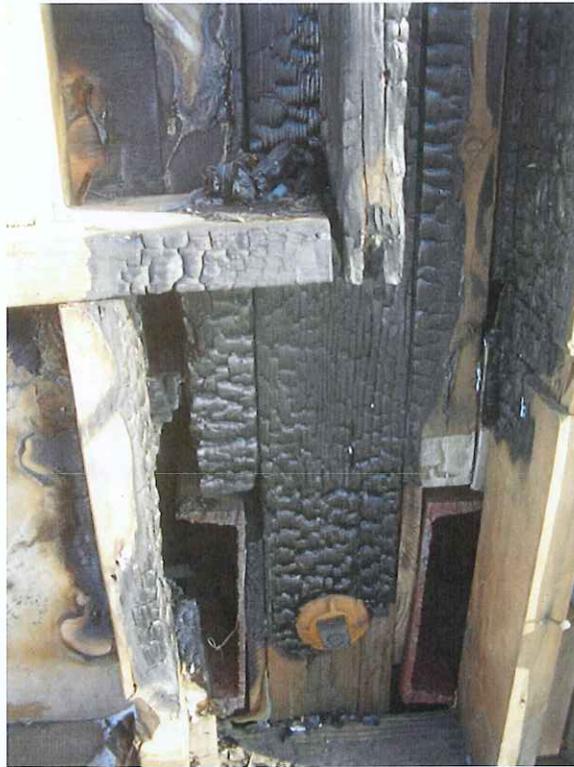
The first stop on the exterior inspection was made at the center of the truss along the bottom chord (see photo 2), noted as joint 21 in the attached as-built drawing. This drawing is from the repair hanger doors project, dated July 21, 1987 and was utilized during the course of the inspection. This joint was noted to have all of the original square nuts loose as the inspector was able to turn them all freely with his fingers. It was also noted that the visible burn patterns appeared to start in this area with charring extending to the roofline along member 39. The truss vertical timber (member 39) had 1/4" to 1/2" of burnt material on the exterior face along the accessible area (see photo 3). No exterior charring was noted on the bottom chord members 38 and 41, indicating that the fire started near the top of the bottom chord and moved upwards from there.

Photo 2: Above Joint 21

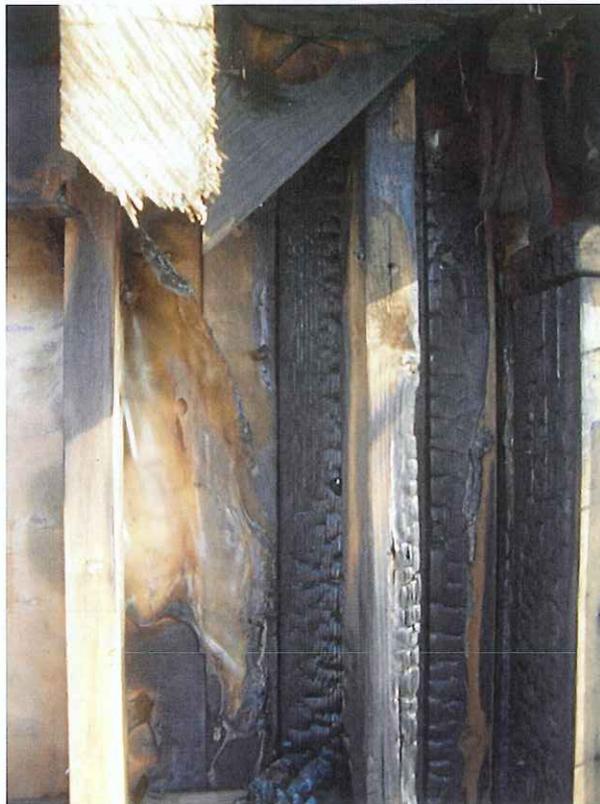
Photo 3: Member 39, above Joint 21

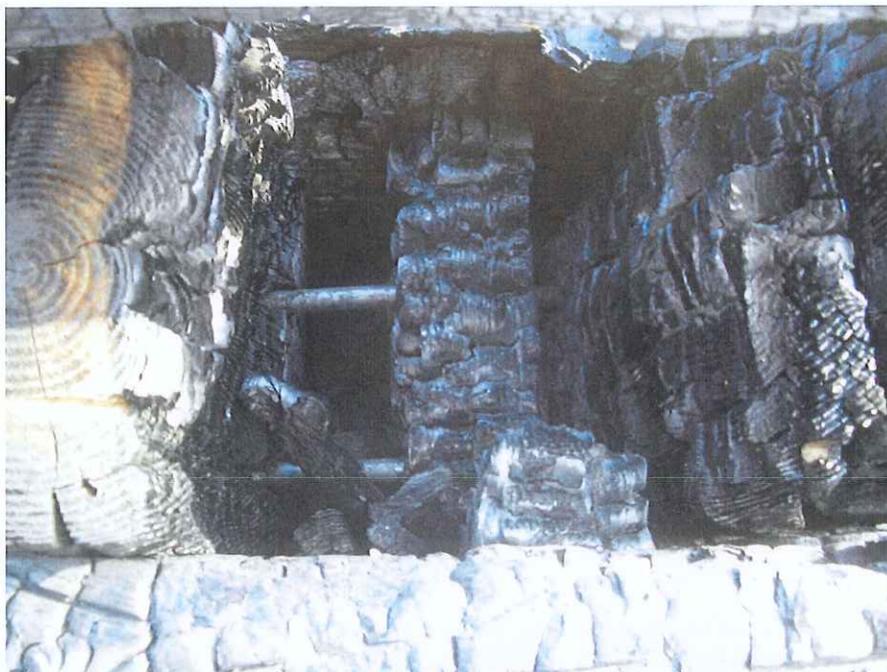
We next moved to joint 20, at the top of the truss along the building centerline. This joint has seen significant fire damage and is in dire need of immediate repair (see photo 4). Charred surface penetration values varied from 1-1/2" to 2" along the exterior face of top chord members 36 and 40 within 2 feet of the building centerline indicating that this was the hottest part of the fire (see photo 5). The roof deck was burned through at this location as well indicating extensive roof deck damage. The damage in this area indicates that this was the hottest part of the fire and it spread outwards from this location along the length of the truss (see photos 6 and 7). Exterior face damage to the top chord is noted at even numbered joints from 14 to 26; a distance of twenty-four (24) lineal feet, straight line; which can also be denoted as 3 panel points each side of centerline. It was also noted that the purlins above all of the above joints have fire damage to some degree, as further described during the interior inspection, below. The double purlin over joint 20 is severely damaged and needs replacement. The bolts that hold these purlins to truss member 39 is visible throughout the width of member 39 due to the fire damage; it was also noted to be visible deformed, indicating intense heat at this location (see photo 8). Web members 37 and 41 also showed signs of severe fire damage near the top; with member 41 having the most noted damage due to it being on the North side of the of the truss, where the majority of the fire damage is found. These members require replacement as well. Penetration tests on these members show that the thickness has been reduced up to one inch; which requires replacement.

Photo 4: Joint 20

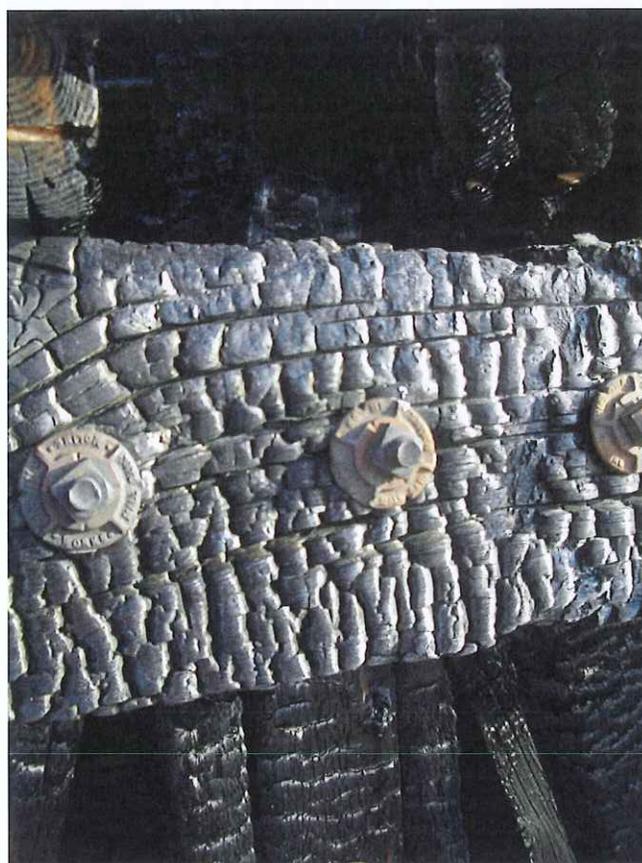
Photo 5: Joint 20, showing damage to each side

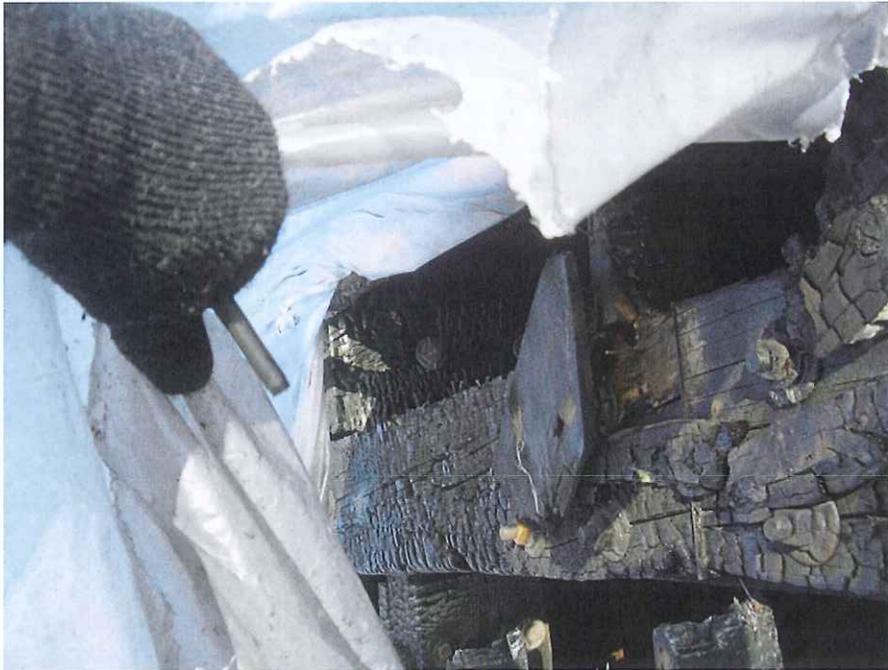
Photo 6: Top Chord, Looking North

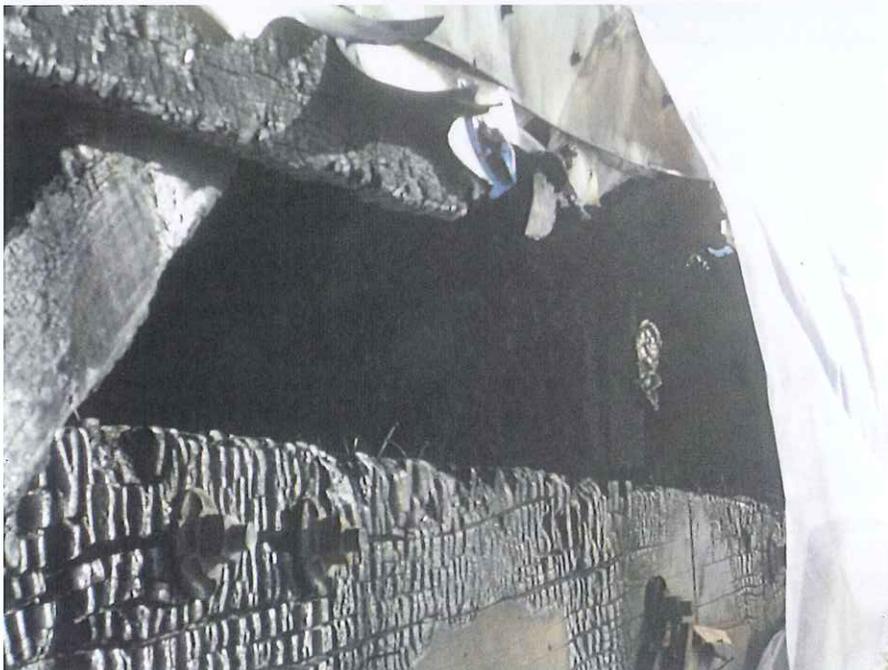
Photo 7: Top Chord, Looking South

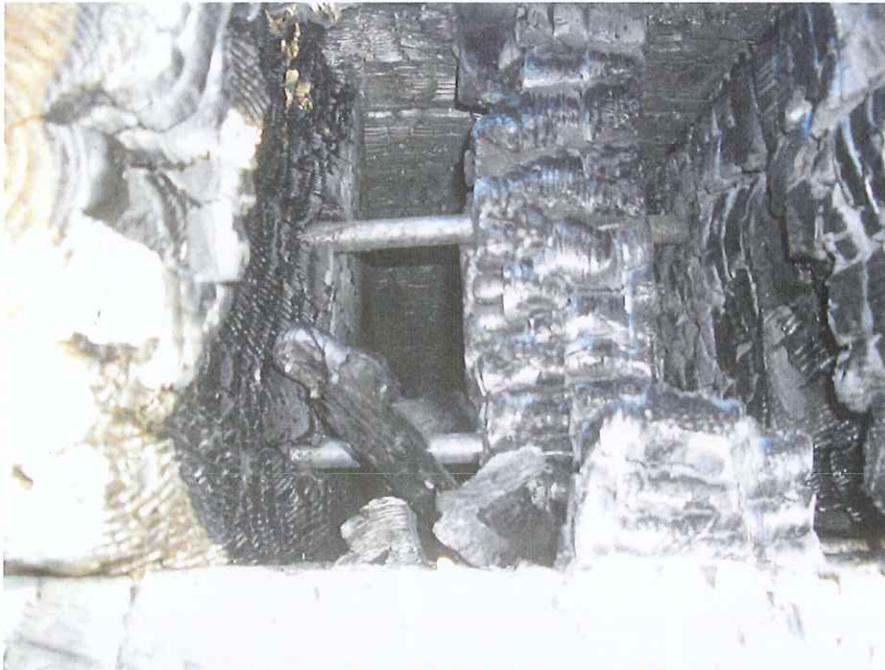
Photo 8: Interior shot of Joint 20, Damaged Hardware

It was also noted that all of the square nuts tested on the truss were found to be finger tight, or extremely loose. This also includes nuts that were over non-burned material. All bolts and associated hardware in the area of fire damage should be replaced with new materials.

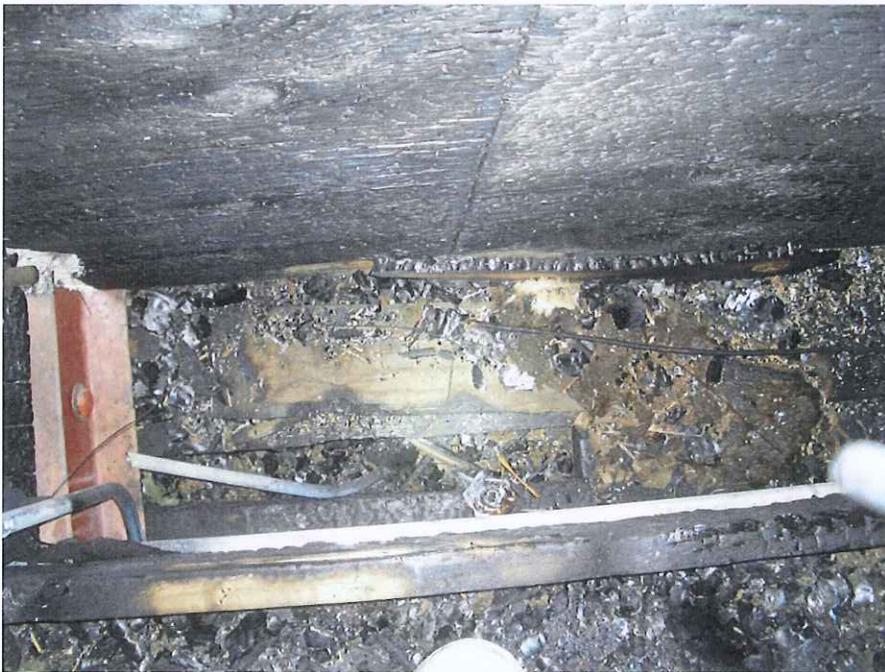
The interior inspection was conducted off of the catwalk system that runs along Truss 1. The catwalk itself was visually inspected for damage before attempting to utilize the system. Access is available from a ladder near the center of the South wall. Due to steel bracing and equipment, the lift could not be utilized to access the truss members, so the interior inspection was performed from the catwalk itself. Some charring was noted on the catwalk toe plate, towards the building exterior above the bottom chord (see photo 9).

Photo 9: Catwalk Charring

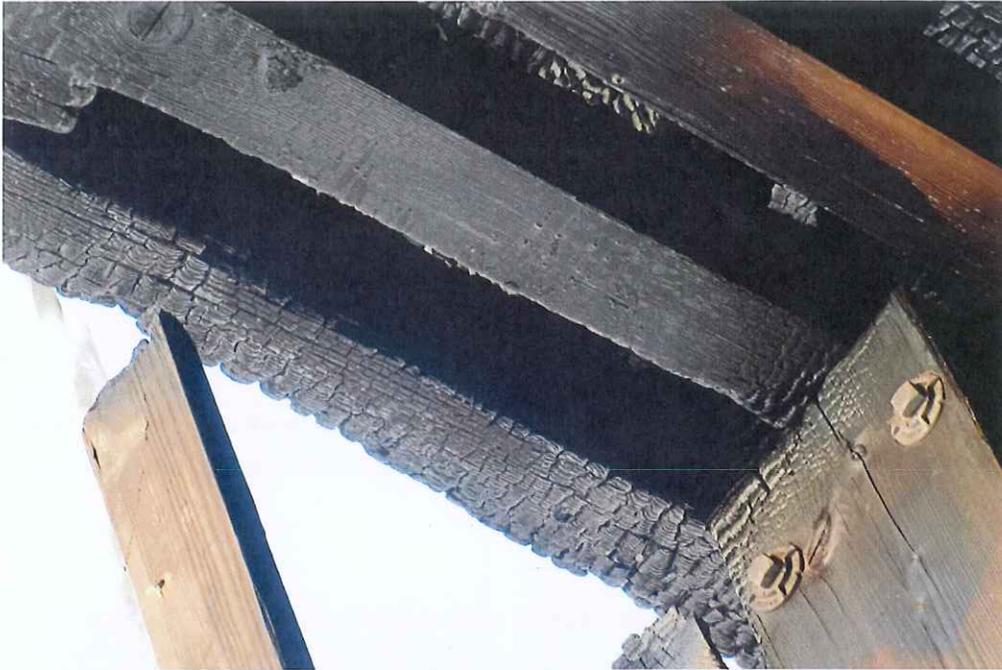
Truss 1 has interior fire damage, but it appears that the majority of the damage is concentrated on the exterior face and exterior ply of the three ply truss. The center ply also shows fire damage; therefore the best recommendation is to replace all plies of the members damaged (see photo 10). The bottom chord of the truss has minor charring along the top edge, penetration depths of approximately 1/4 inch; characteristic of being below the fire origin (see photo 11).

Photo 10: Top Chord Ply Damage @ Joint 22

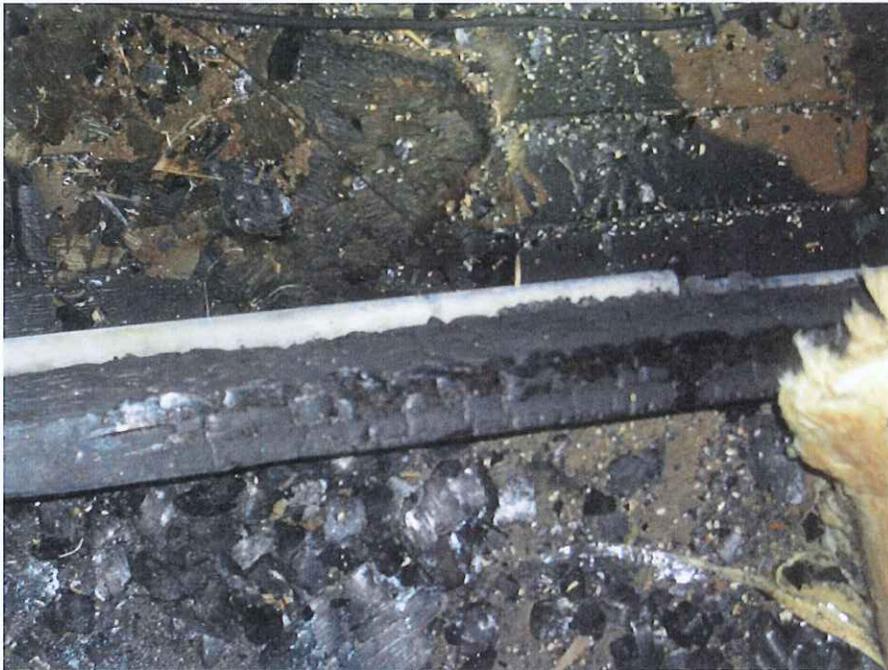
Photo 11: Top of Bottom Chord (Member 42) Charring

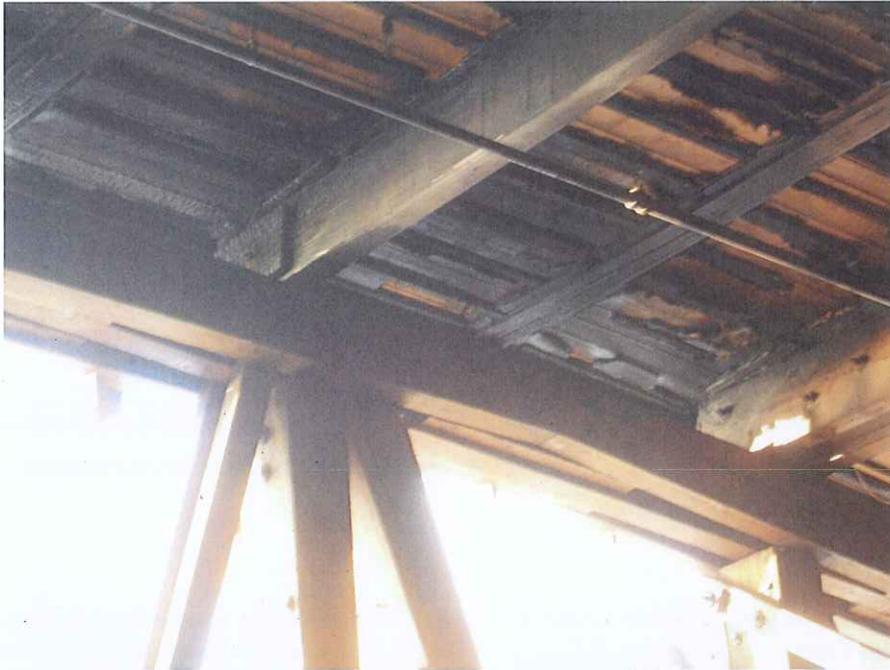
Above Joint 26, previously repaired with Glu-lam beams on each side – approximately 2 feet on South face, none noted on North face (see photo 12)

Above Joint 24 – approximately 3 feet on South face, 1 foot or less on North face (see photo 12)

Photo 12: Purlins above Joints 24 & 26

Due to the previous recommendations for purlin repairs, it is recommended that all of these purlins be replaced in kind with new glu-lam material. This will require roof decking removal and replacement back to Truss 2. It is noted that the roof deck is damaged to approximately the same distance back from the exterior face as the purlins, shown above. The decking is braced mid-span by a flat laid 2x nailed in place. These members will also need replacement due to damage along the exterior edge of the facility (see photo 14).

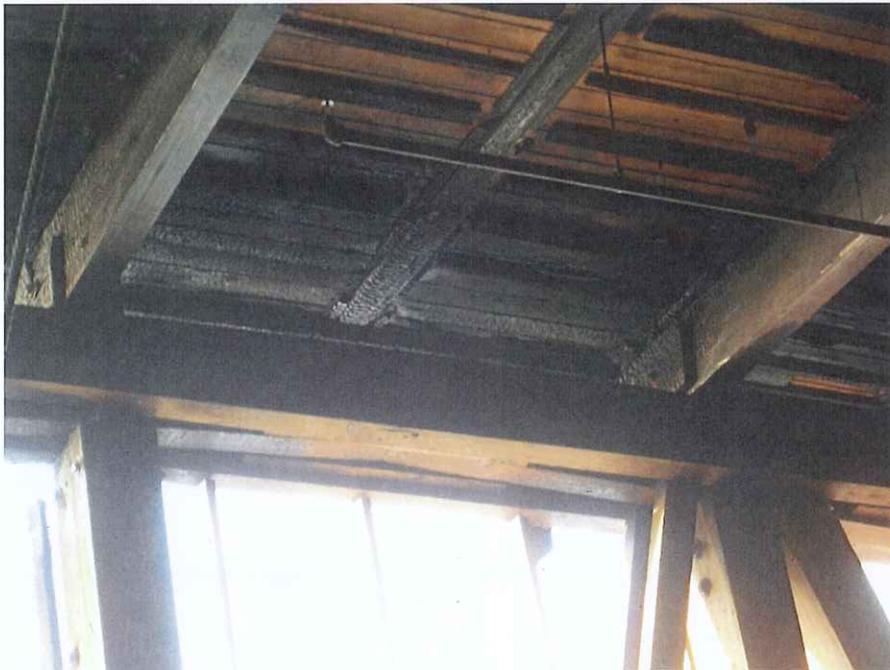
Above Joint 22 – approximately 6 feet on South face, 4 feet or less on North face (see photo 13)

Photo 13: Purlins above Joints 22 & 24

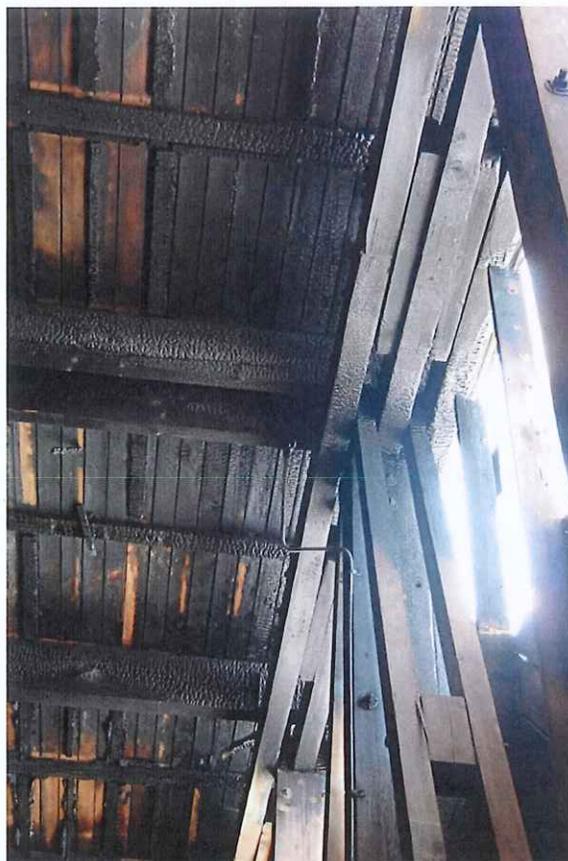
Above Joint 20 – approximately 10 feet, all visible faces (see photo 14)

Photo 14: Purlins above Joints 20 & 18

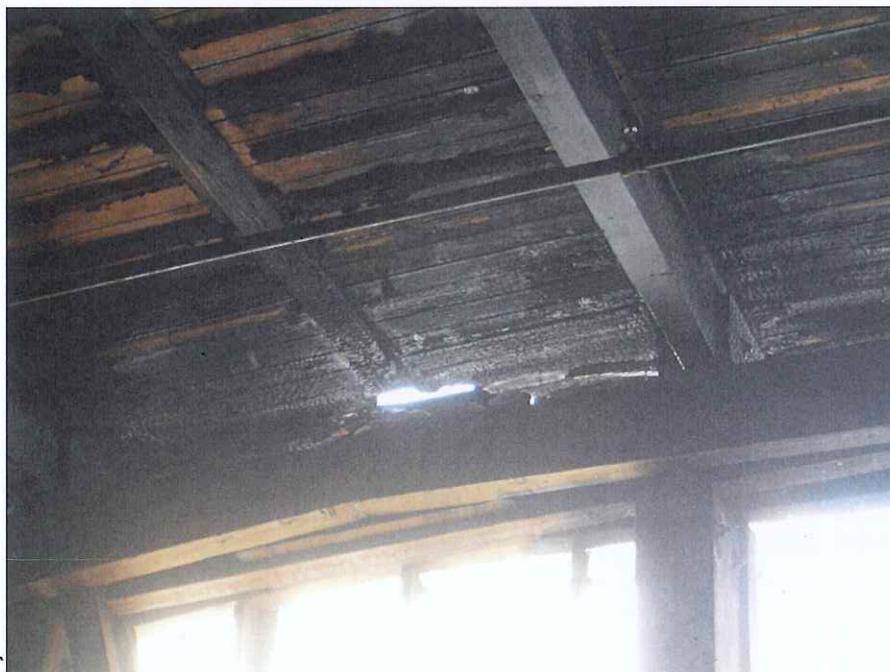
Above Joint 18 – approximately 8 feet on North face, 4 feet or less on South face (see photo 15)

Above Joint 16 – approximately 6 feet on North face, 3 feet or less on South face (see photo 15)

Photo 15: Purlins above Joints 18 & 16

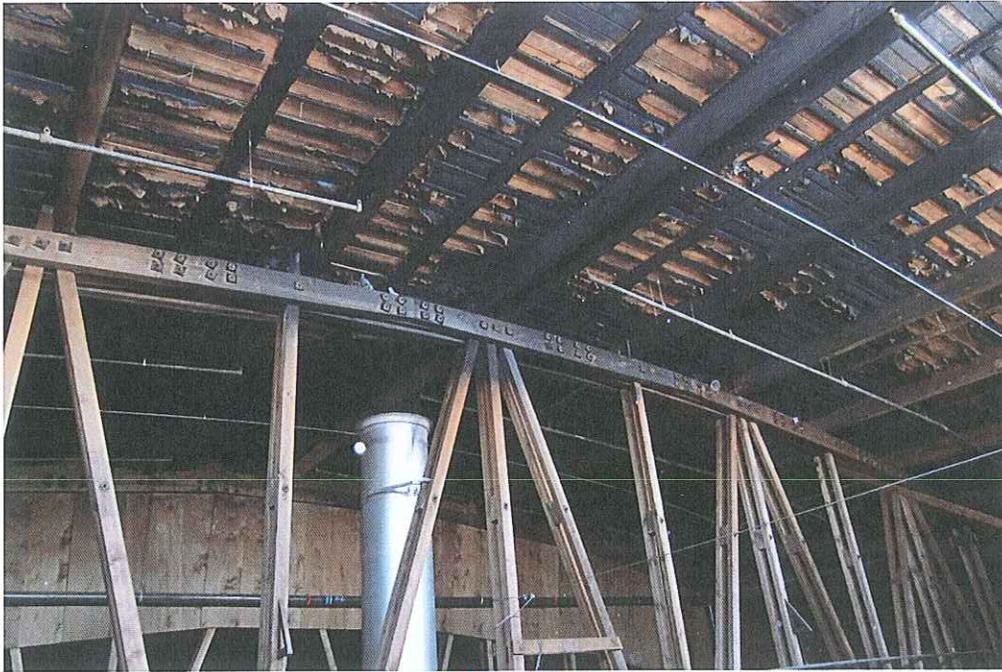
Truss two has experienced slight water and smoke damage, which is considered primarily cosmetic. There are no visible signs of direct fire contact with this member. While this member was heated during the course of the fire, it does not appear to be visibly damaged. It was noted that the center joint on the top chord was blackened with smoke (see photo 16). It is marked as having water damage due to the firefighting efforts and lack of intact fire sprinkler heads in the area of the fire. It is believed that this truss is sufficient to continue service without any structural repairs from fire damage. Any repairs scheduled for this truss due to prior inspections and adequacy testing should be performed while work is ongoing with Truss 1.

Photo 16: Truss 2, West Face
