Building 3005
Hanger 2

Year Built: circa 1943
Truss Construction: Wood Bowstring
Building Const: Wood
Roofing Material: Torch-down Membrane, Fair
Overall Condition: Poor
Repair Need: **Replacement Needed**

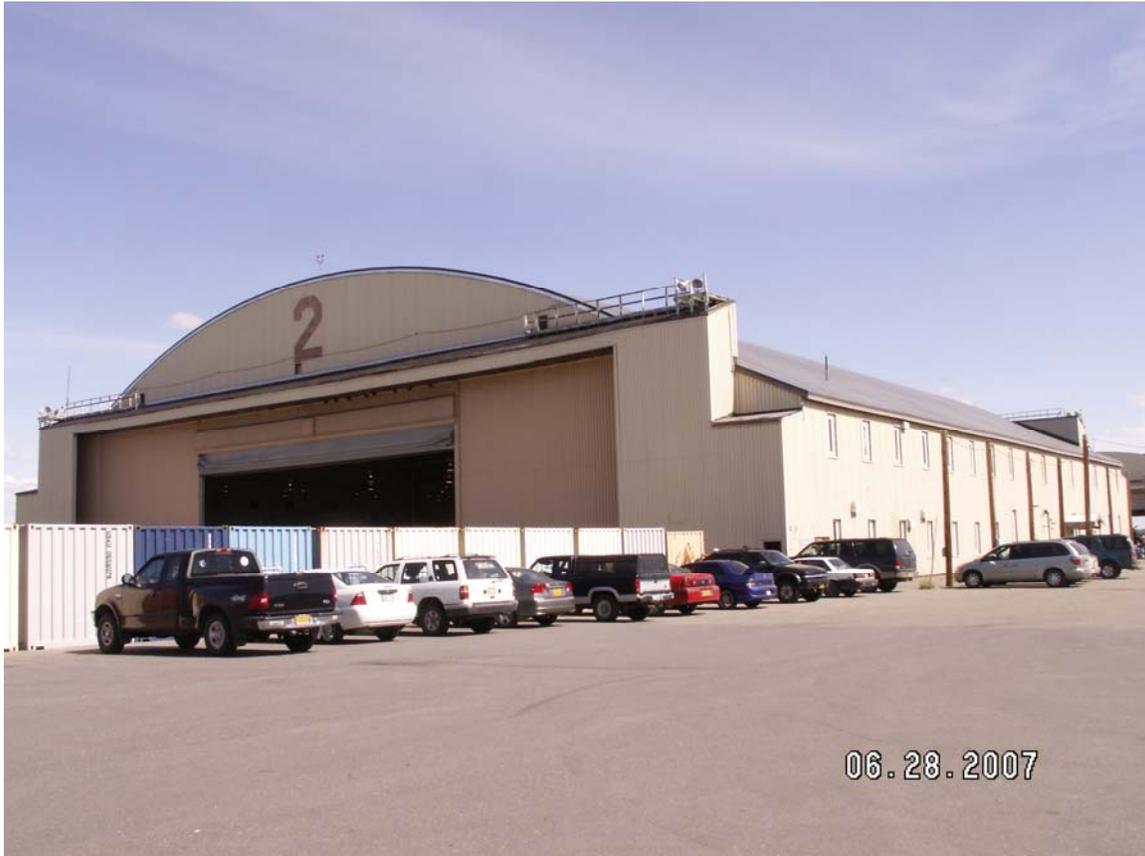
Photo #1 – Exterior View, West Side

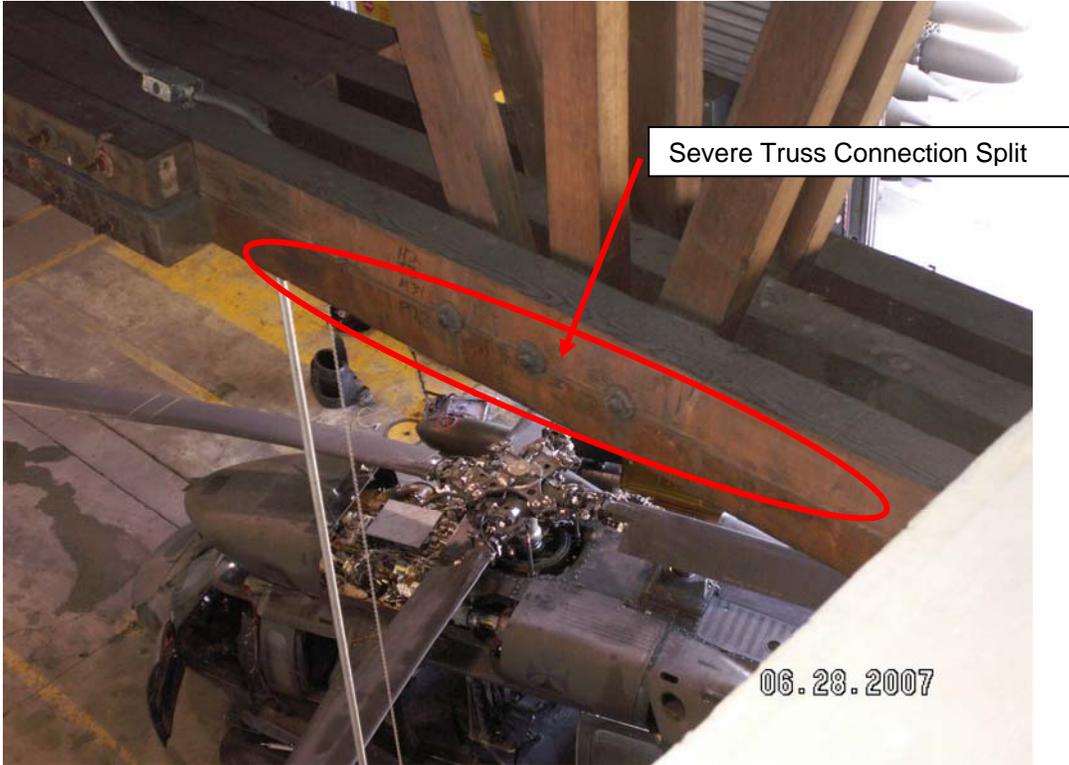
Truss #2 from the east end is in failure mode (see pictures #2 through #6) with lateral buckling and a split running along it's length. This truss needs immediate repair to mitigate any life safety issues. The other trusses vary from poor to fair condition with many of the truss connections showing signs of having been overstressed. A design analysis "Hanger Bowstring Truss Repair, Fort Wainwright, Alaska" dated June 24, 1987, by Loftus and Dailey, Inc. outlined general truss repairs for Hangers #2, #3 and #6. The report noted that some of the truss members were overstressed from 30 – 50% and the trusses as a whole were near their load-carrying capacity. Current inspection of

Photo #2 - Split truss bottom chord at a panel point.

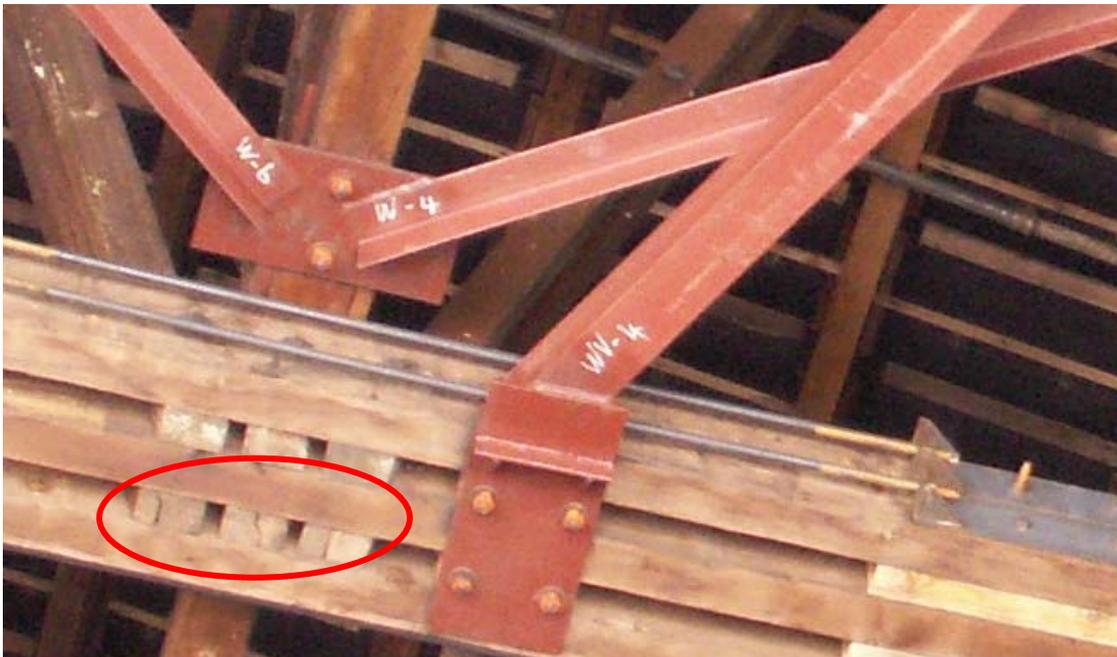
Photo #3 - Web members split through connection @ panel points.

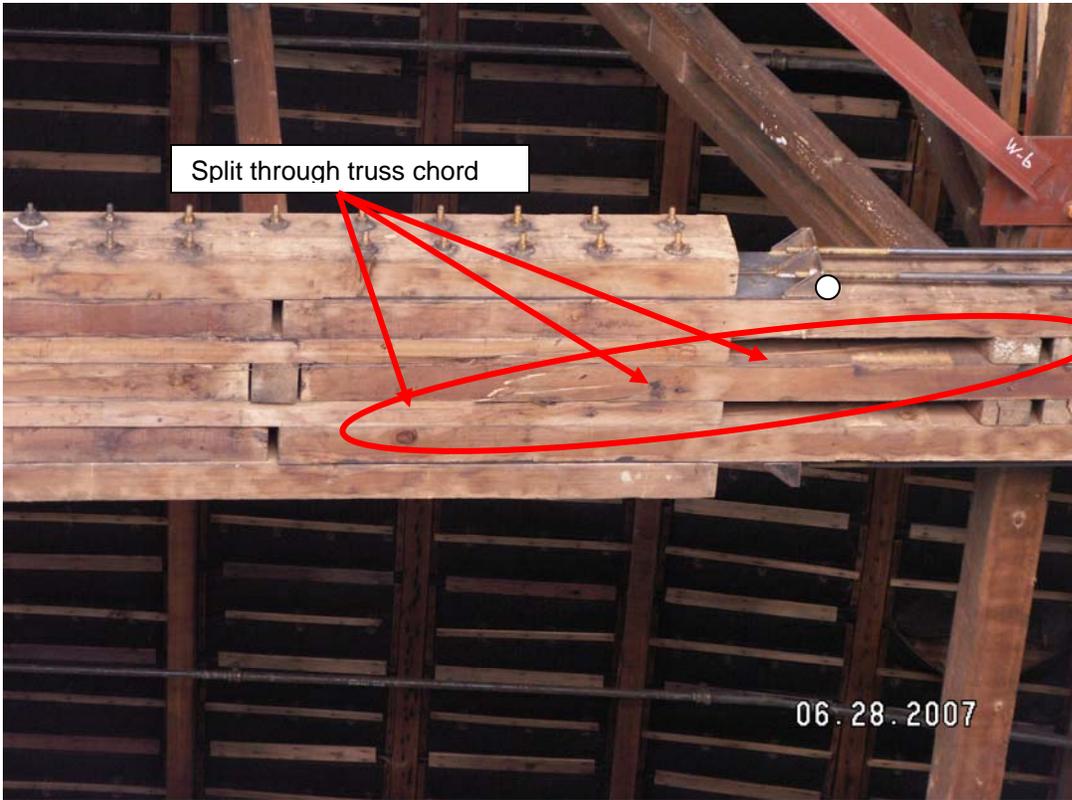
Photo #4 - Truss bottom chord fracture at repair.

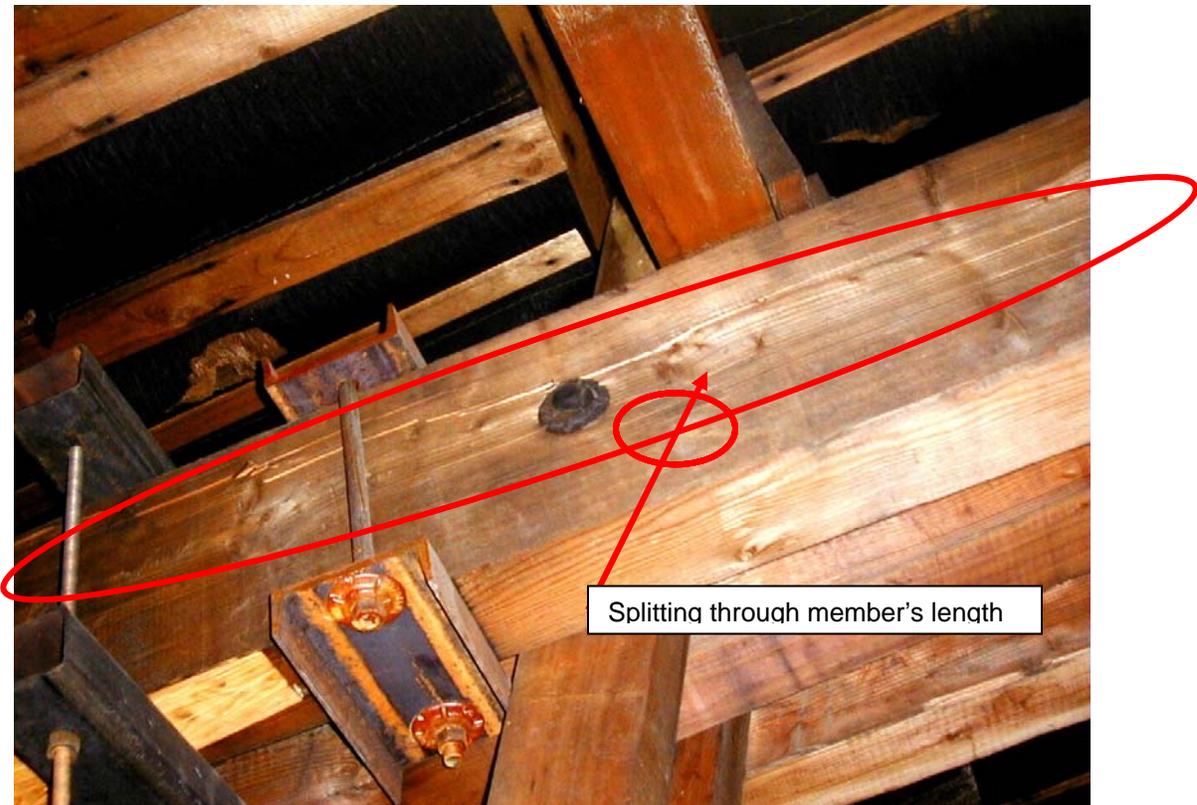
Photo #5 - Failing truss member (from 2003 report)

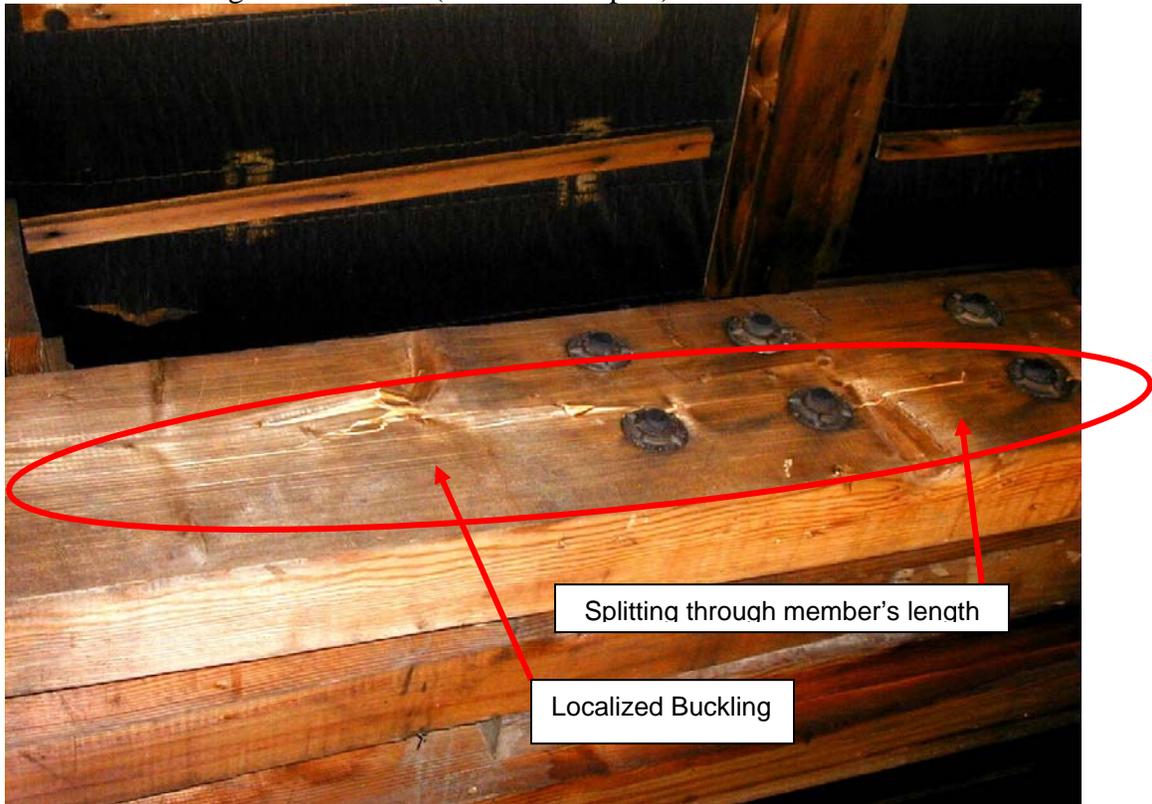
Photo #6 - Failing truss member, cont'd (from 2003 report)

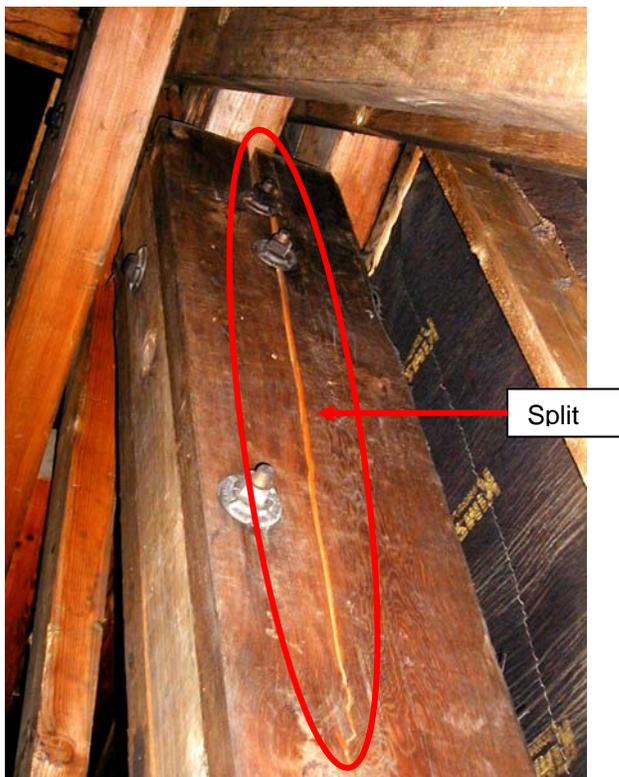
Photo #7 - Failed truss splice (from 2003 report)

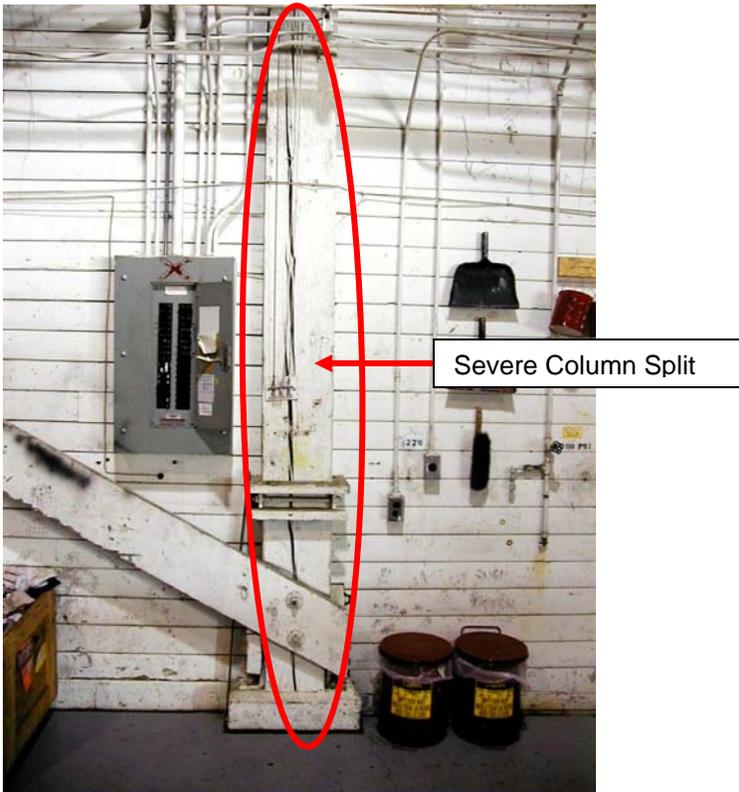
Photo #8 - Failing column (from 2003 report).

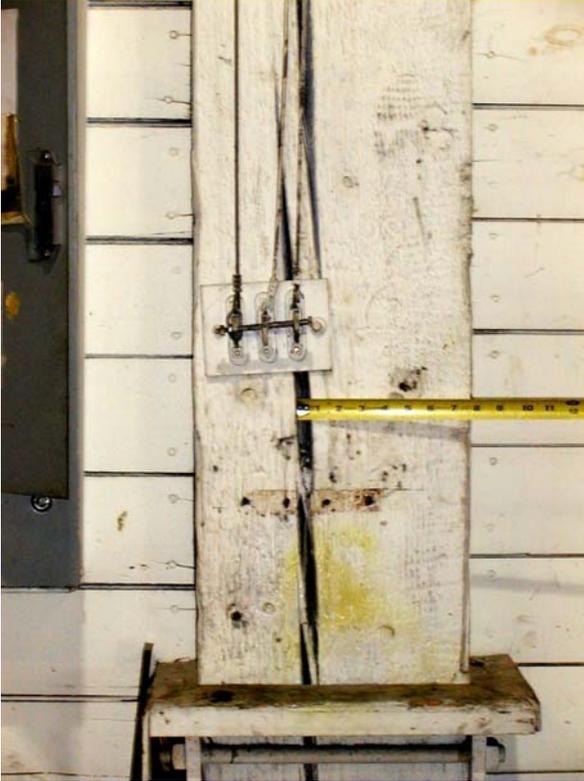
Photo #9 - Failing column closeup (from 2003 report).

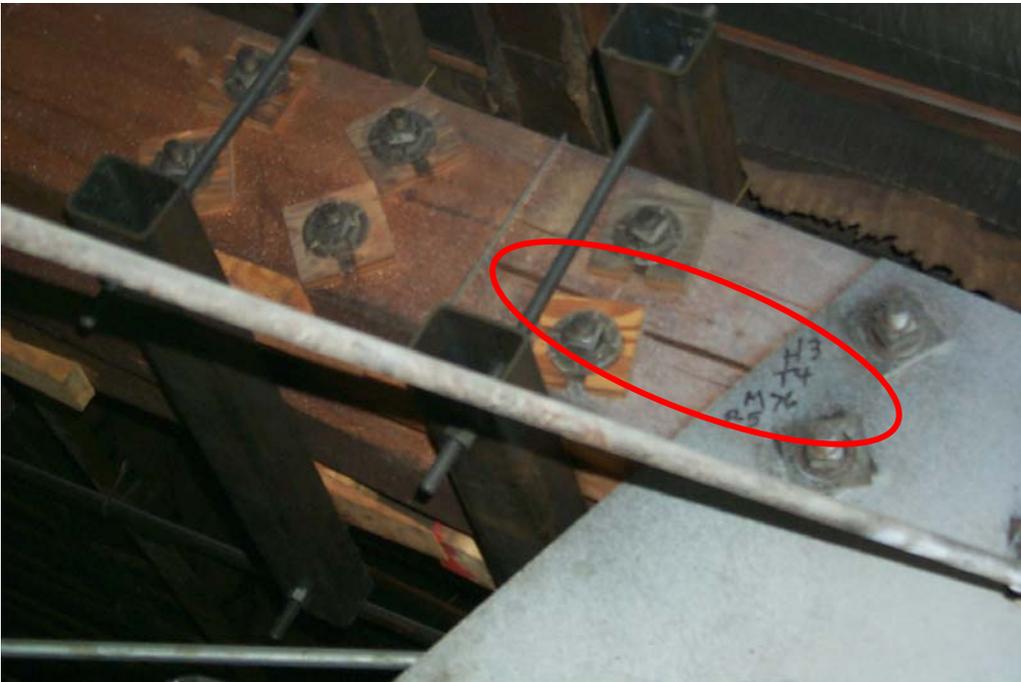
Photo #10 - Interior View Showing Repaired Truss Connection, Typical. Note extensive lateral cracks and truss repair clamps (taken from 2000 report).

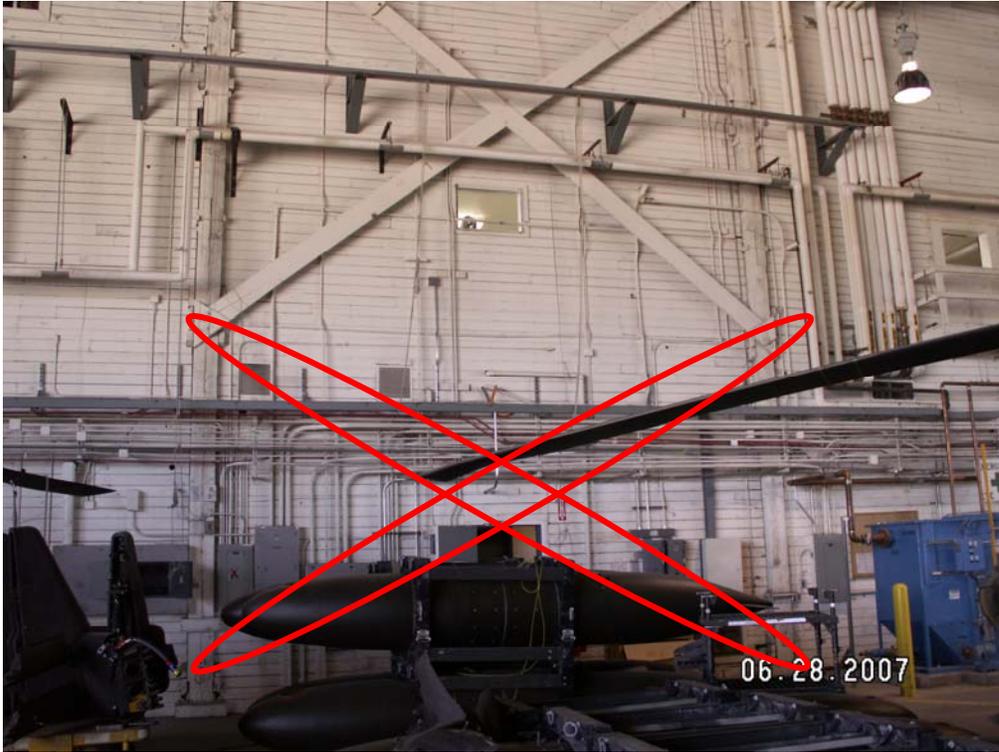
Photo #11- Removed lower cross bracing .

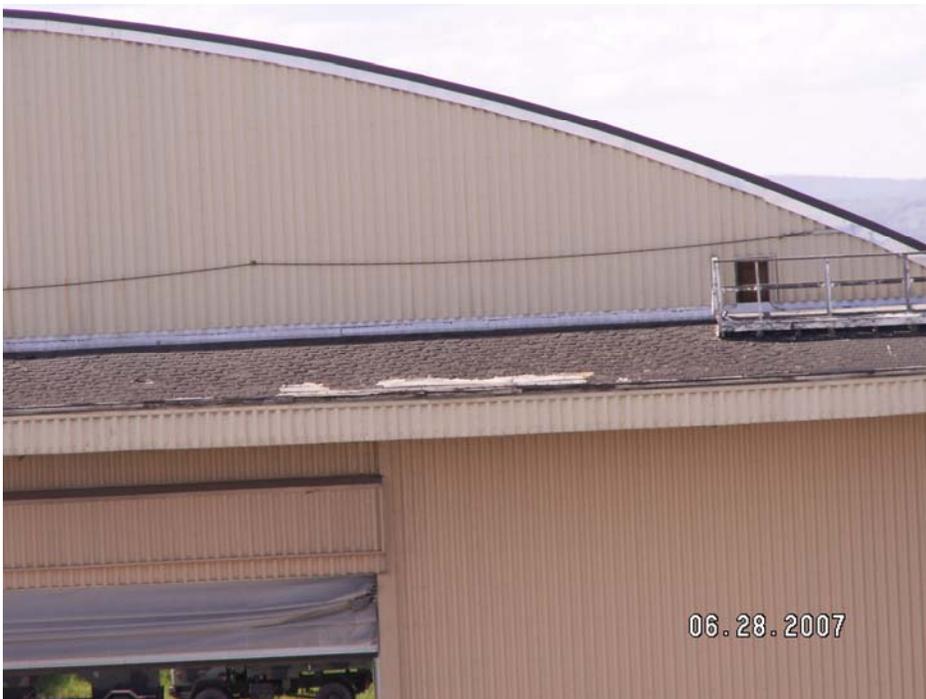
Photo #12 - Shingles on low roof above overhead doors need replacement.

The low roof shingles over the hangar doors need to be replaced to prevent decay of the framing at the ends of the building.

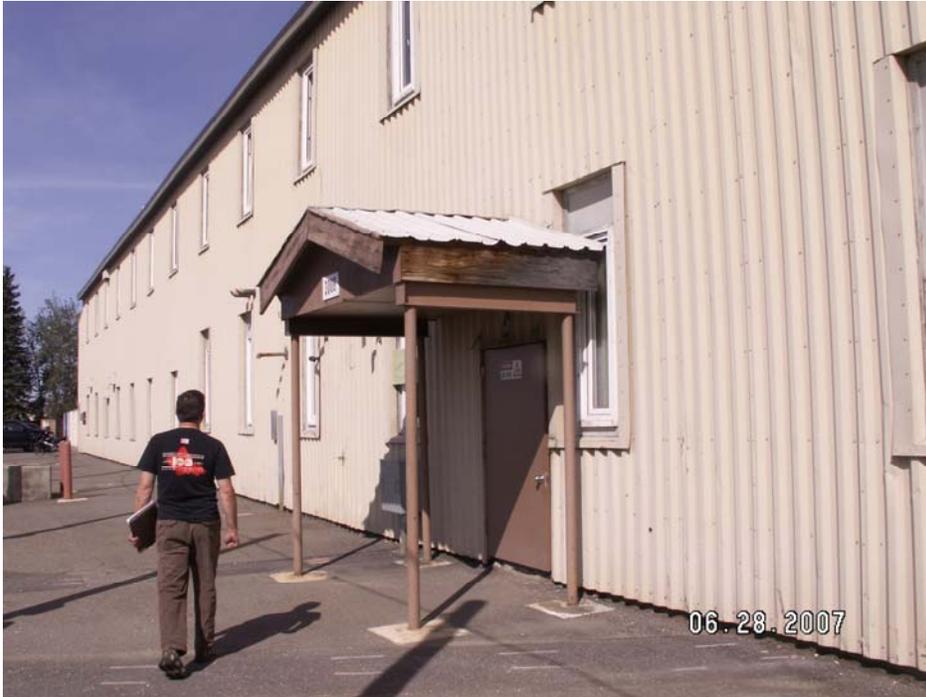
The entry canopy is in a weathered deteriorated condition.

Photo #13 - Metal roof and fascia on the South canopy is in a weathered condition.
