CONDITION ASSESSMENT AND REHABILITATION PLANS, HANGARS 2 AND 3, LADD FIELD NATIONAL HISTORIC LANDMARK FORT WAINWRIGHT, ALASKA

*Final Submission
January 2008*

As part of a Cooperative Agreement with the United States Army Environmental Center (USAEC), The Louis Berger Group, Inc. (Berger) was tasked to produce a Condition Assessment and Rehabilitation Plan (CARP) for use by the Department of the Army to determine the feasibility and use of the World War II era hangars to meet current and future anticipated mission needs associated with the projected move of the Aviation Task Force at Fort Wainwright, Alaska.

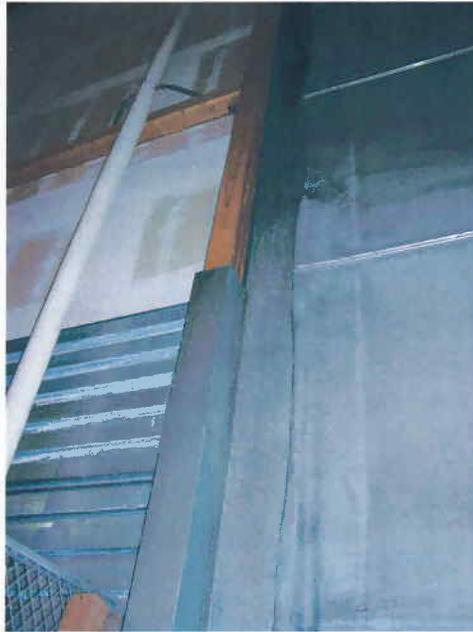
Figure 3.1 Exterior Hangar wall and door - Hangars 2 & 3.

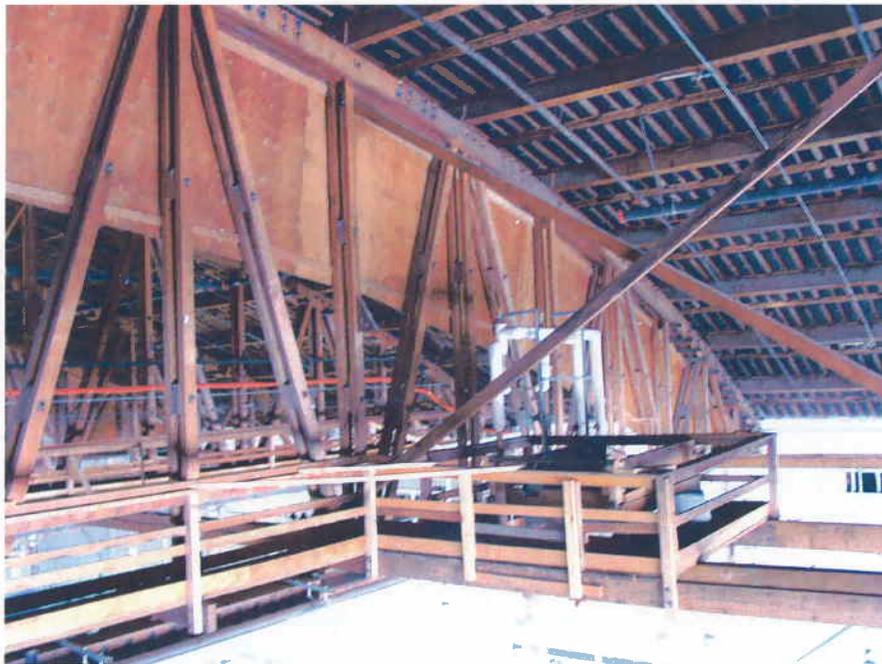
Figure 3.2 Wood Truss, existing draft stop, and catwalk - Hangars 2 & 3.

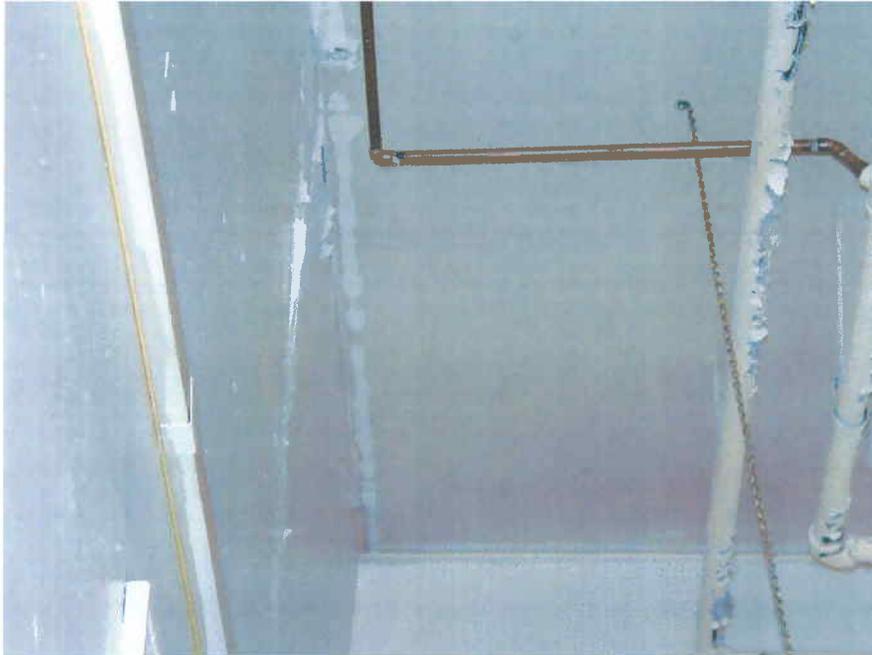
Figure 3.5 Gypsum board failure and repair at exterior wall - Hangar 3.

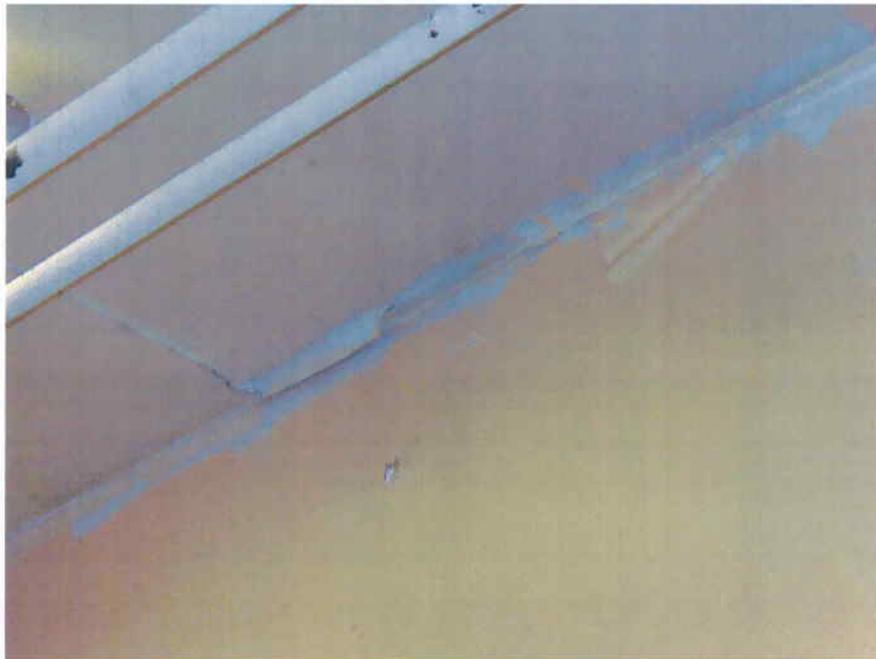
Figure 3.6 Gypsum board failure and repair at exterior wall - Hangar 3.

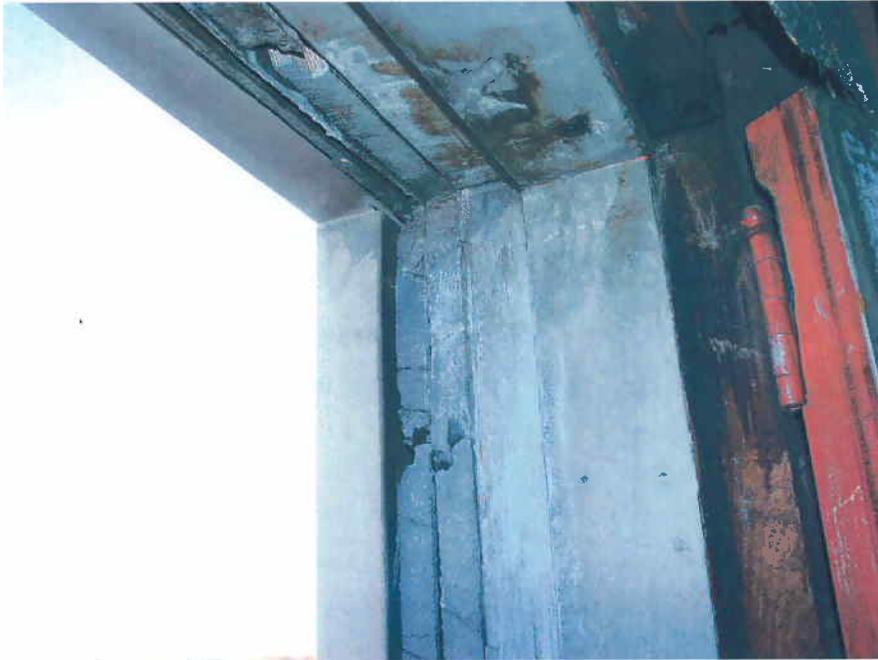
Figure 3.7 Above catwalk exterior access doors - head conditions - Hangars.

23. Repair or (if repair is not possible) replace all exterior doors and frame openings above the catwalks, including repairs/upgrades to the catwalks and exterior balconies (Tab 3).

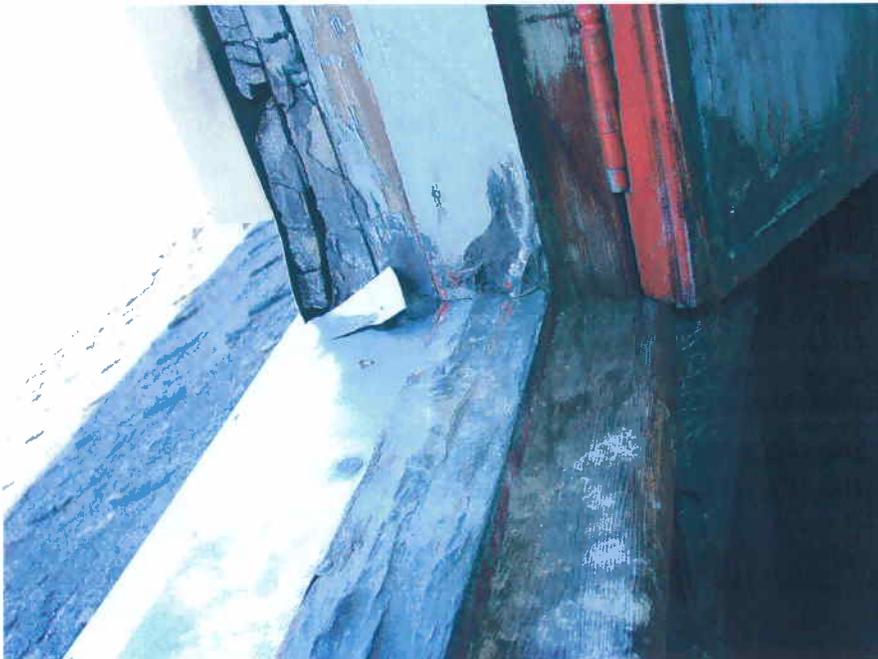
Figure 3.8 Above catwalk exterior access doors - sill condition - Hangars 2 & 3.

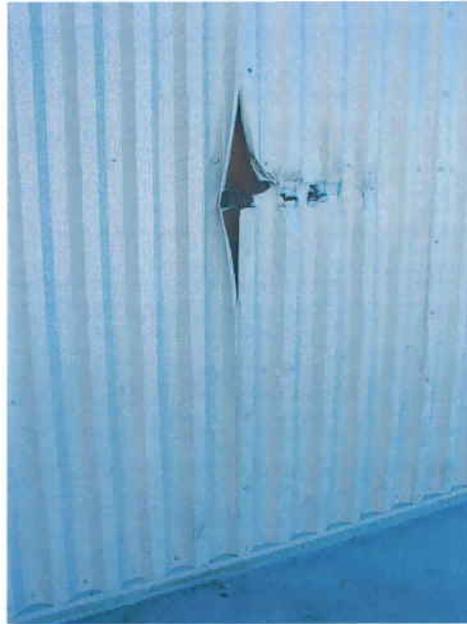
Figure 3.9 Exterior siding damage Hangars 2 & 3.

21. Replace existing exterior wall assemblies with new - to include vapor retarders, insulation, repairs to framing and new visually appropriate, low-maintenance, pre-finished exterior metal siding that replicates the historic original coursing of the siding (Tab 3).

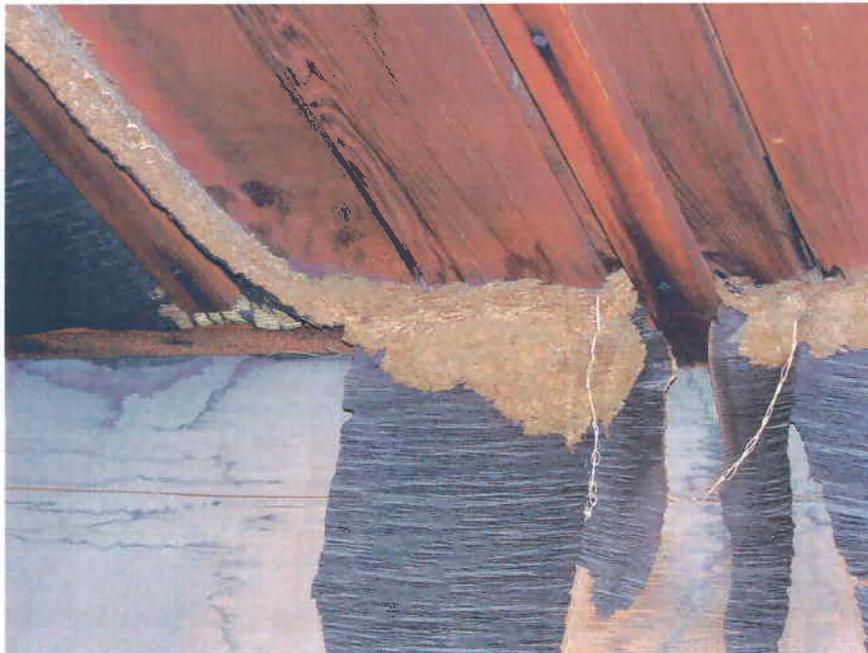
Figure 3.10 Roof insulation at underside of decking held in place with furring strips - Hangars 2 & 3.

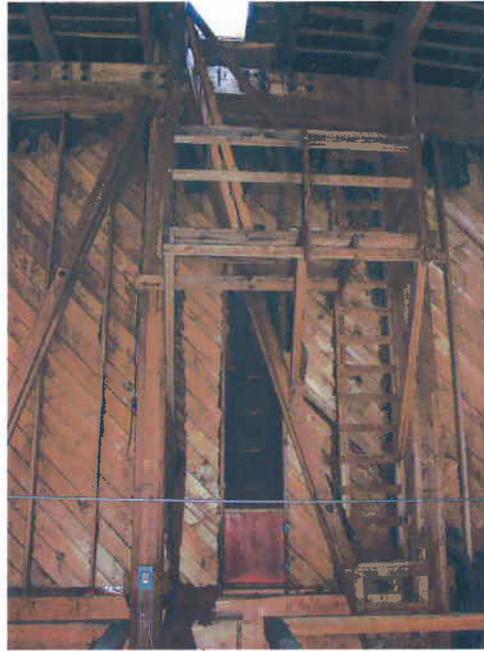
Figure 3.11 Inadequate vapor retarder at exterior walls - Hangars 2 & 3.

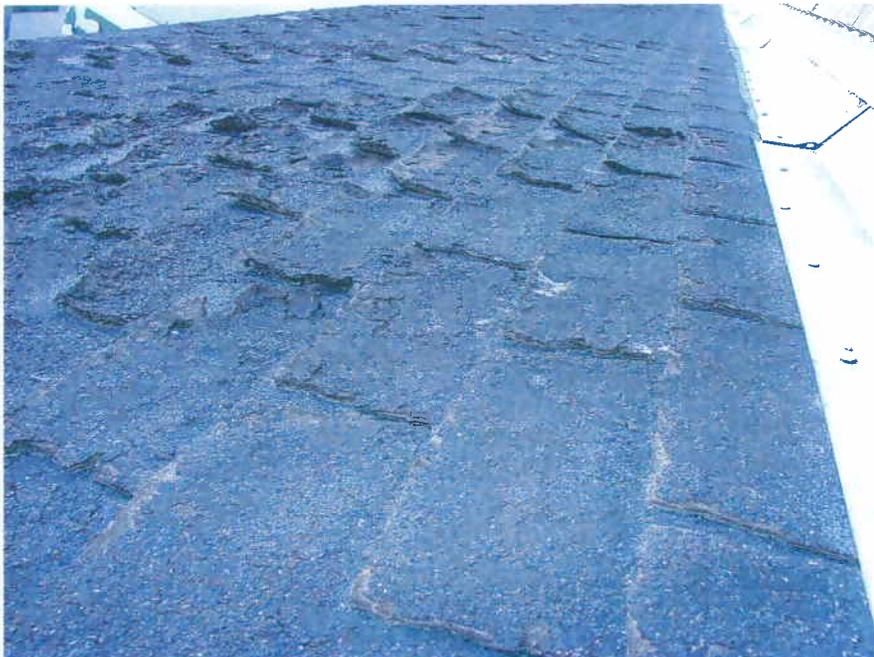
Figure 3.12 Asphalt shingles - over hangar doors - Hangars 2 & 3.

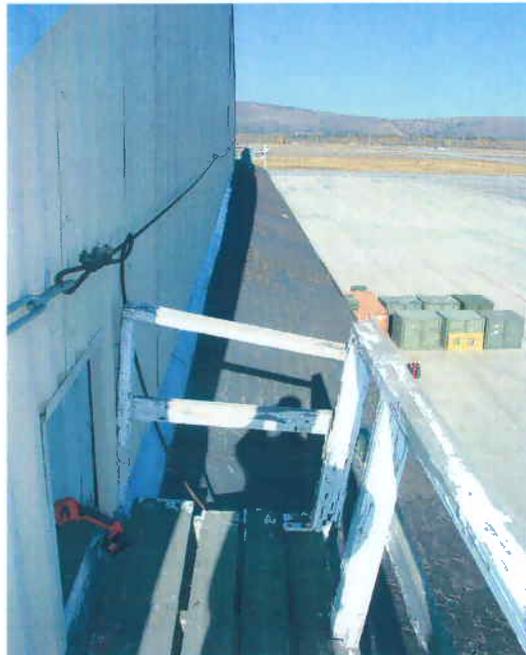
Figure 3.14 Failing asphalt shingles and rotten exterior wood platforms - Hangars 2& 3.

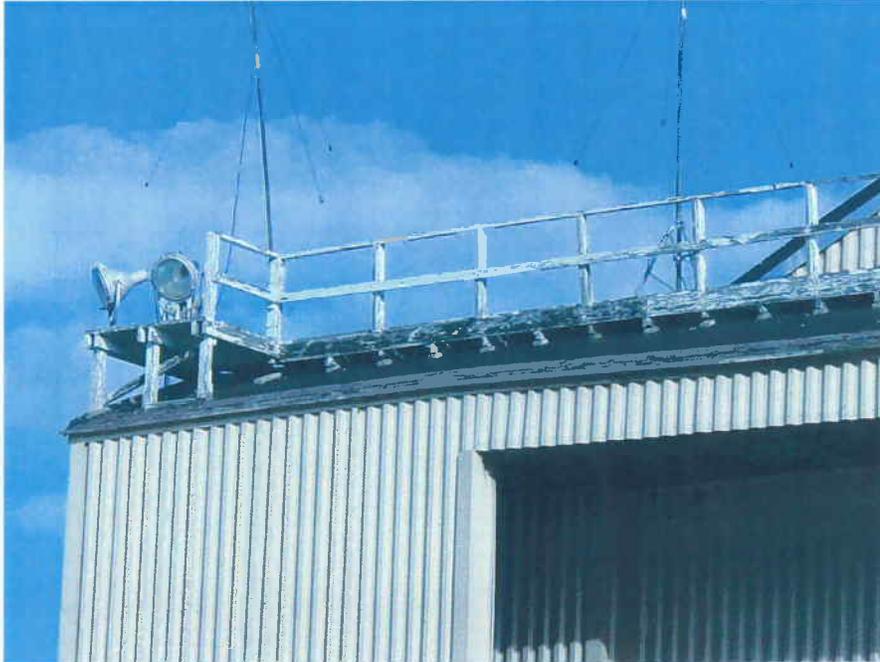
Figure 3.15 Rotten exterior wood platform railings - Hangars 2 & 3.

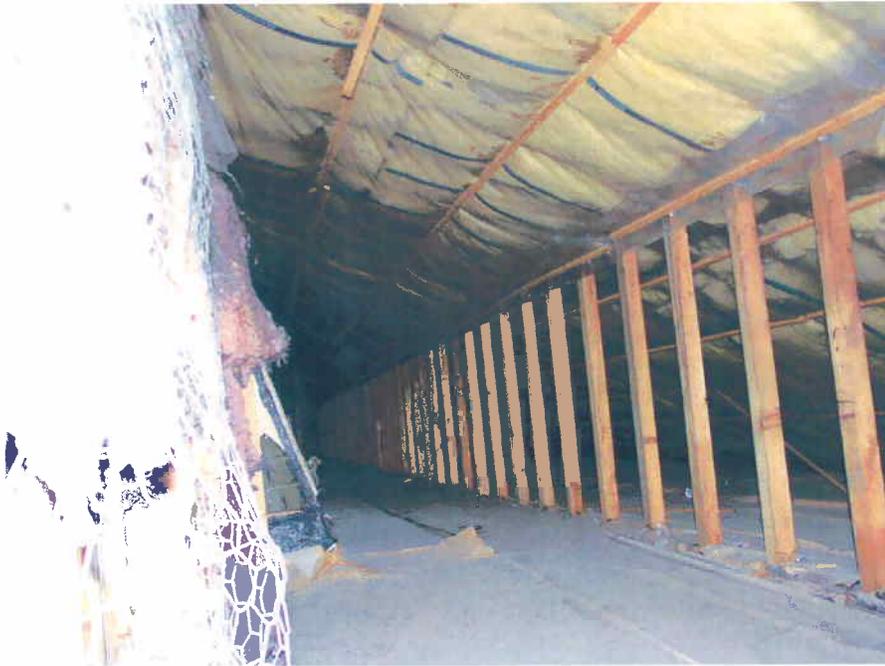
Figure 3.17 Support bay failing roof furring - Hangars 2 & 3.

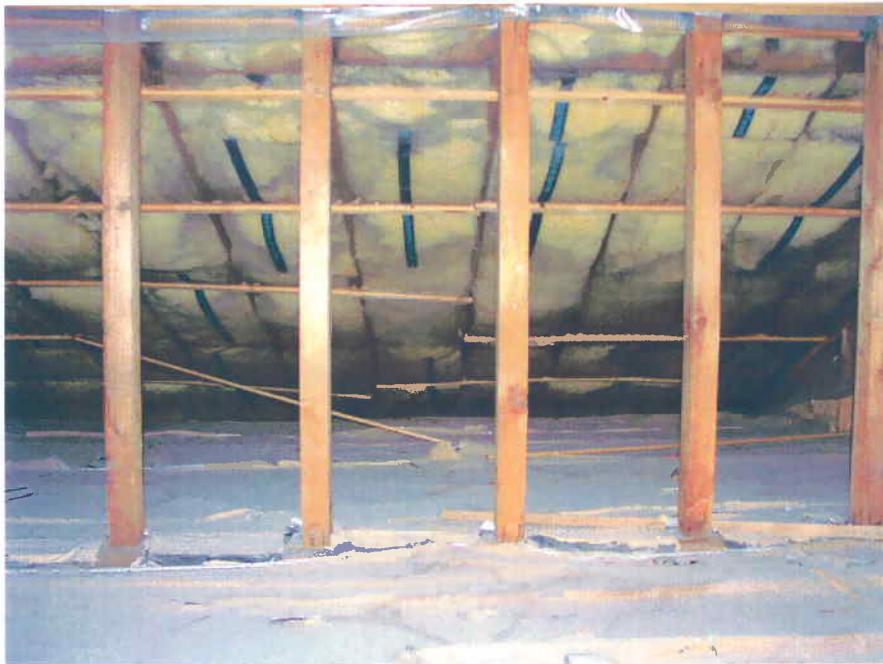
Figure 3.18 Support bay roof furring - Hangars 2 & 3

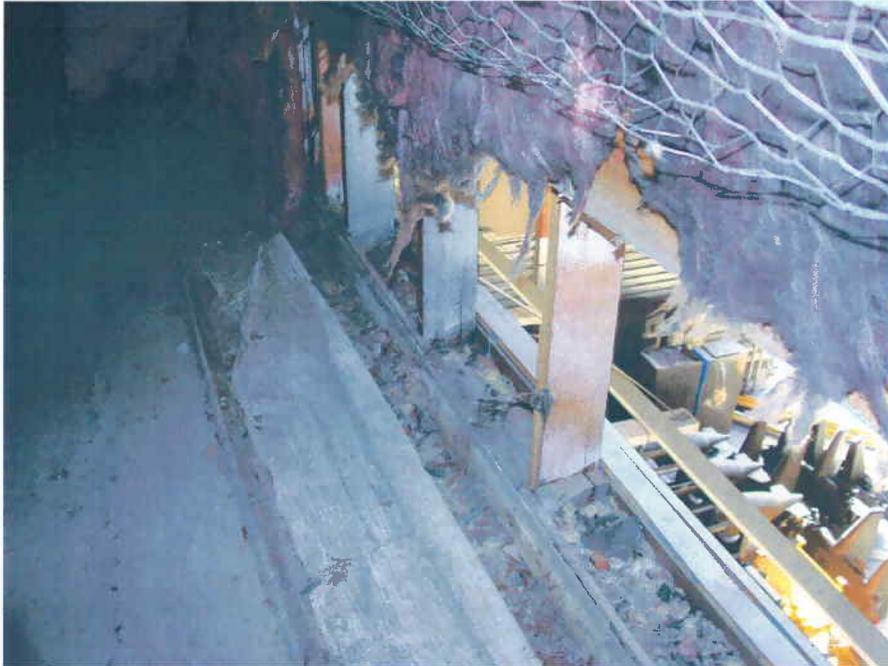
Figure 3.19 Un-rated wall between support bay roof and hangar bay - Hangar 2.

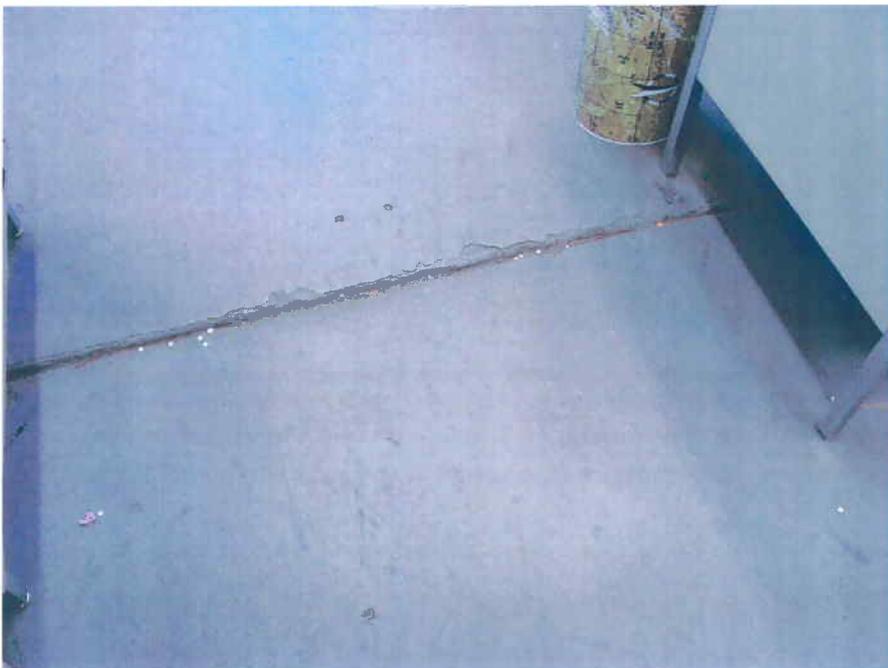
Figure 3.20 Concrete floor slab settlement in support bays - Hangars 2 & 3.

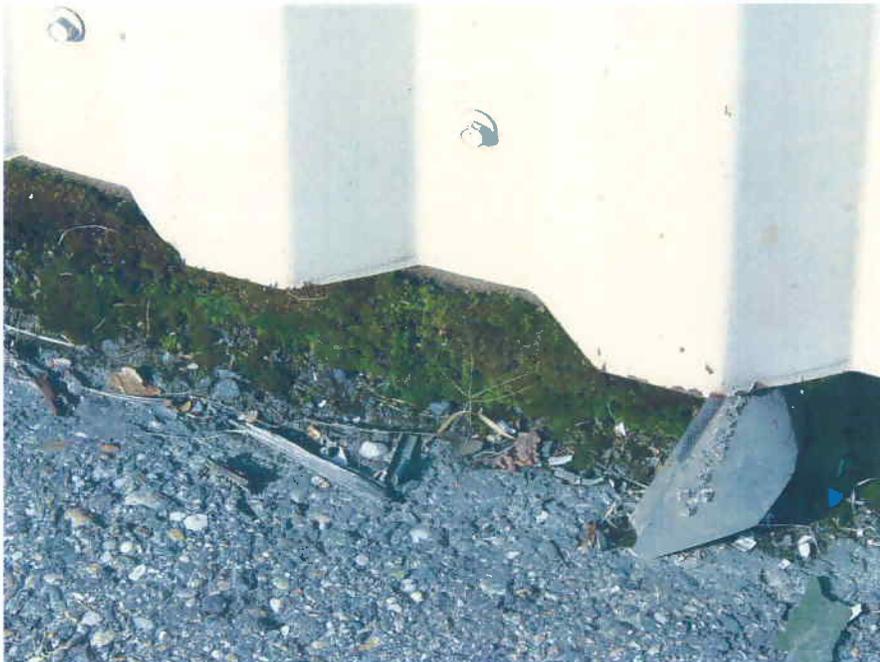
Figure 3.24 Moisture problem (moss) at exterior wall base - north side
- Hangars 2 & 3.

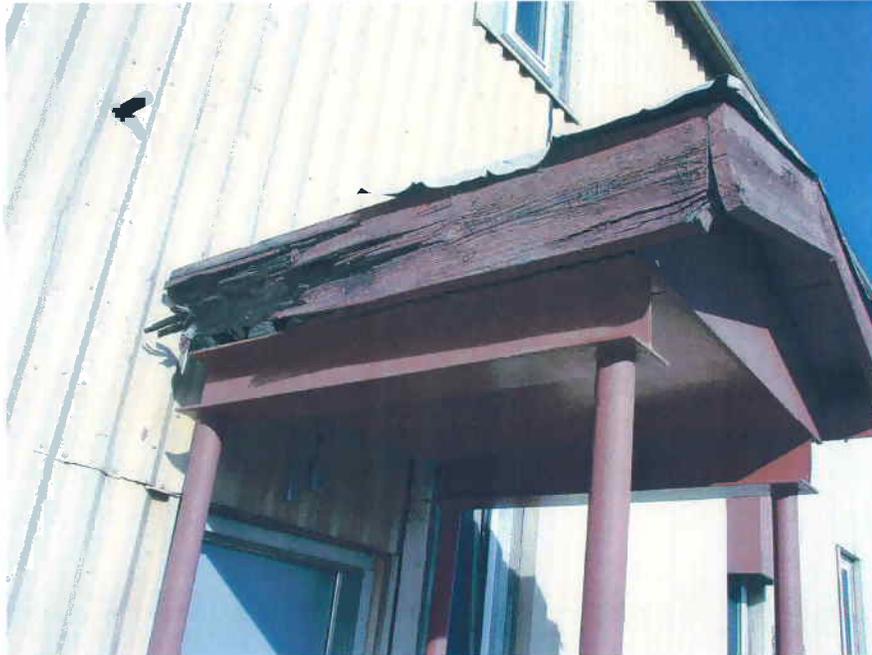
Figure 3.25 Rotted canopy fascia board - Hangars 2 & 3.

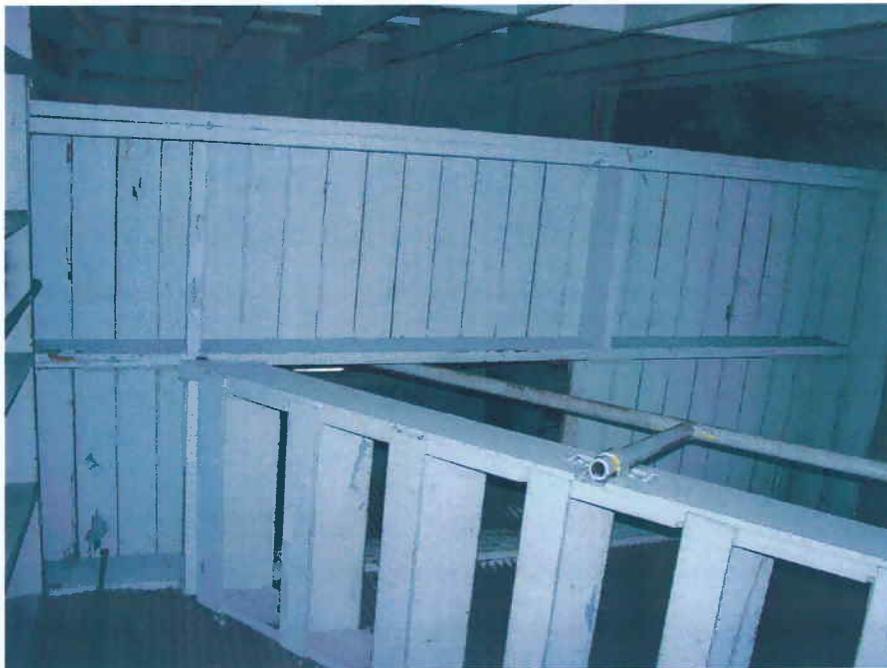
Figure 3.32 Exterior Stair tower, landing from below, pipe railings - Hangars 2 & 3.

6. Replace wood stair towers in all four corners of the building (all are badly rotted and cannot carry the occupant loads) with new steel pan stairs that will be consistent with IBC requirements for occupant loading, and including compliant handrails, treads, risers, nosings and stringers. Reconstruct the badly deteriorated stair tower enclosures with new noncombustible materials that can withstand the weather but which are visually consistent in scale and character with the original, including asphalt composition roof shingles. Replace thresholds at second floor exit doors (Tab 5). Estimated cost: \$130,465.

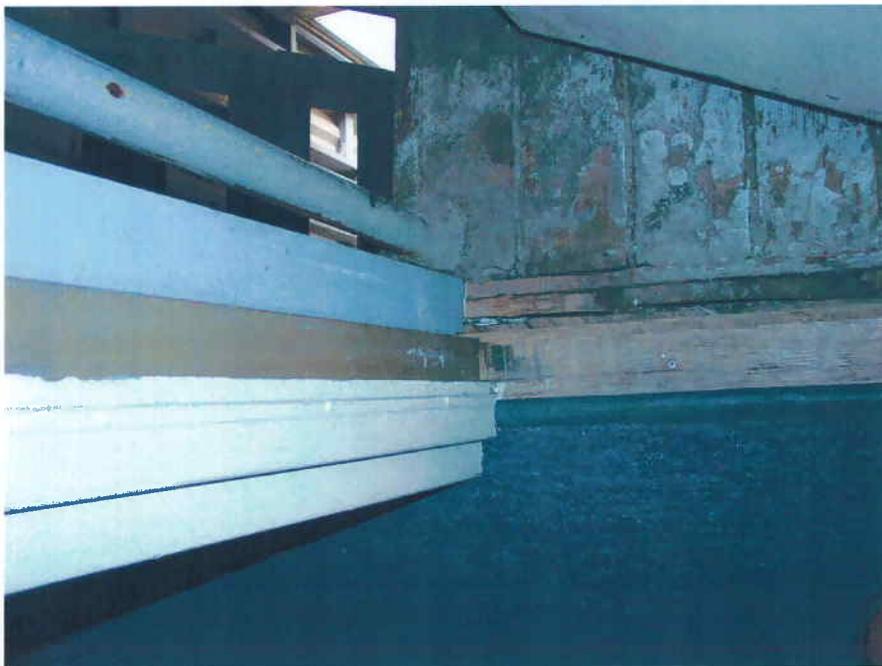
Figure 3.34 Exterior stair tower, threshold at exit door - Hangars 2 & 3.

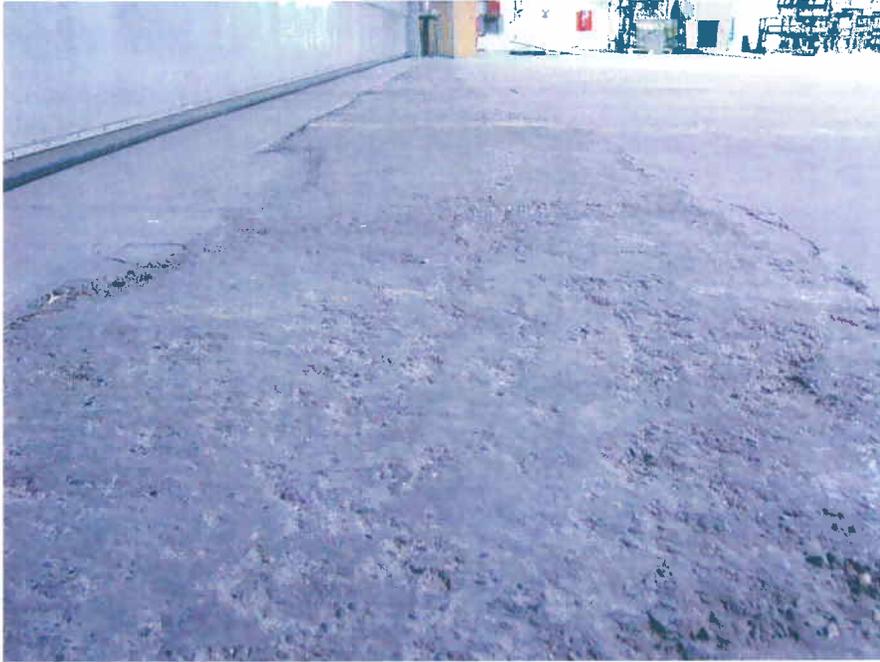
Figure 3.35 Spalling concrete outside at hangar door entry apron - Hangars 2 & 3.

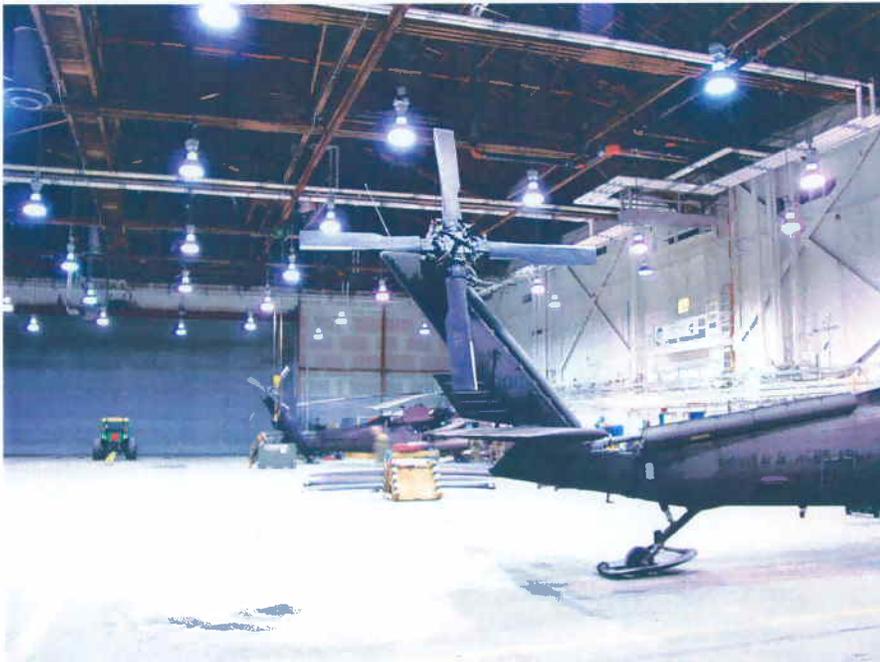
Figure 3.36 No slope to hangar floors at Hangars 2 & 3 - view at floor slab level.

3. Install new hangar bay slab drainage system, including all necessary piping to carry water 400’ away from the building, and including a new, properly-sloped concrete floor. This is necessary if the buildings continue to be used for helicopter maintenance and repair - (Tab 6 and Tab 8). Estimated direct cost: \$277,422.

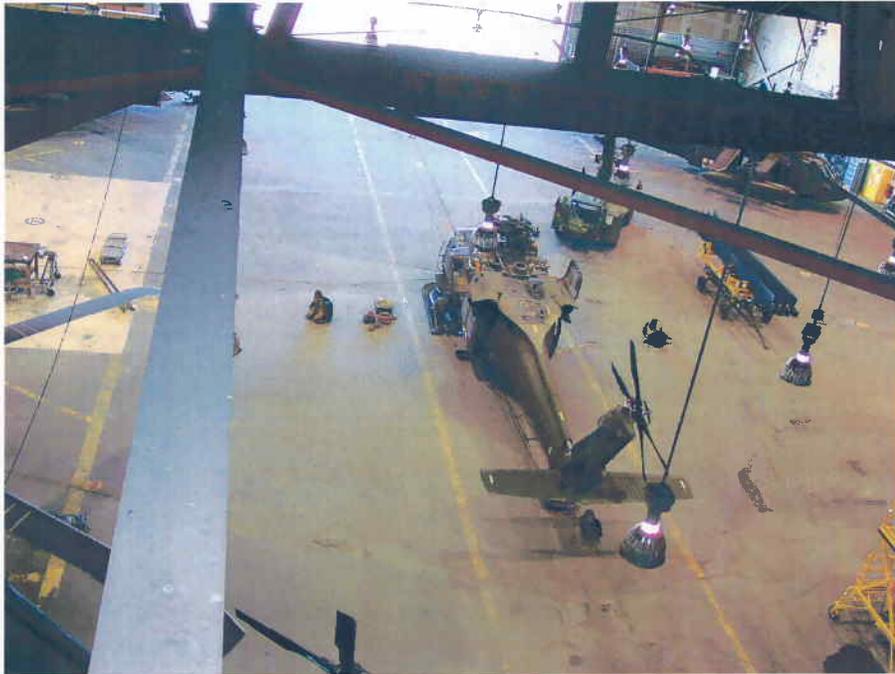
Figure 3.37 No slope to hangar floor at Hangars 2 & 3 - view from catwalk.

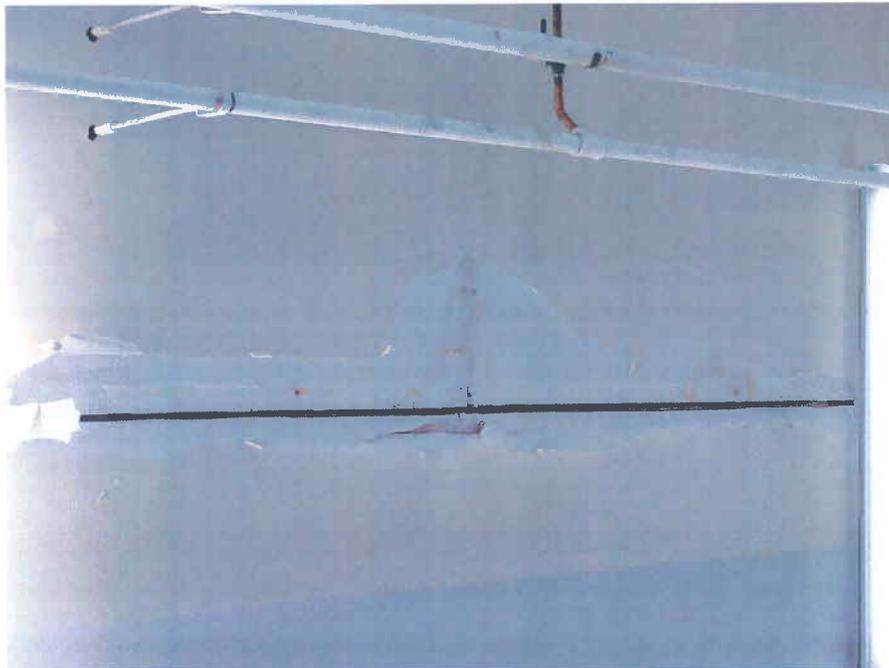
Figure 3.44 Interior ceiling condition - Hangars 2 & 3.

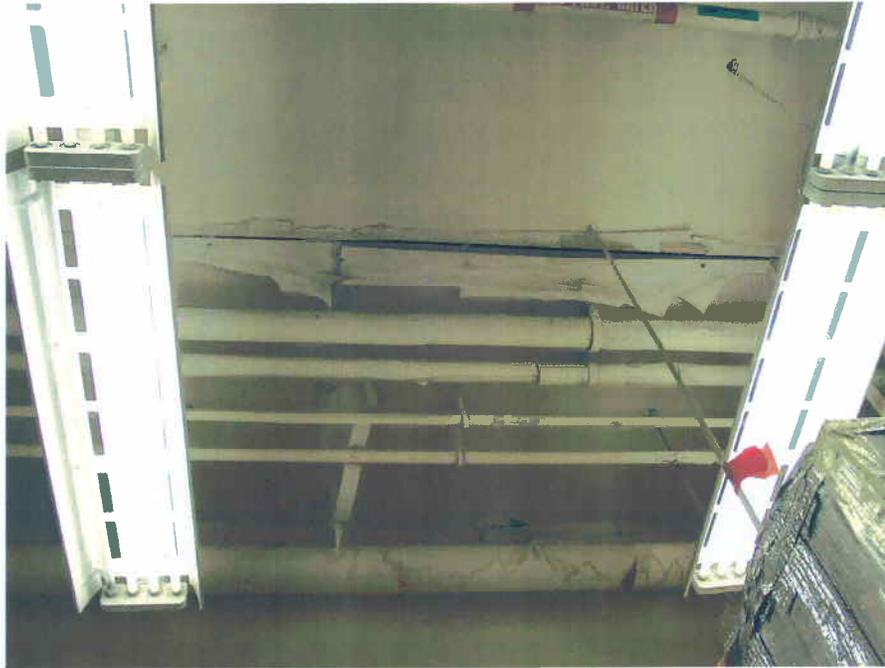
Figure 3.45 Interior ceiling damage - Hangars 2 & 3.

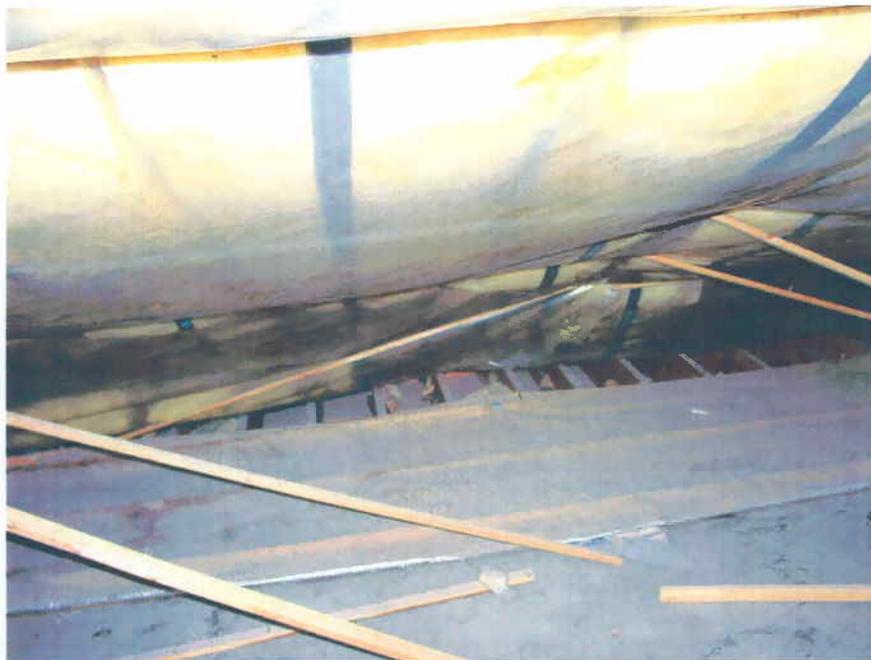
Figure 3.46 Floor/ceiling support bay roof cavity at exterior walls.

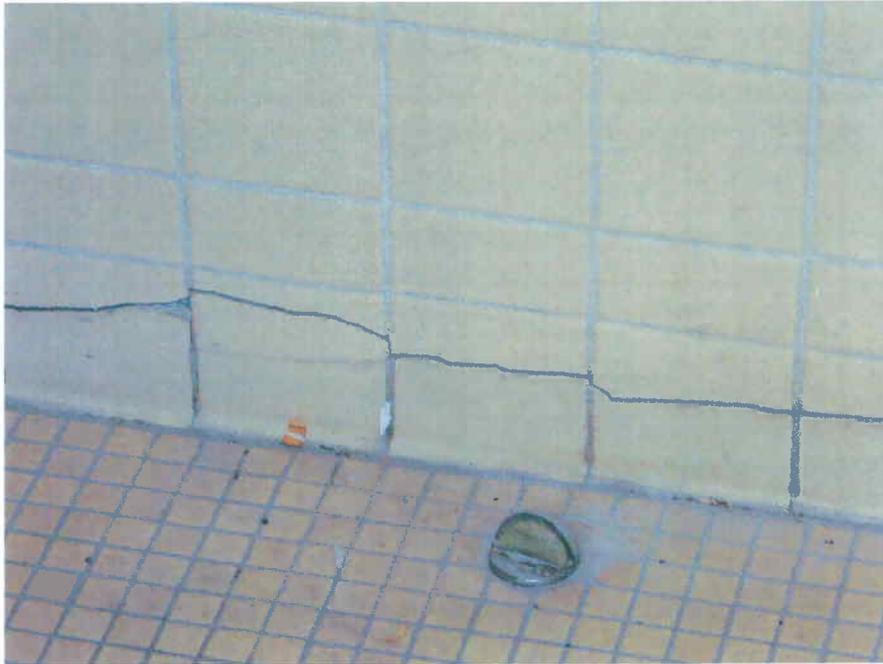
Figure 3.49 Base of ceramic tile walls - Hangars 2 & 3.

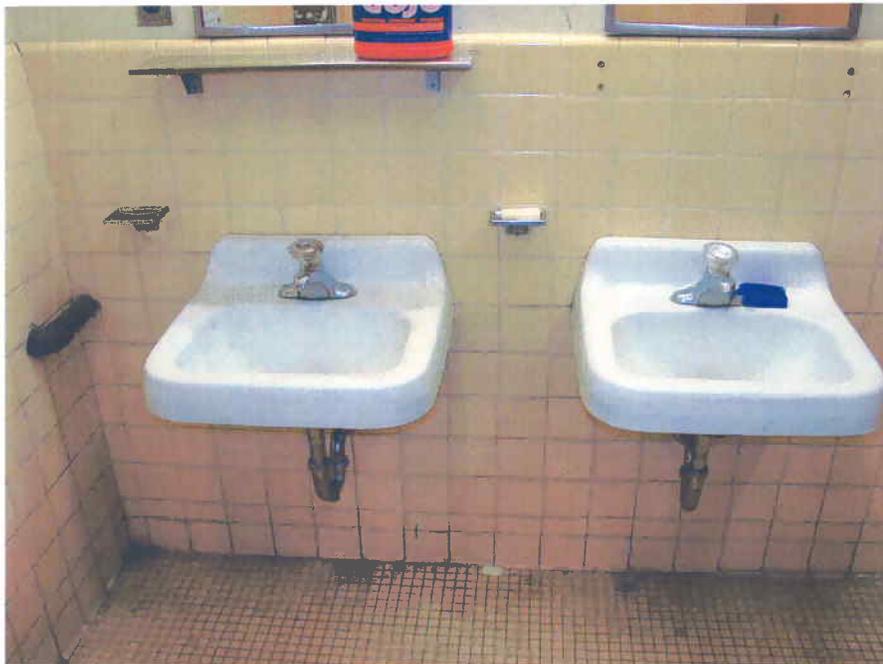
Figure 3.50 Ceramic tile walls at sinks - Hangars 2 & 3.

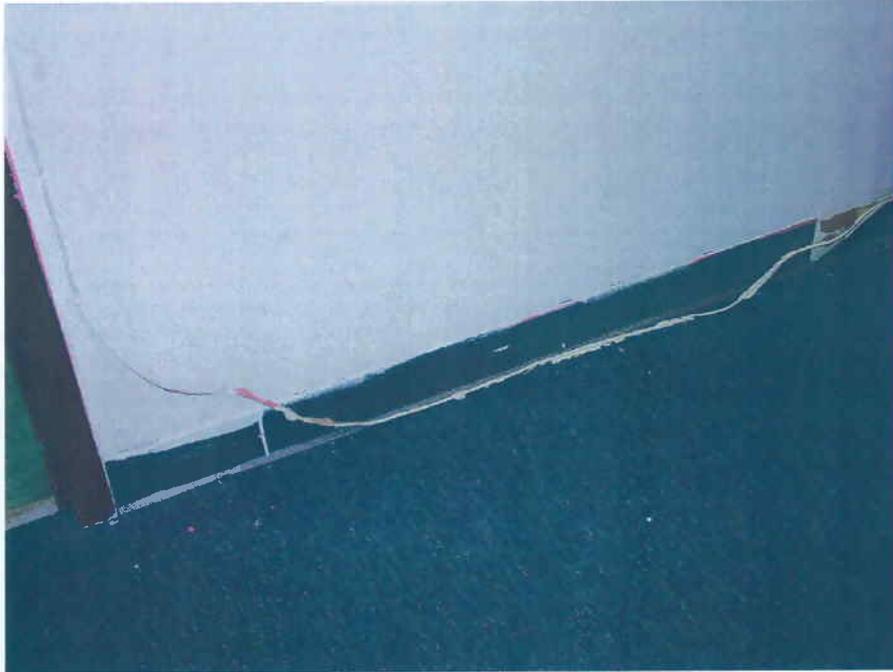
Figure 3.51 Base and wiring at walls - Hangars 2 & 3.

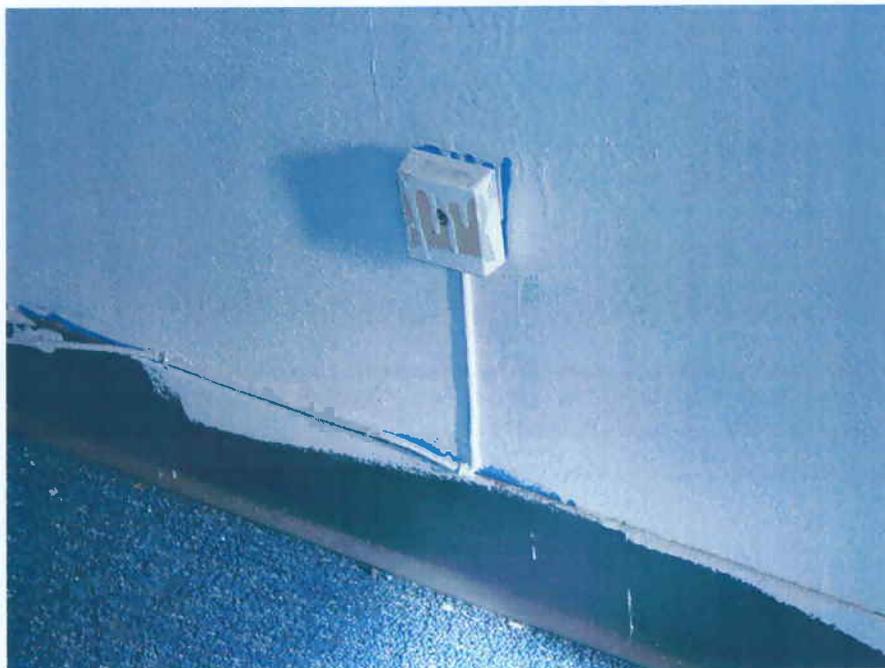
Figure 3.52 Comm. outlet, wiring and base at walls - Hangars 2 & 3.

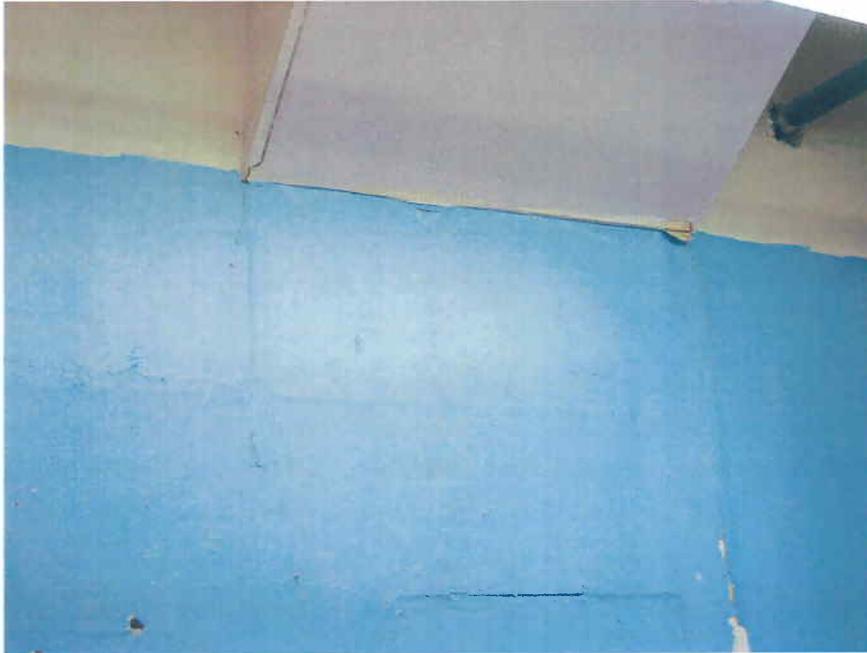
Figure 3.53 Cracks in wall finish - Hangars 2 & 3.

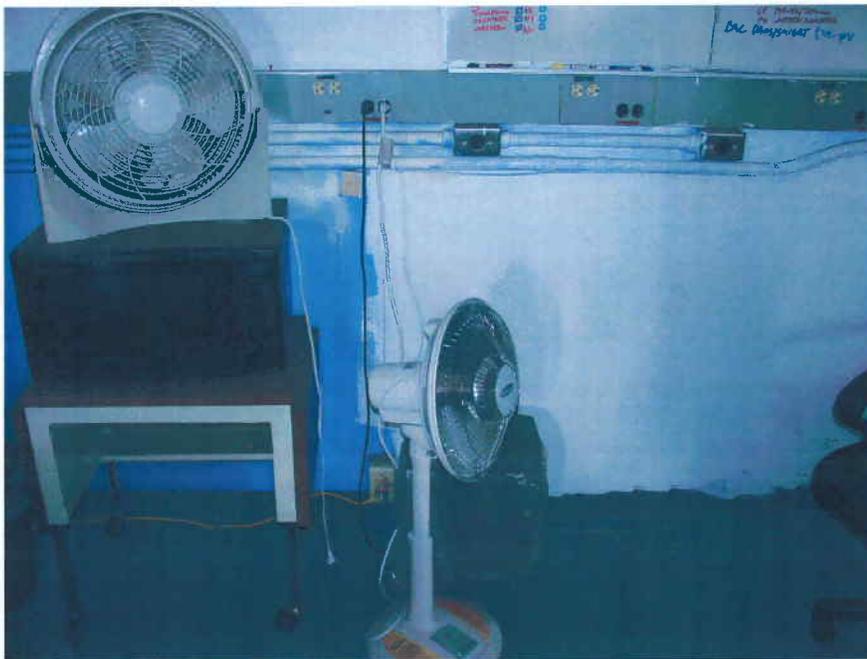
Figure 3.54 Wiring and wall finish - Hangars 2 & 3.

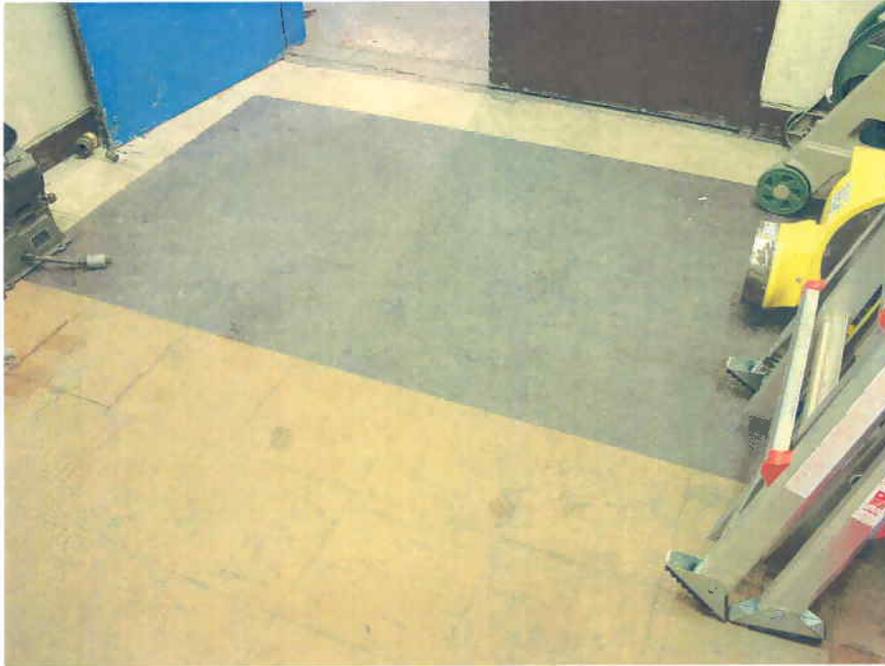
Figure 3.55 Floor finish changes - Hangars 2 & 3.

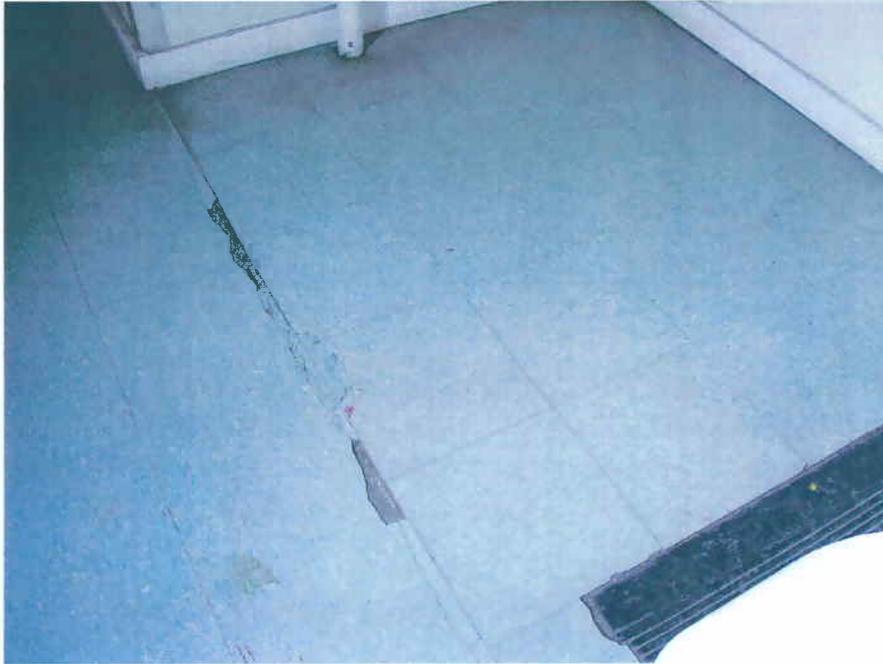
Figure 3.57 Chipped floor finish - Hangars 2 & 3.

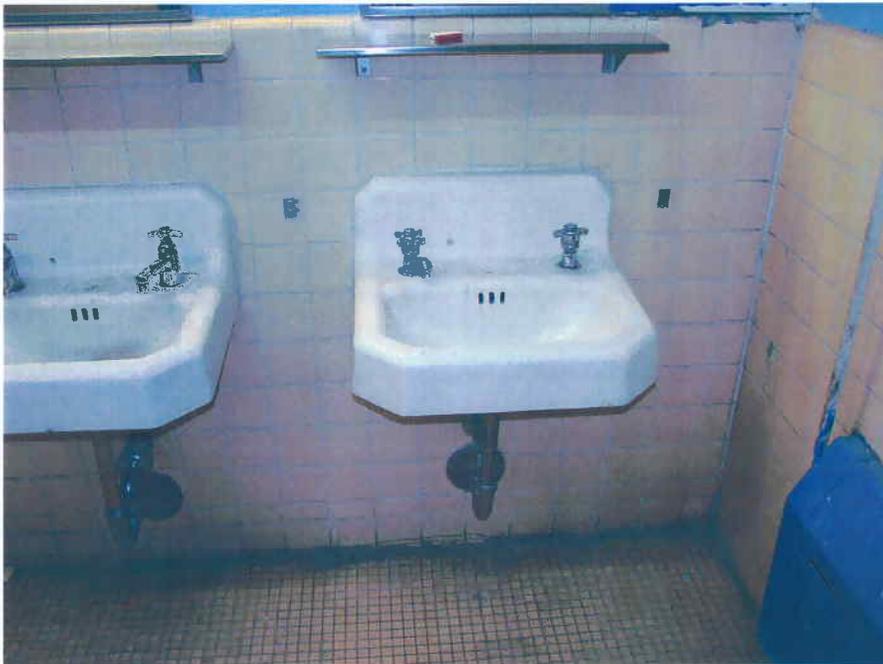
Figure 3.58 Damaged base/tiles floor finish - Hangars 2 & 3.

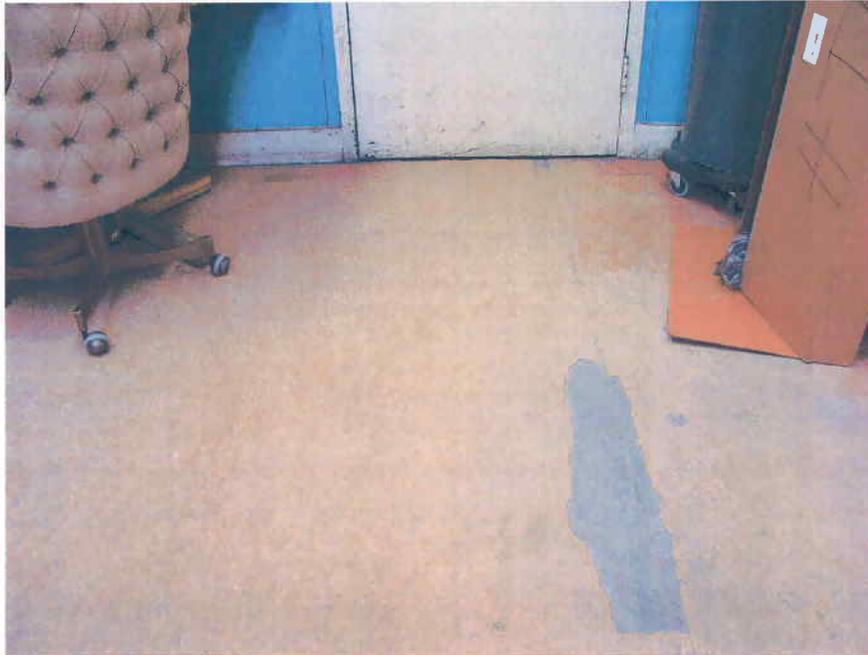
Figure 3.59 Chipped tiles - floor finish - Hangars 2 & 3.

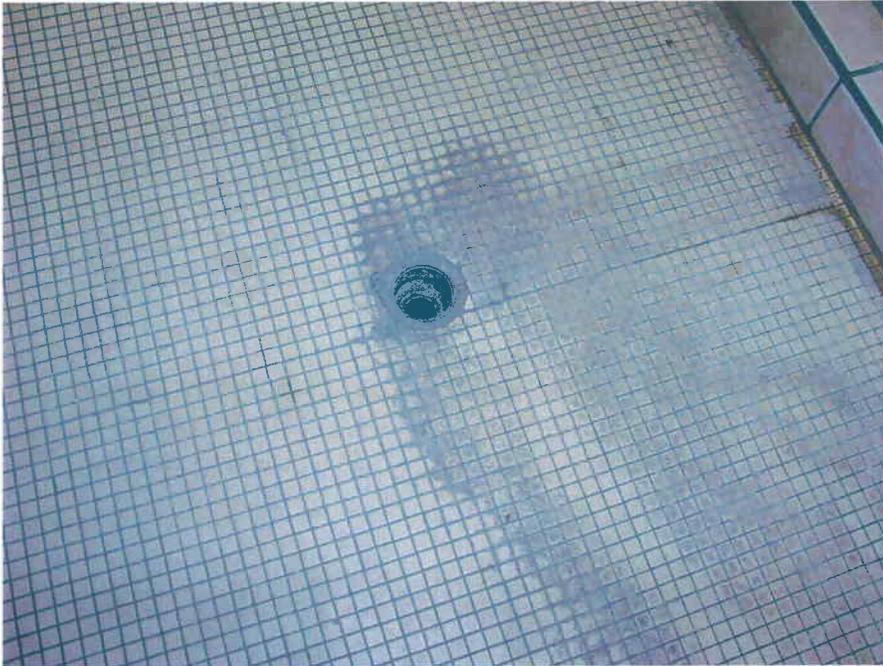
Figure 3.65 Ceramic tile floor and drain without cover - Hangars 2 & 3.

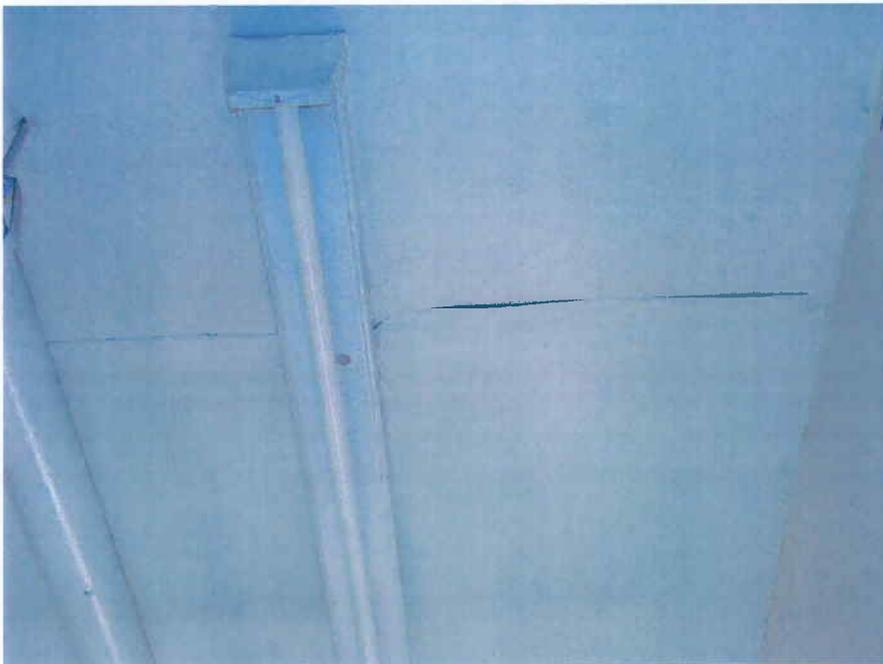
Figure 3.66 Cracks at gypsum board ceiling - Hangars 2 & 3.

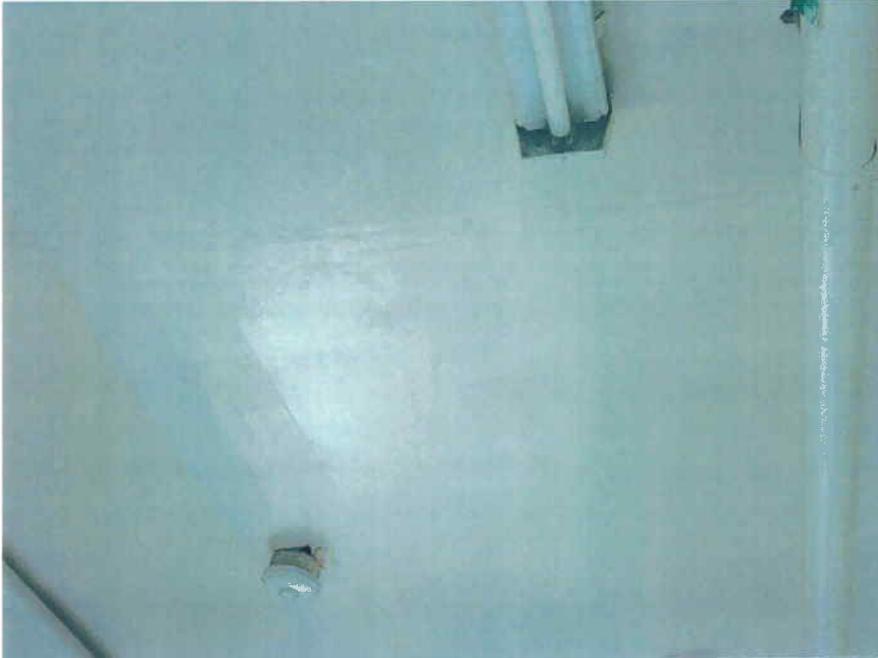
Figure 3.67 Damaged gypsum board ceiling - Hangars 2 & 3.
