CONDITION ASSESSMENT AND REHABILITATION PLANS, HANGARS 2 AND 3, LADD FIELD NATIONAL HISTORIC LANDMARK FORT WAINWRIGHT, ALASKA

*Final Submission
January 2008*

As part of a Cooperative Agreement with the United States Army Environmental Center (USAEC), The Louis Berger Group, Inc. (Berger) was tasked to produce a Condition Assessment and Rehabilitation Plan (CARP) for use by the Department of the Army to determine the feasibility and use of the World War II era hangars to meet current and future anticipated mission needs associated with the projected move of the Aviation Task Force at Fort Wainwright, Alaska.

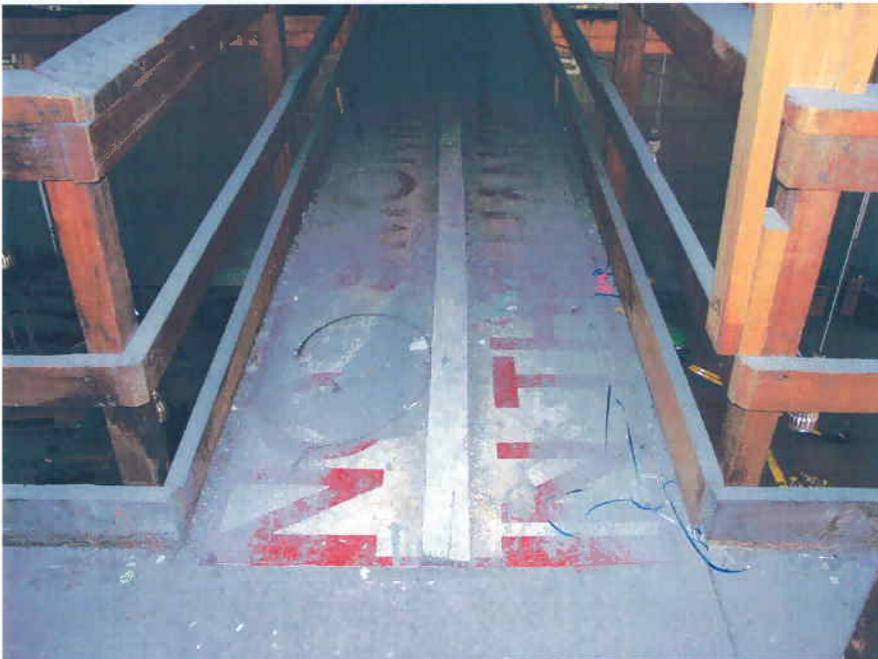
Figure 3.68 Catwalk walking surface temporary patch - Hangar 3.

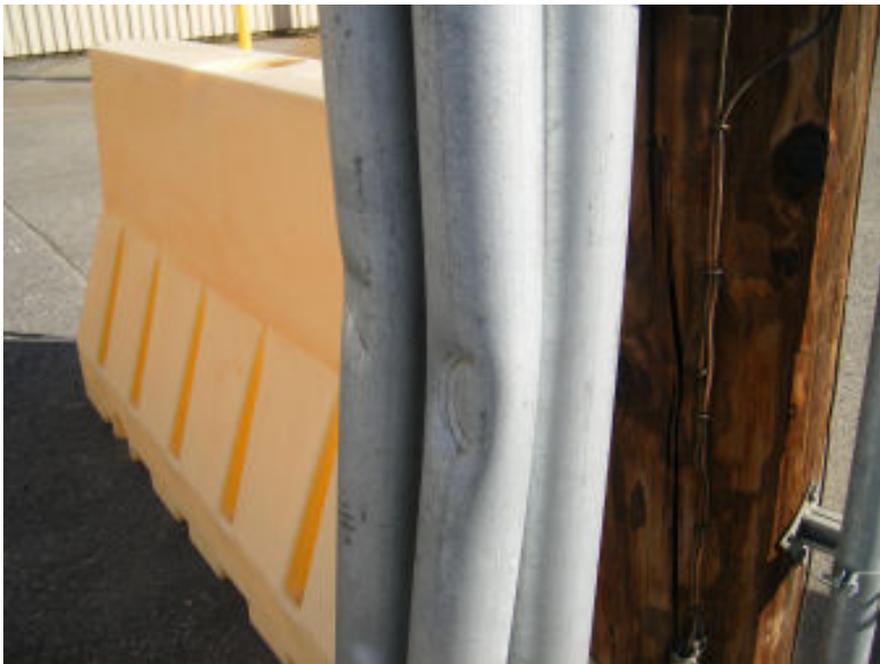
Figure 7.2 Damaged service conduits.

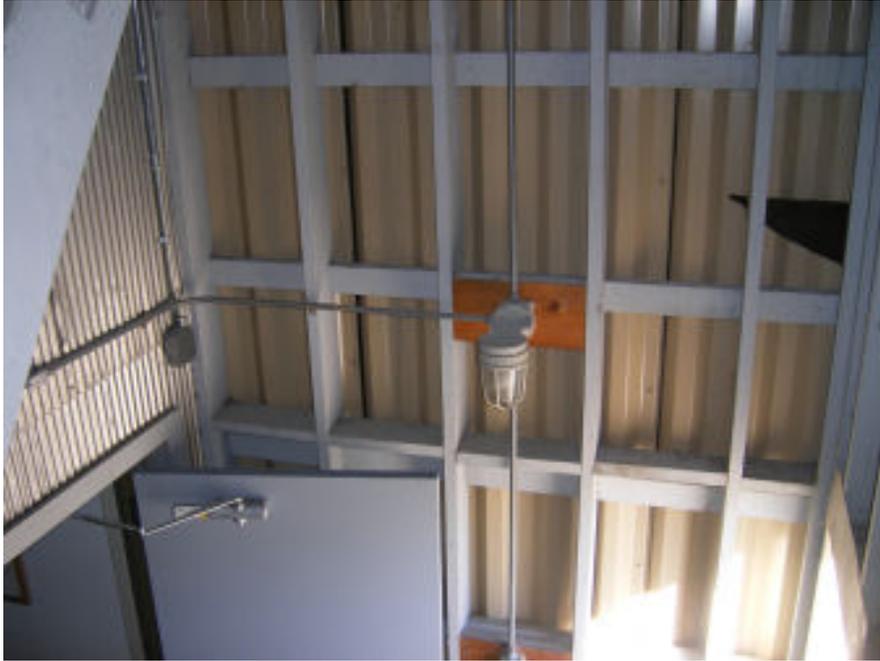
Figure 7.3 Stairway lighting is not emergency powered.

7. Replace all exit lights and augment the amount of emergency lights employed throughout the building (Tab 7). Estimated subcontractor cost: \$61,218.

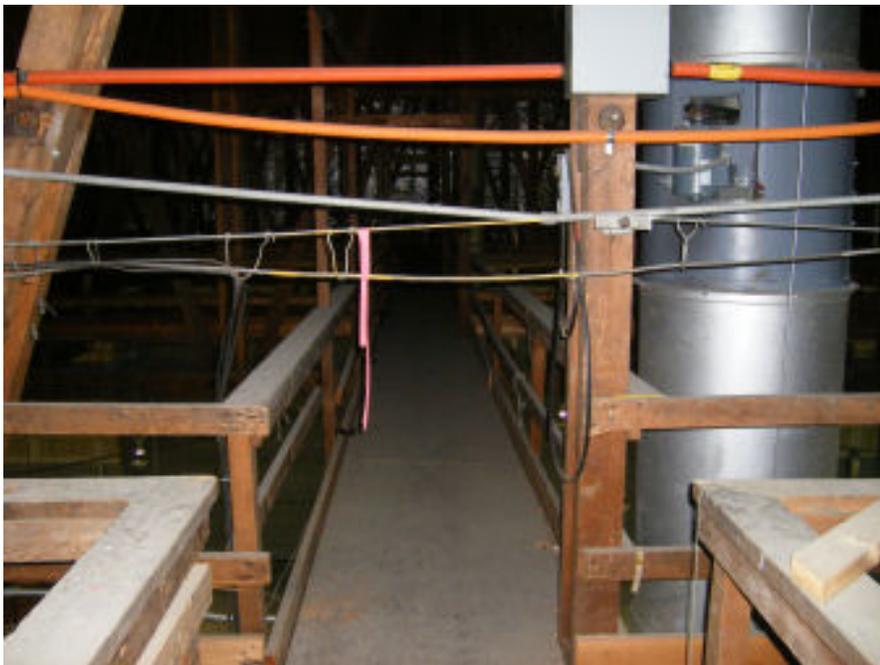
Figure 7.6 Poorly placed conductors on catwalk impede normal progress.

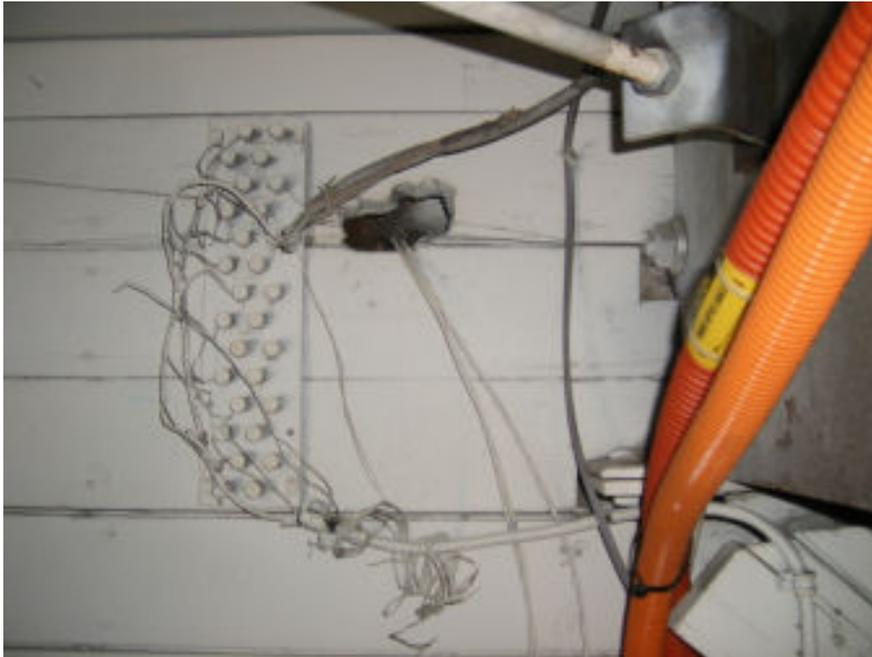
Figure 7.9 Antiquated telephone blocks. Recommend new telephone wiring be terminated in communications cabinets.

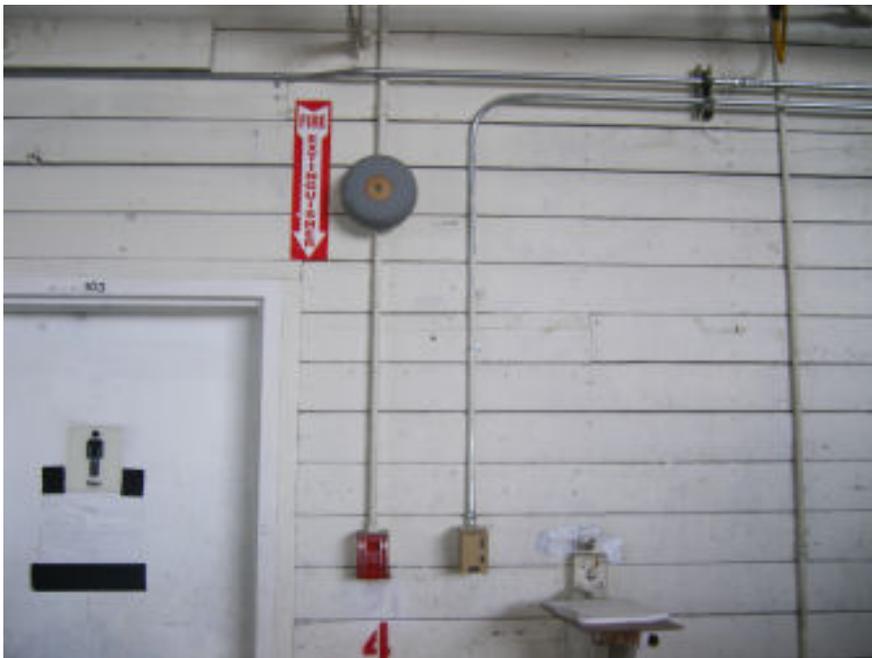
Figure 7.10 Fire alarm system with bell annunciation.

1. Repair/replace existing fire alarm detection system and/or components with new fully addressable system, including fire alarm control panels and all initiation and notification devices. Include the relocation of manual pull stations to within mandated distances from exitways. Include also the installation of magnetic hold-opens for fire doors (Tab 7). Estimated subcontractor cost: \$149,128.

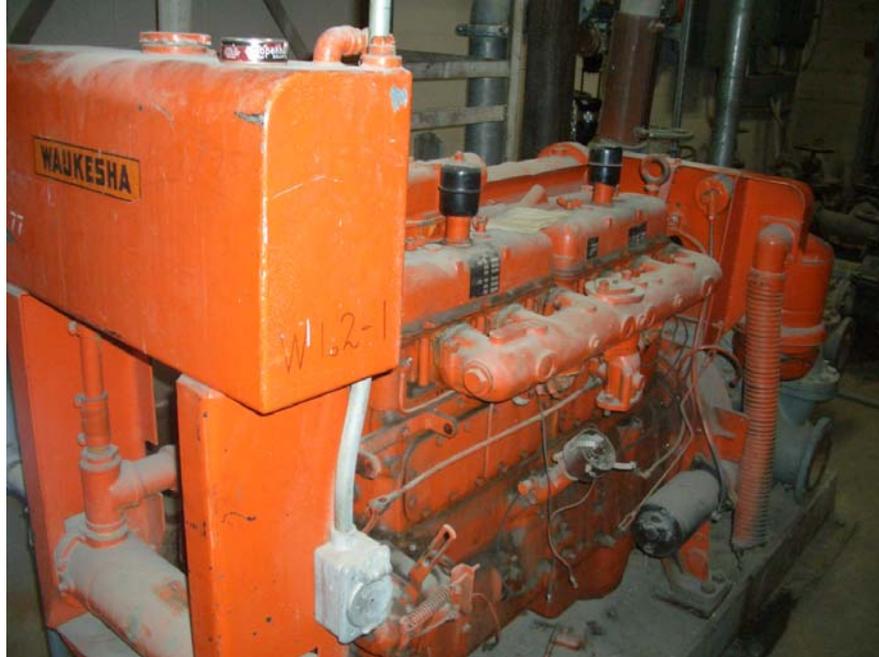
Figure 8.1 Bldg 3011 Defunct Diesel Fire Pump
