Building 3008
Hangar 3

Year Built: circa 1943
Truss Construction: Wood Bowstring
Building Const: Wood
Roofing Material: Torch-down Membrane, Fair
Overall Condition: Poor
Repair Need: **Replacement Needed**

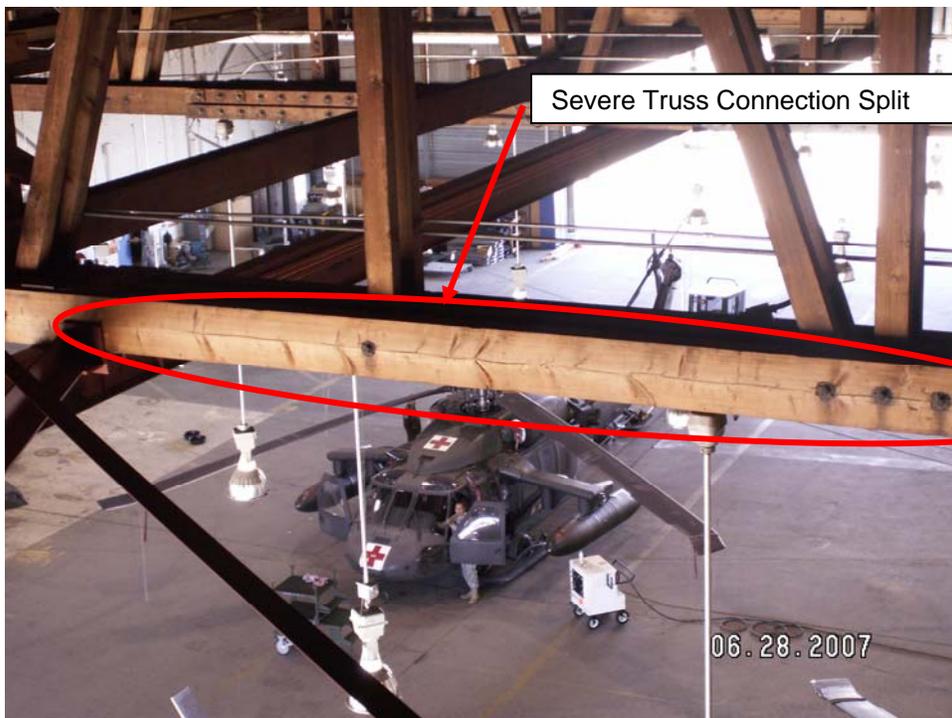
Photo #2 - Split Truss Connection

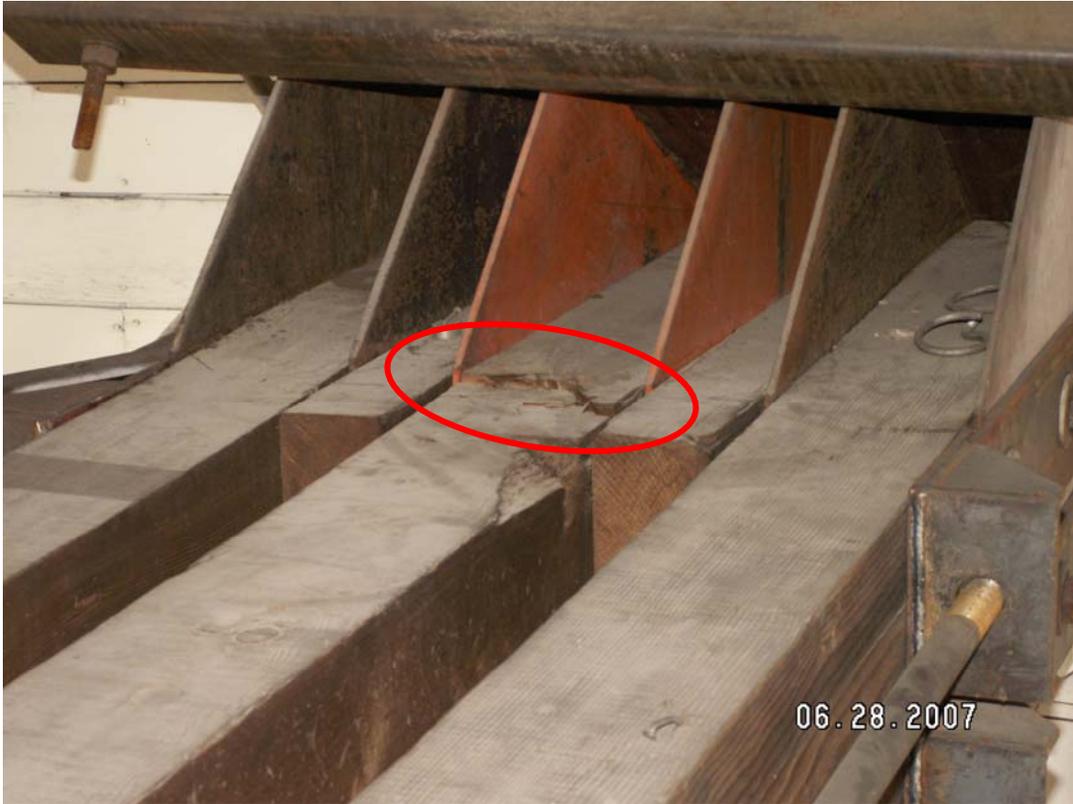
The trusses vary from poor to fair condition with many of the truss connections showing signs of having been overstressed (as indicated by the broken truss chords). A design analysis “Hangar Bowstring Truss Repair, Fort Wainwright, Alaska” dated June 24, 1987, by Loftus and Dailey, Inc. outlined general truss repairs for Hangars #2 and #3 (Hangar 6 has been replaced). The report noted that some of the truss members were overstressed from 30 – 50% and the trusses as a whole were near their load-carrying capacity. Specific repairs to each truss were outlined in a final report issued October 2, 1987 for Hangar #3. Current inspection of the trusses in Hangar #3, like Hangar #2, show that many of the checks, splits and cracks noted in the report dated June 24, 1987

Photo #3 - Broken truss chord.

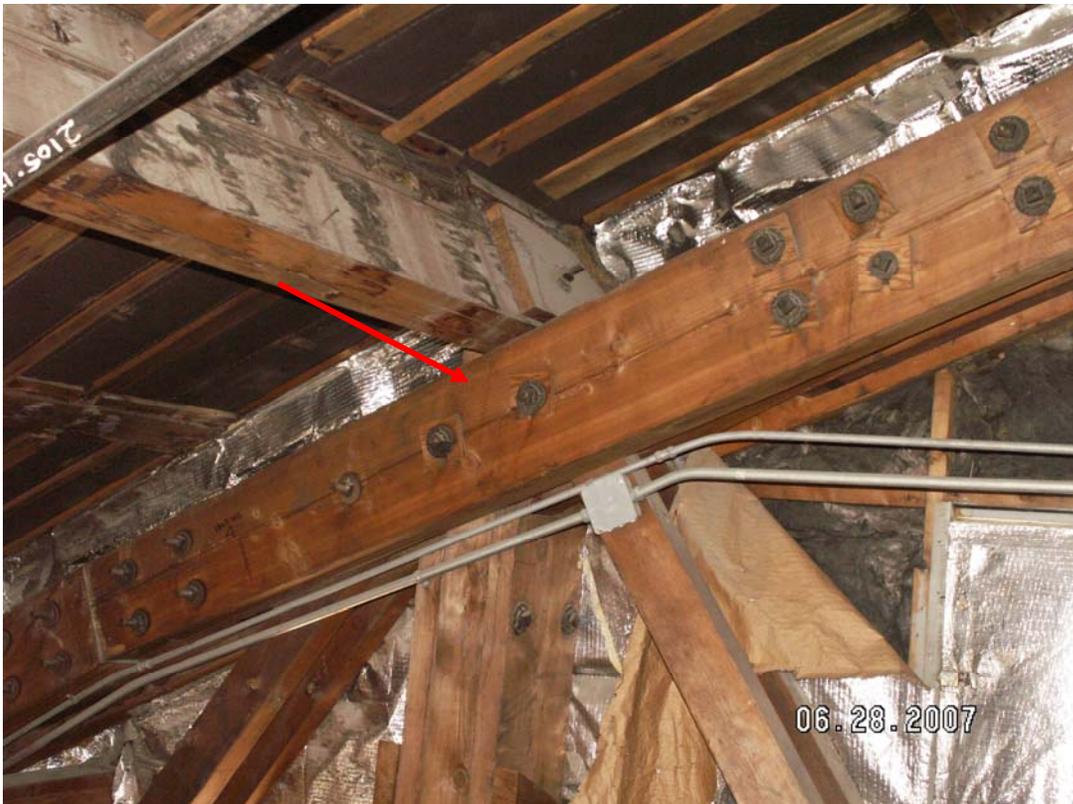
Photo #4 - Split through truss top chord panel point connection.

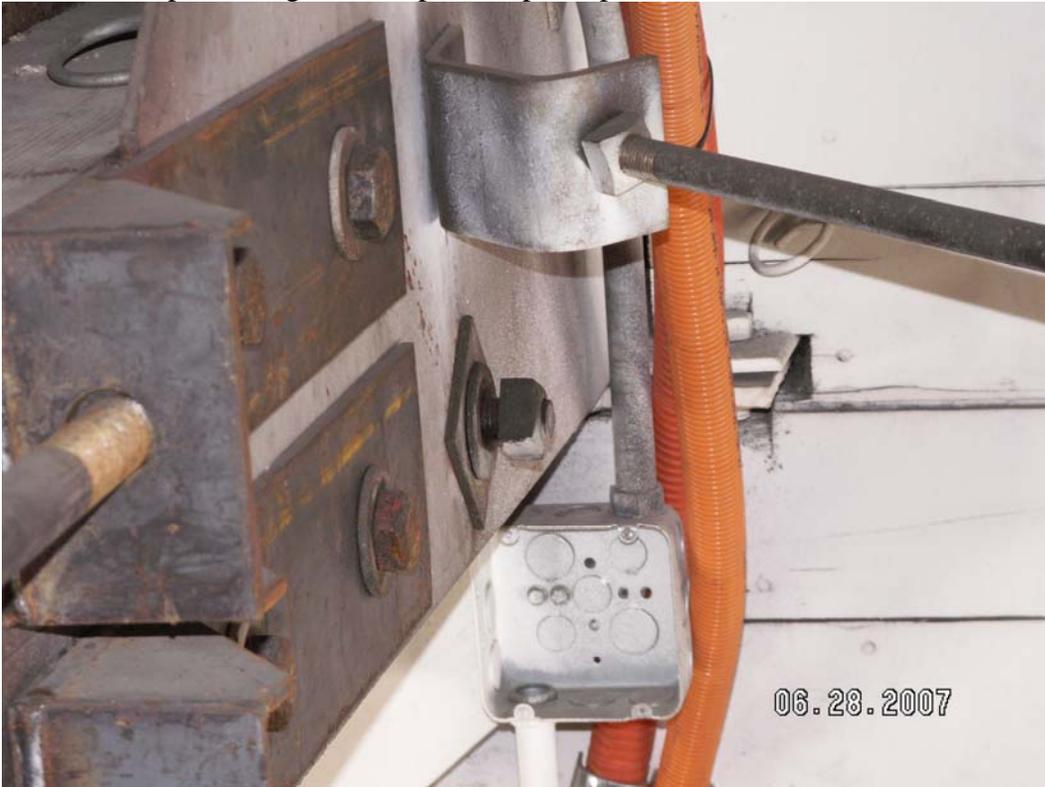
Photo #5 - Loose bolts.

This building has substantial structural deficiencies and needs replacing as soon as possible. It is recommended that snow not be allowed to accumulate on the roof. Though repairs were been done in the late 1980's, it is questionable as to whether or not they have improved the strength of the trusses to current life safety requirements. Many of the truss connections are beyond rehabilitation. Recurring inspections of the deficient truss members are recommended as long as this building is occupied. Repair and/or replacement of the exterior catwalks and eyebrow roofs over the hanger door openings are recommended if this facility is to continue to be used. The low eyebrow roof shingles over the hangar doors need to be replaced to prevent decay of the framing at the ends of the building. The North entry canopies are dilapidated and need repair (see photo #13). Loose roof slats have become a falling hazard (see photo #9). Also, loose bolts were noted during the 1987 inspections and identified as needing tightening. Loose bolts at wood connections were also encountered during this current inspection and also need to be tightened.

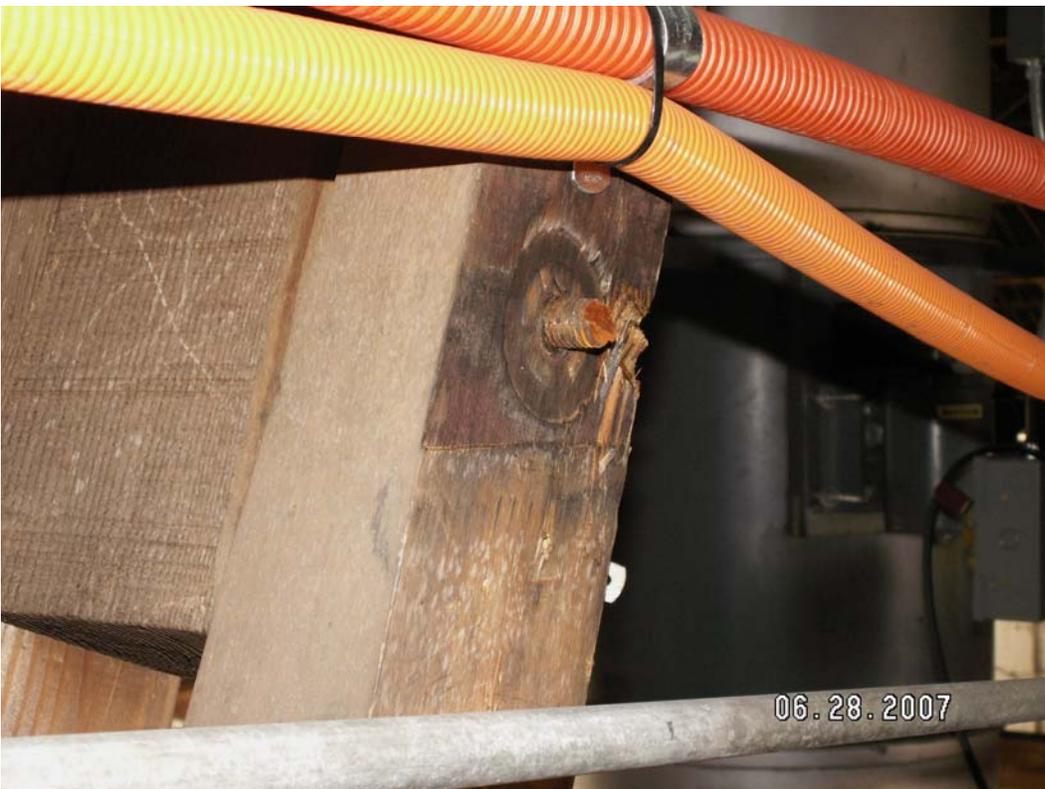
Photo #6 - Nut removed to install wiring.

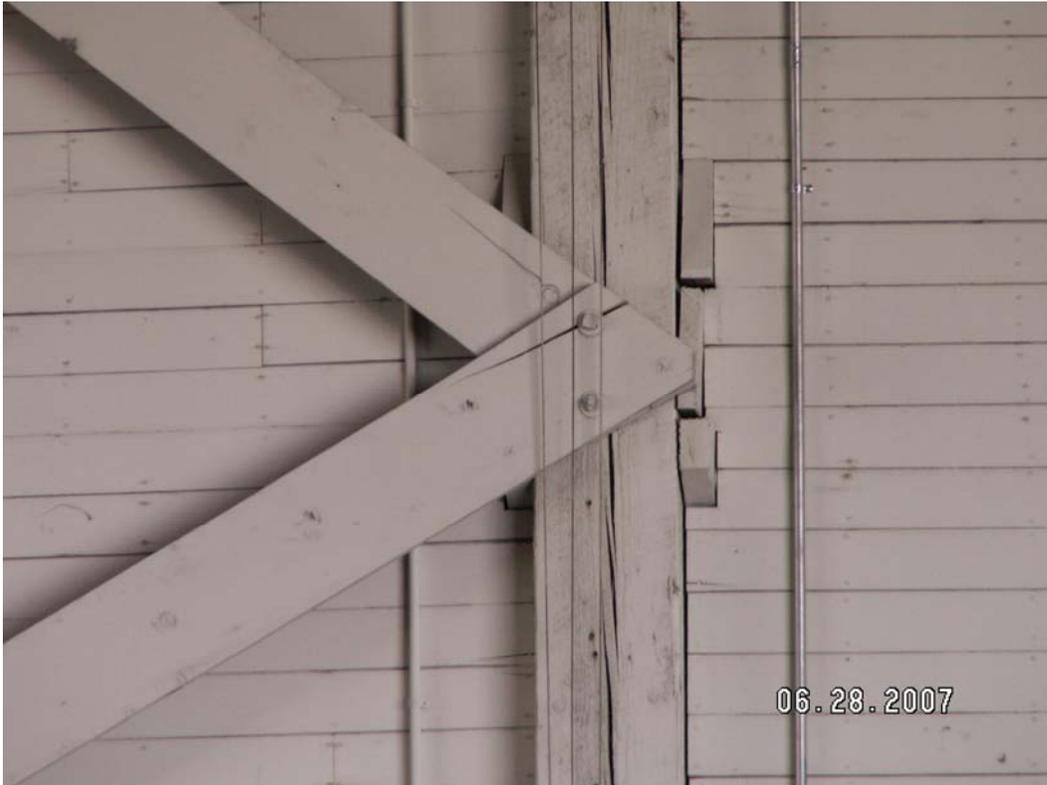
Photo #7 - Split cross bracing connection

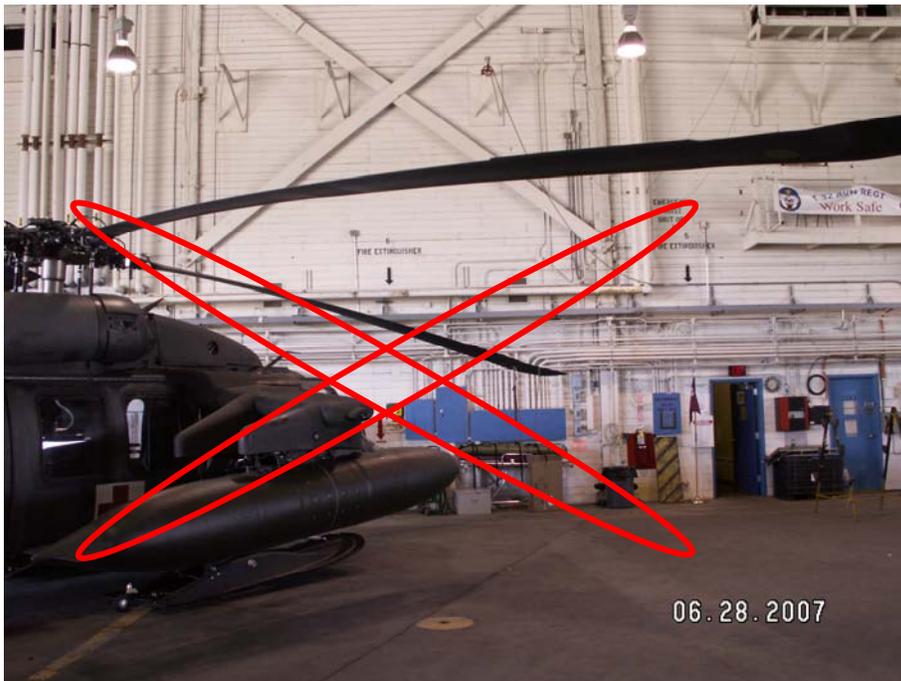
still exist. It was not possible to determine whether these have deteriorated since the 1987 inspection. The structure is currently in poor condition, even with the repairs done to the trusses. Deficiencies noted include poor condition of the trusses and removed lateral bracing along the south side of the hanger. The expense of repairing these connections to current design requirements would require that substantial demolition be done to replace the affected trusses. Replacement of this building should be strongly considered.

Photo #8 - Removed lower cross bracing

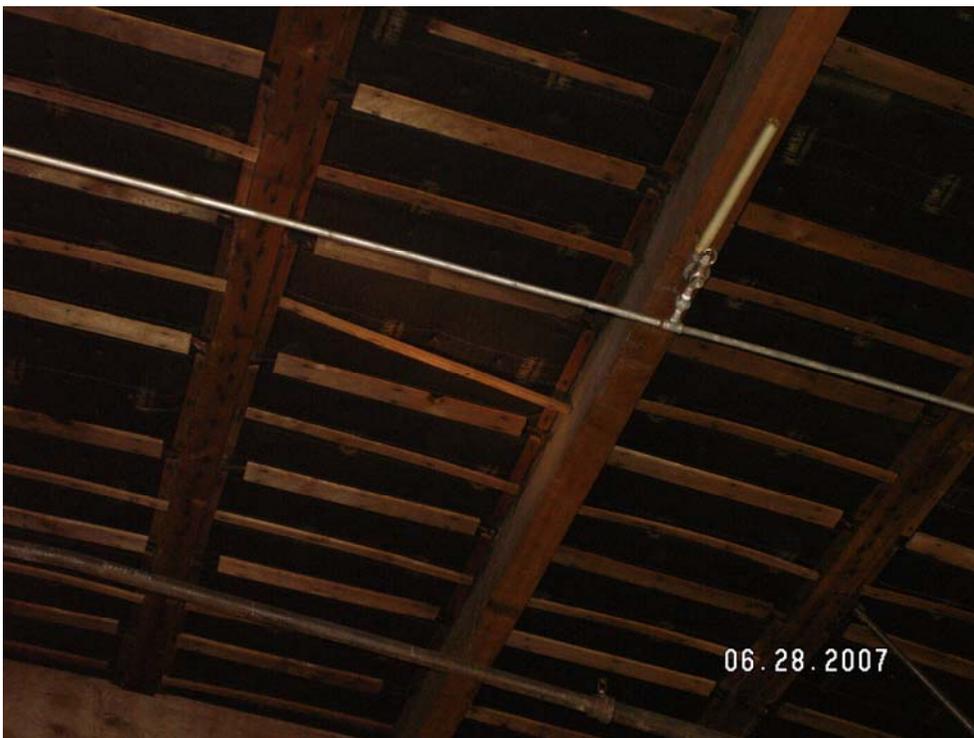
Photo #9 – Loose slats on underside of roof are a falling hazard.

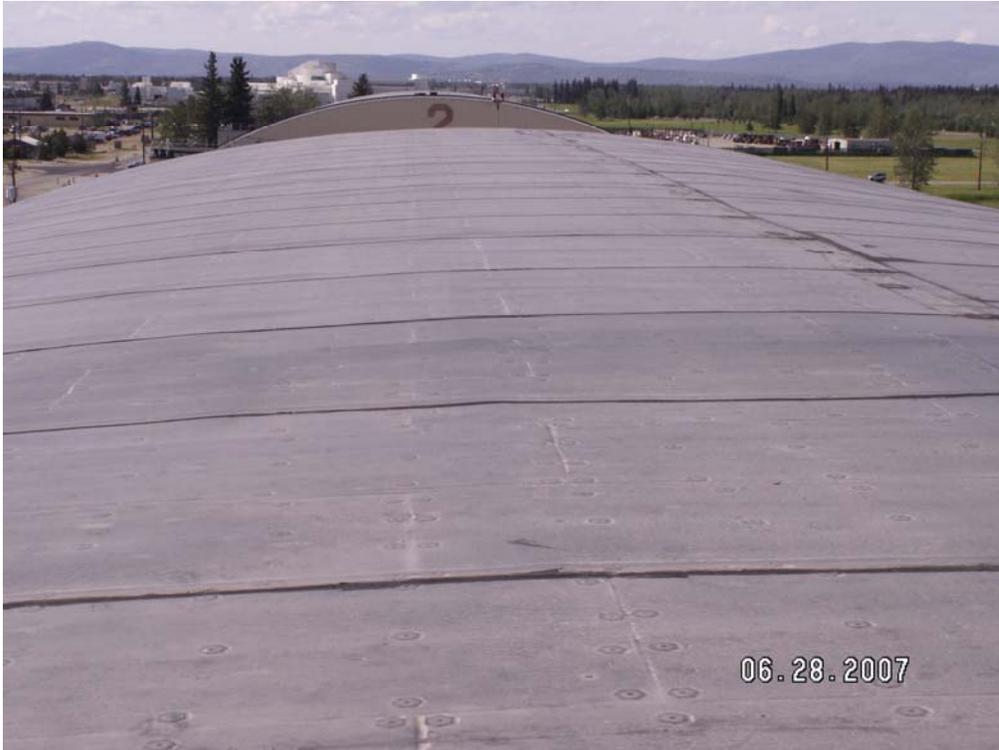
Photo #10 - Hangar roof membrane condition.

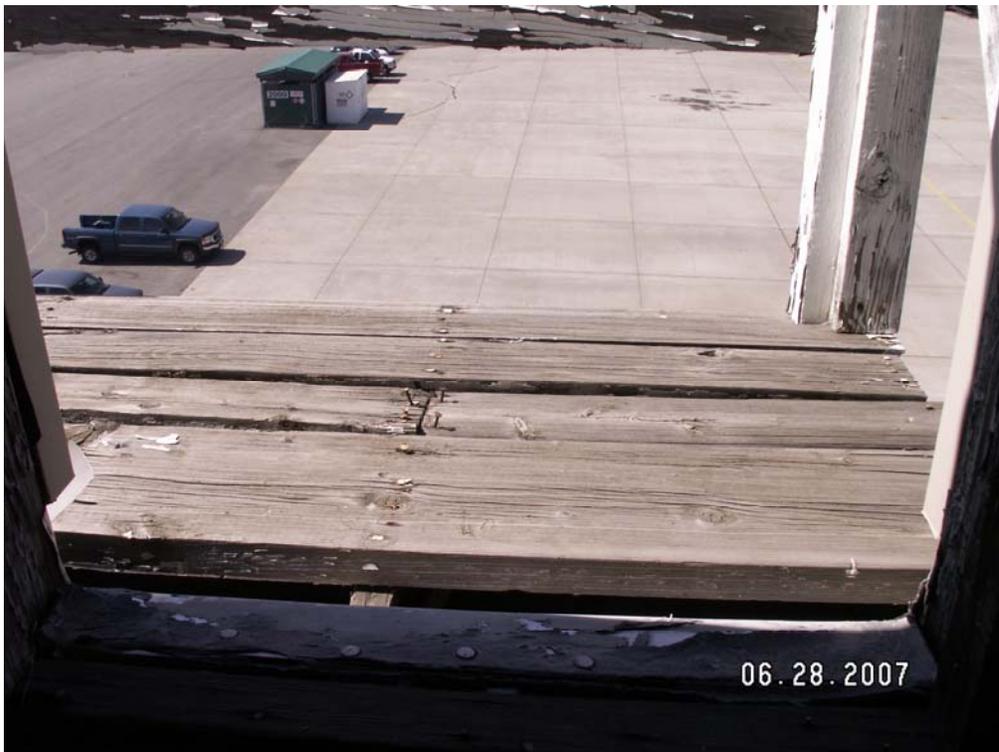
Photo #11 - Exterior catwalk condition.

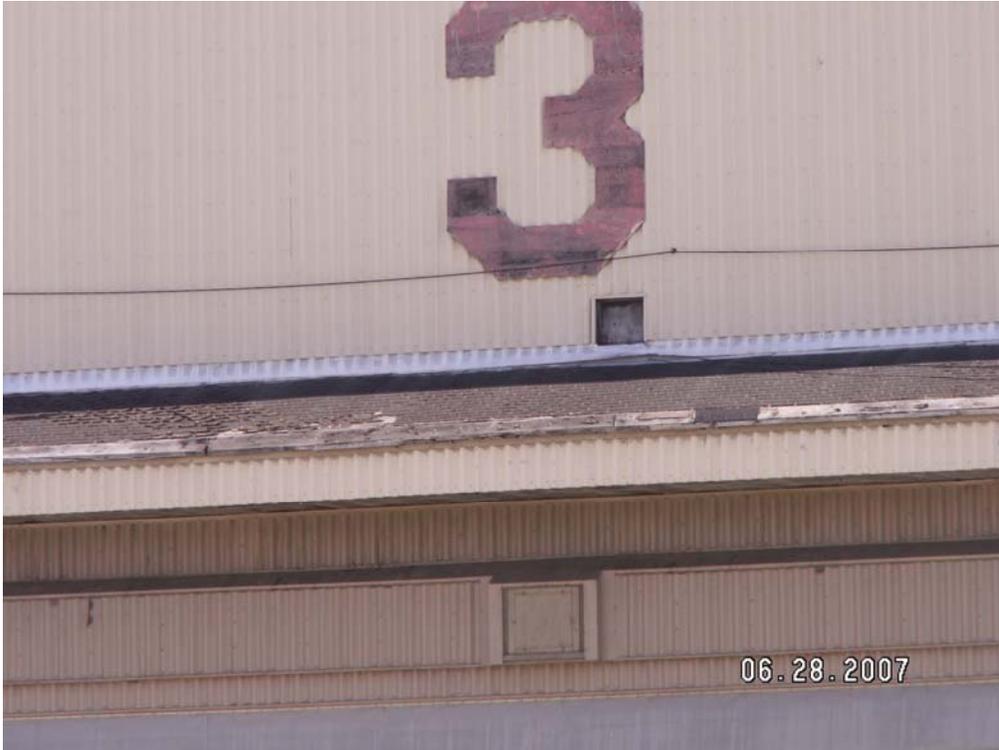
Photo # 12 – Eyebrow roof shingle condition.

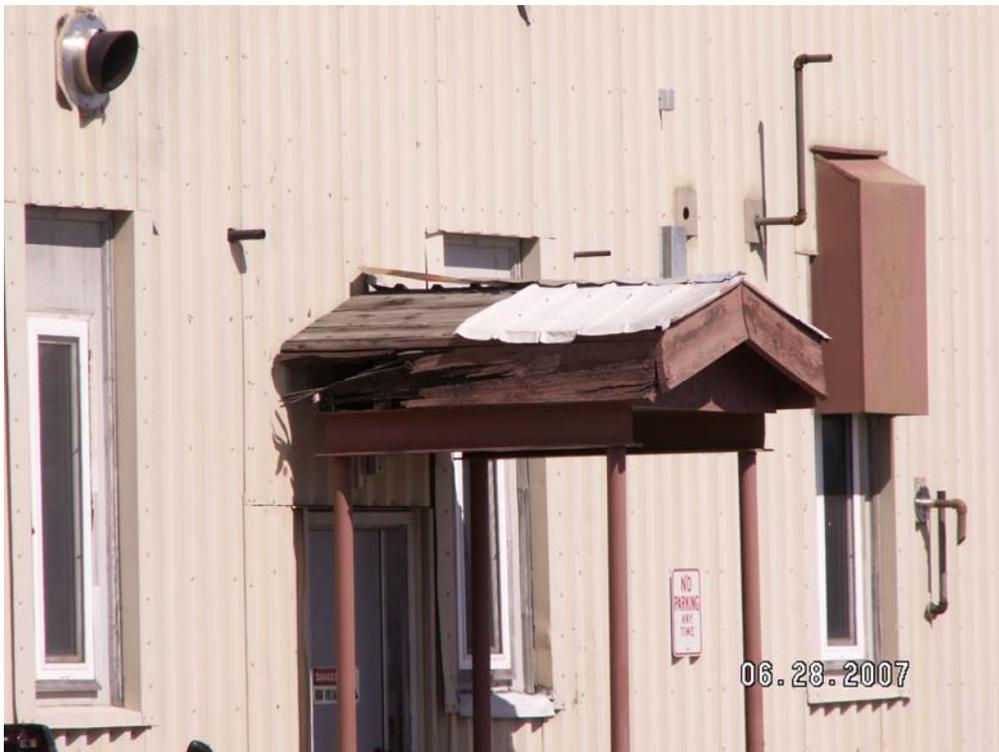
Photo #13 – North canopy condition.
