# Existing Conditions

## Fort Wainwright Disposition of Hangars 2 & 3

Environmental Impact Statement and National Historic Preservation Act Section 106 Consultation

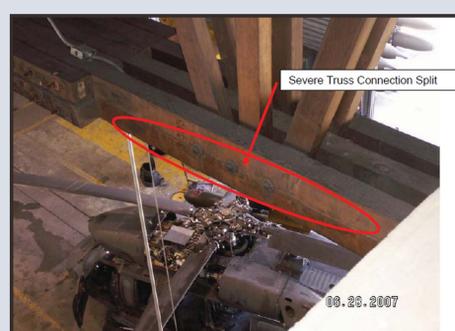
**Hangars 2 and 3** were constructed in 1943 and over the years the structural integrity of the wooden trusses has deteriorated with age and due to environmental conditions. Structural assessments indicate that most framing members display weaknesses resulting from cracking and splitting. As a result, the hangars' ceiling trusses cannot support helicopter maintenance equipment, their roofs do not meet building code for snow load, and their infrastructure no longer meets the standards of a functional and safe workplace.

Example of Hangar 2 Damage  
*US Army*

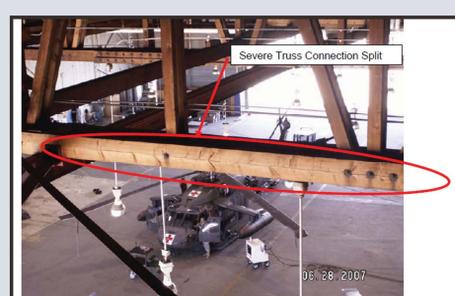
Example of Hangar 3 Damage  
*US Army*

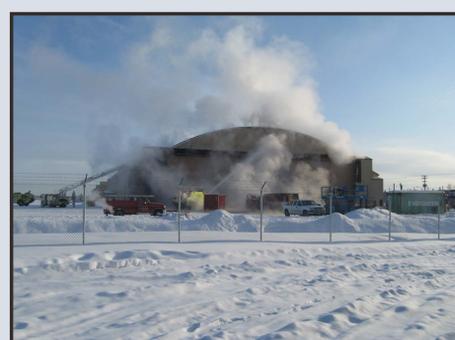
**On February 17, 2011,** an electrical fire in Hangar 2 severely damaged the west end of the hangar roof decking and the west end roof trusses. Subsequent structural investigations indicated that Hangar 2 lacked structural integrity and that the same structural deficiencies existed in Hangar 3. Since that time, both hangars have been found to be unsafe for occupancy and are currently vacant.

Hangar 2 Fire  
*US Army*

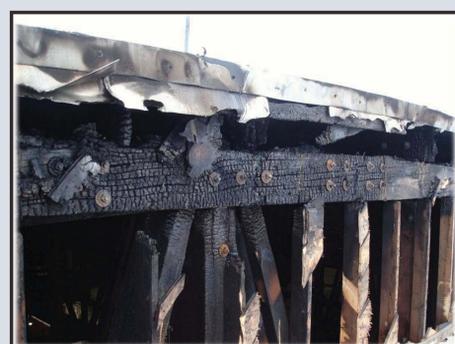
Hangar 2 Fire Damage  
*US Army*
