Hangar 2 (Building 3005) After Fire Structural Inspection Report

Jason L. Webb P.E.

FT. WAINWRIGHT-DPW

11/22/11

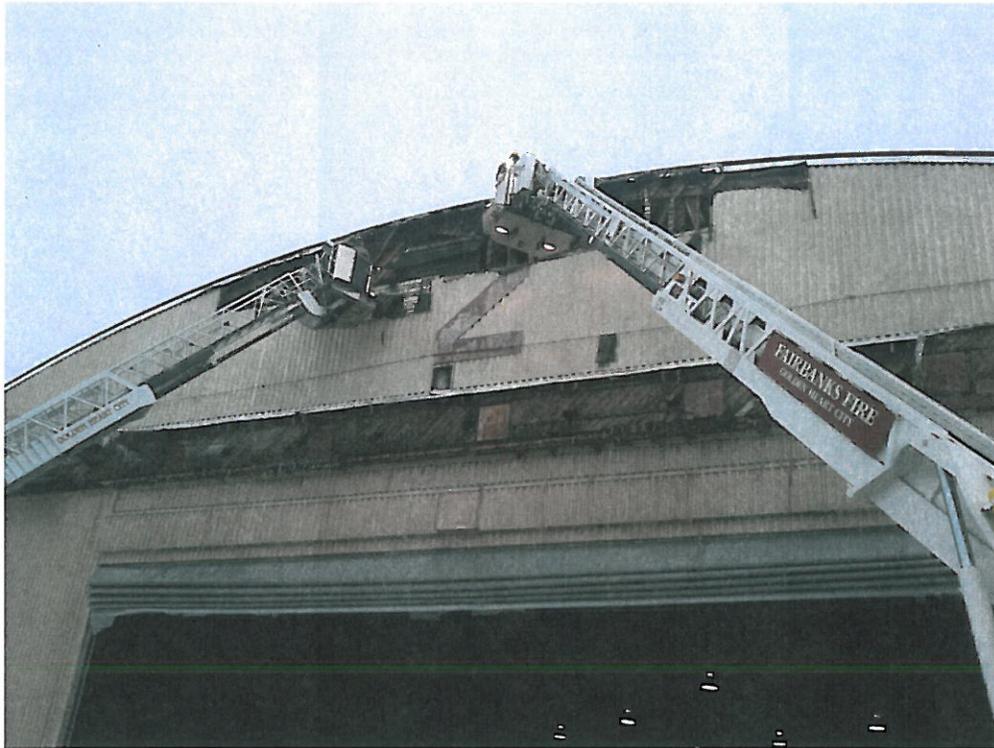
**Hangar 2 siding and sheathing removed to ensure fire was fully extinguished**

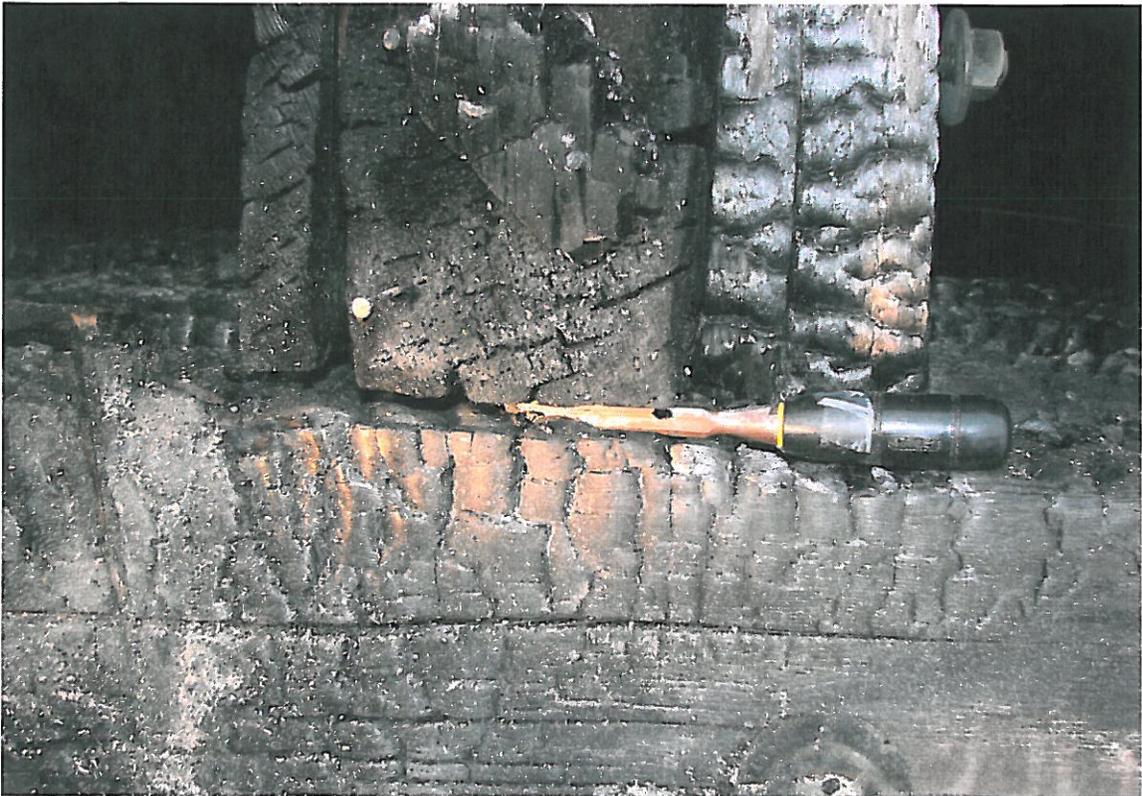
The fire was concentrated in the west end of the hangar. Trusses in earlier reports (US Army Corps of Engineers-Truss Inspection Report 2007) were numbered 1-8 going from east to west. I will use the same notation system as the USACE report as it will be referenced again in this report. The easternmost truss (#8) sustained the most damage and is a total structural loss; many of the connections have up to 2" of charring. Damage to the webs is most critical at the connection to the top cord of the truss. The main ridgeline beam that spans from truss #7 to truss #8 was also heavily damaged at the connection and is no longer supported by truss #8 and is currently being carried by truss #7.

Ridge beam is no longer supported by truss #8

The entire west wall of the building will have to be replaced due to the fire damage, this includes truss #8, the roof beams, the interior cladding, exterior cladding, and the roof deck will need to be replaced for at least the last two truss bays between truss #6 and truss #7 and between truss #7 and truss #8. The ridge beam and all secondary beams that were damaged in the fire will need to

be replaced to their nearest current splice location. This may necessitate the need for further roof decking removal.

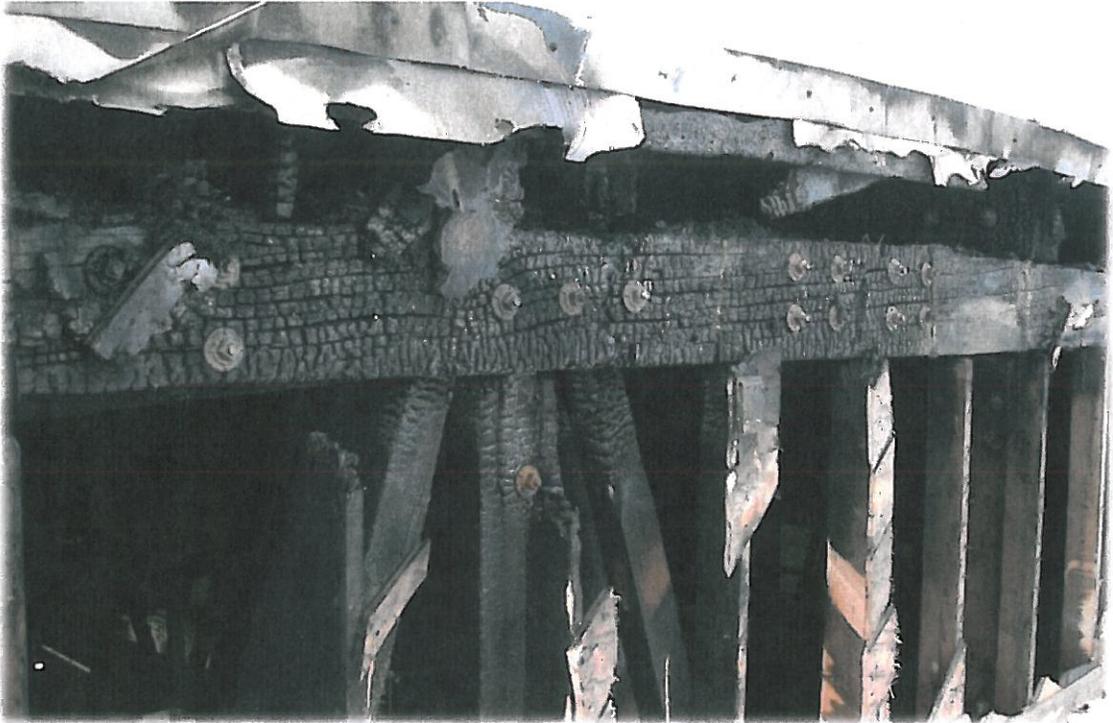
Fire damage on truss #8

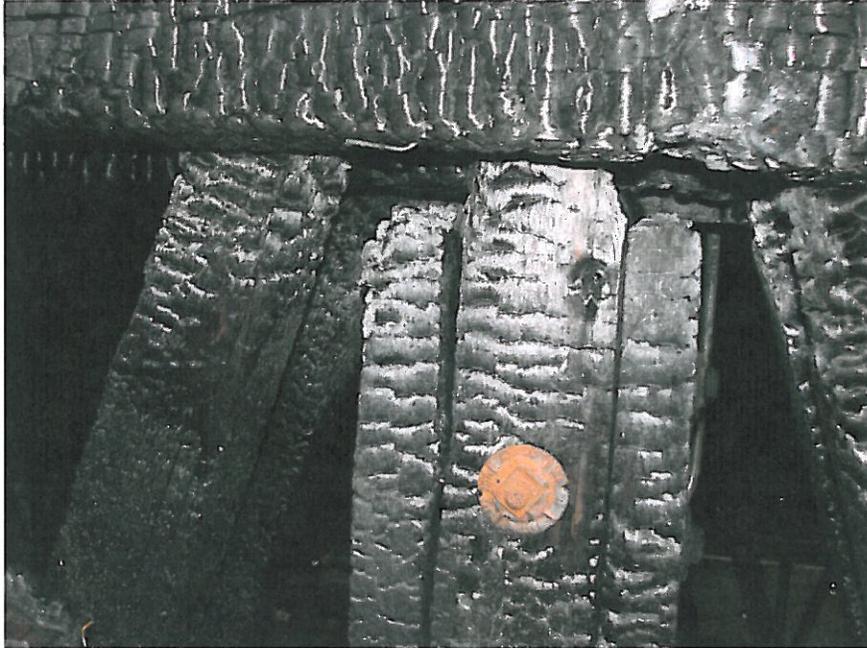
**Damage to truss #8 shows loss of connectivity between members**

To this point only physical damage has been discussed. However the greater damage to the structure might not be visible. One contributing factor to the unseen damage is the high heat in the adjacent truss bays. Even when the surface of the wood doesn't reach the flash point, the heat can cause property changes in the wood. The same goes for the steel that holds the wood together; it could see even greater stresses due to its large capacity for thermal expansion coupled with the quenching from the fire hoses. Sudden changes in the temperature of the steel causes the steel to stress and become brittle. The thermal expansion of the steel is between 4 and 5 times that of wood, this additional expansion may have caused the holes the bolts go through to stretch beyond the cooled size of the steel bolts. This damage is difficult to assess as there was no baseline assessment for the connections before the fire.

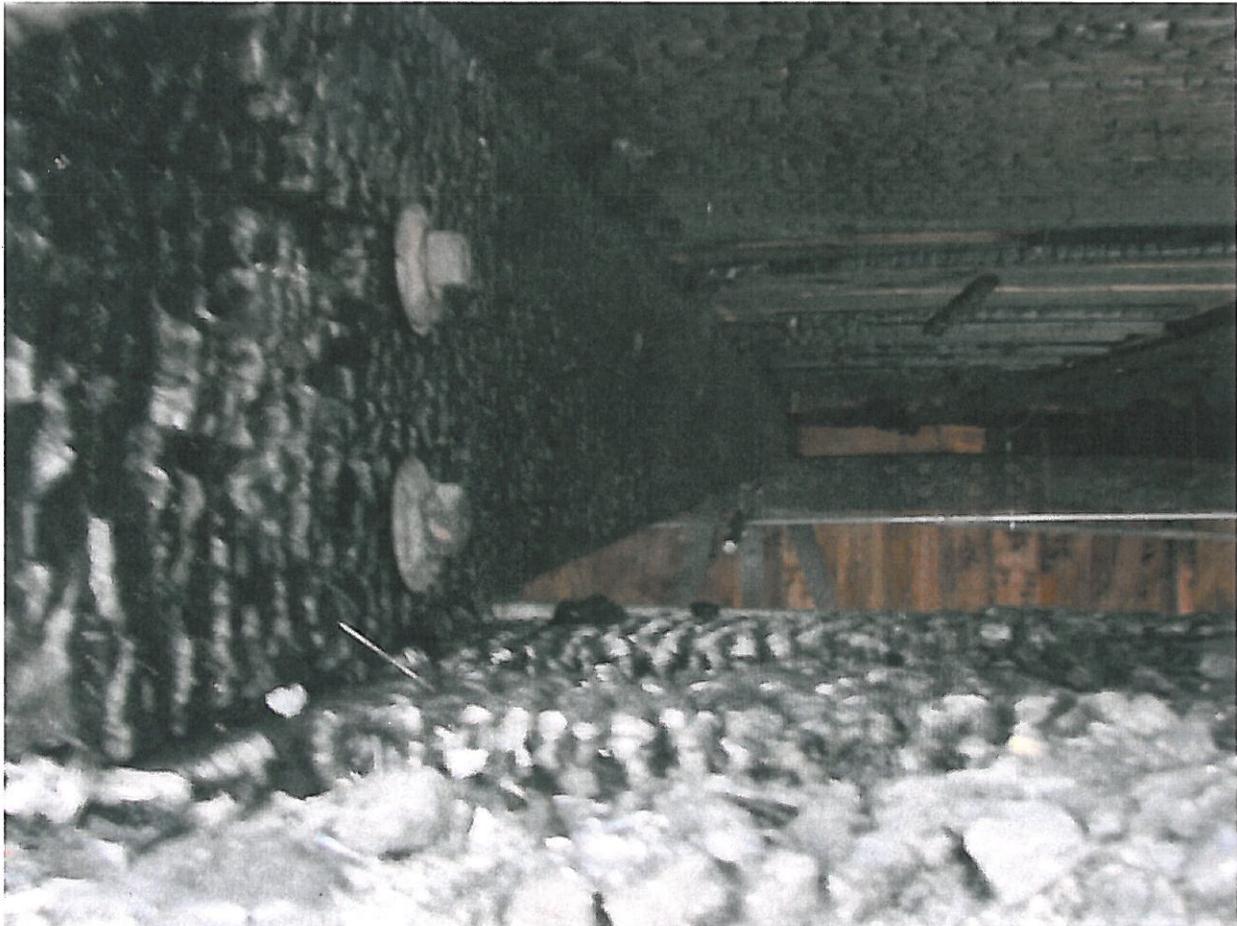
Truss #7 shows minor charring and the connections have no physically apparent damage. The roof deck shows significant fire damage eastward to truss #7 with minor charring to truss #6. Much of the exterior cladding on the west end of the hangar was damaged in the fighting of the fire.

Ridge beam damage with truss #7 beyond and roof deck damage is visible

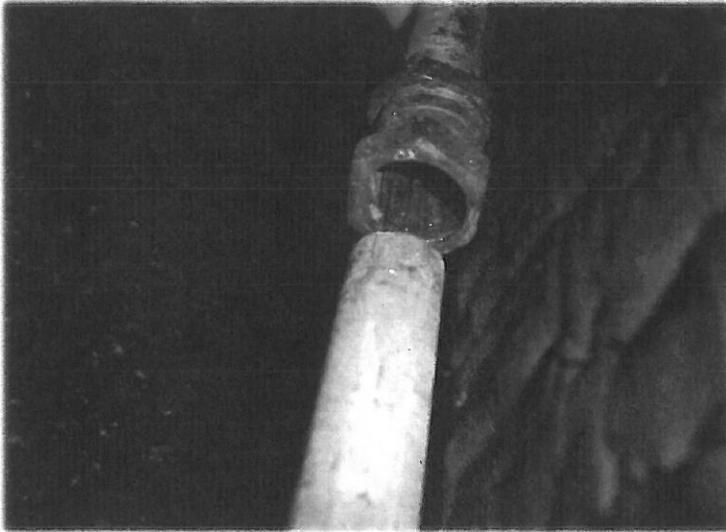
**Separated conduit with charred wires is the point of ignition**

The Ft. Wainwright Fire Department inspector determined that the fire was caused by separation of an electrical conduit. The inspectors report is included as Appendix C at the end of this report. This is a situation that could continue to happen again. If the building is to be rehabilitated the entire electrical system should be brought up to current code standards to reduce the risk of additional Fires.
