Final

Remedial Investigation FWA 102 Former Communications Site, Fort Wainwright, Alaska

Prepared for
U.S. Army Garrison, Fort Wainwright, Alaska

December 2010

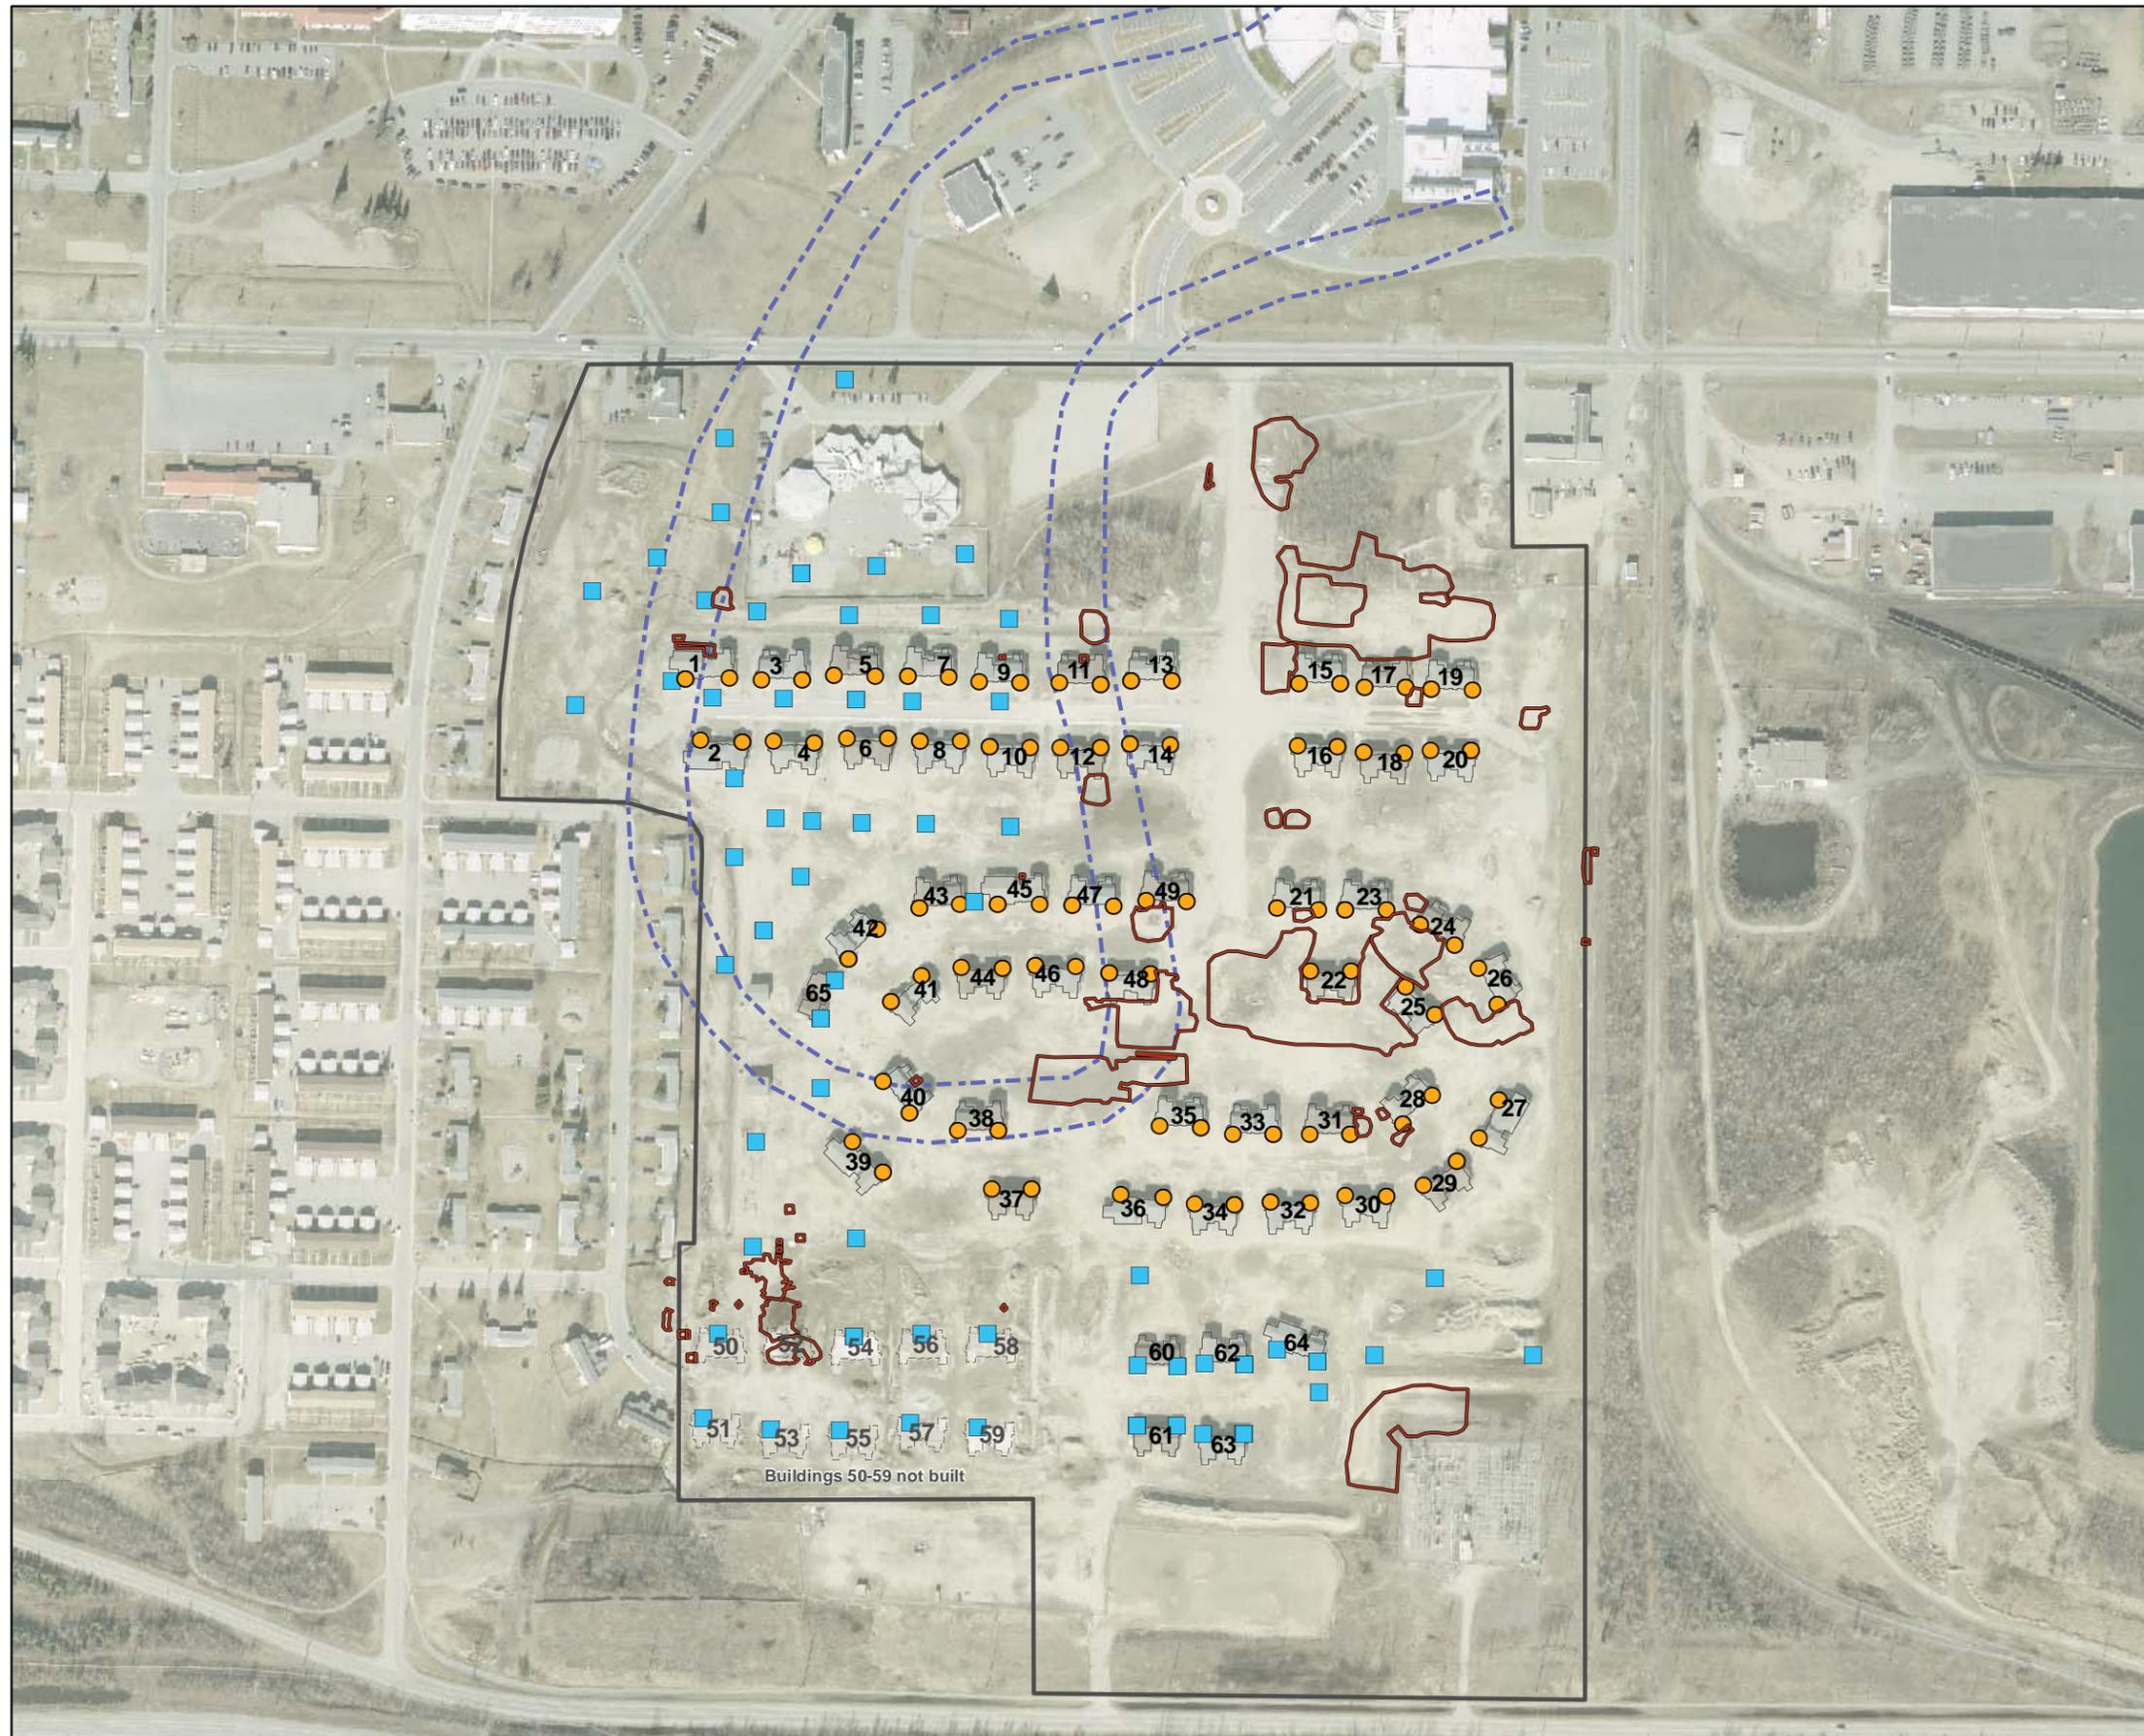
FIGURE 3-7
Groundwater Samples Used in Nature and Extent and Risk Evaluations
Final Remedial Investigation Report
 Former Communications Site, Fort Wainwright, Alaska

- Monitoring Well Location
- Water Supply Well Location
- ▲ Direct-push Grab Sample Location

- **Groundwater:** The samples used in the nature and extent evaluation for groundwater were collected at monitoring wells distributed throughout FCS, at the water supply wells in Building 3559, and from borings advanced north of FCS during the 2009 northern plume investigation. Due to the age, MDL, and sample coverage issues described in Section 3.2.5, only samples collected during the five most recent sampling events at FCS (fall 2007, spring 2008, fall 2008, spring 2009, and fall 2009) and from the 2009 northern plumes and 1,2,3-trichloropropane investigation were considered in the evaluation. Sample locations are shown in Figure 3-7. Full listings of the analytical results for the evaluation group are provided in Appendix I.

2. As a source of recharge water to offsite surface water (Chena River). Represented by analytical data from 10 groundwater samples collected in the downgradient monitoring wells (see Figure 3-7; MW35, MW36, MW37, MW38, MW40, MW41, MW77, MW82, MW83, and MW84) nearest the Chena River.

Groundwater Samples. Analytical data (see Table 7-15) from 10 groundwater locations were used for the ERA. These samples were collected from the northern-most, downgradient monitoring wells (MW35, MW36, MW37, MW38, MW40, MW41, MW77, MW82, MW83, and MW84; shown on Figure 3-7) nearest the Chena River. These seven monitoring wells are located along the northern edge of the FCS. A total of 54 chemicals, including metals, PAHs, organochlorine pesticides, VOCs, SVOCs, explosive compounds, and DRO, were detected in at least one of the perimeter groundwater wells. Groundwater data from additional nearby wells are used to assess the degree of spatial attenuation.

Considering that the distance between the northern perimeter monitoring wells and the Chena River is greater than 1,500 feet, significant attenuation is expected before groundwater reaches actual aquatic or benthic receptors in the Chena River. This attenuation would be a result of biodegradation, dispersion, dilution, adsorption, volatilization, and chemical or biological stabilization or destruction of constituents. To provide some indication of the degree of spatial attenuation that could occur at the site, levels of TCE were evaluated because this chemical is relatively persistent in groundwater and is believed to have originated from onsite groundwater and migrated north of the FCS. TCE concentrations were compared between MW77 and MW 84 (see locations on Figure 3-7), which is located approximately 450 feet downgradient of MW77. The TCE

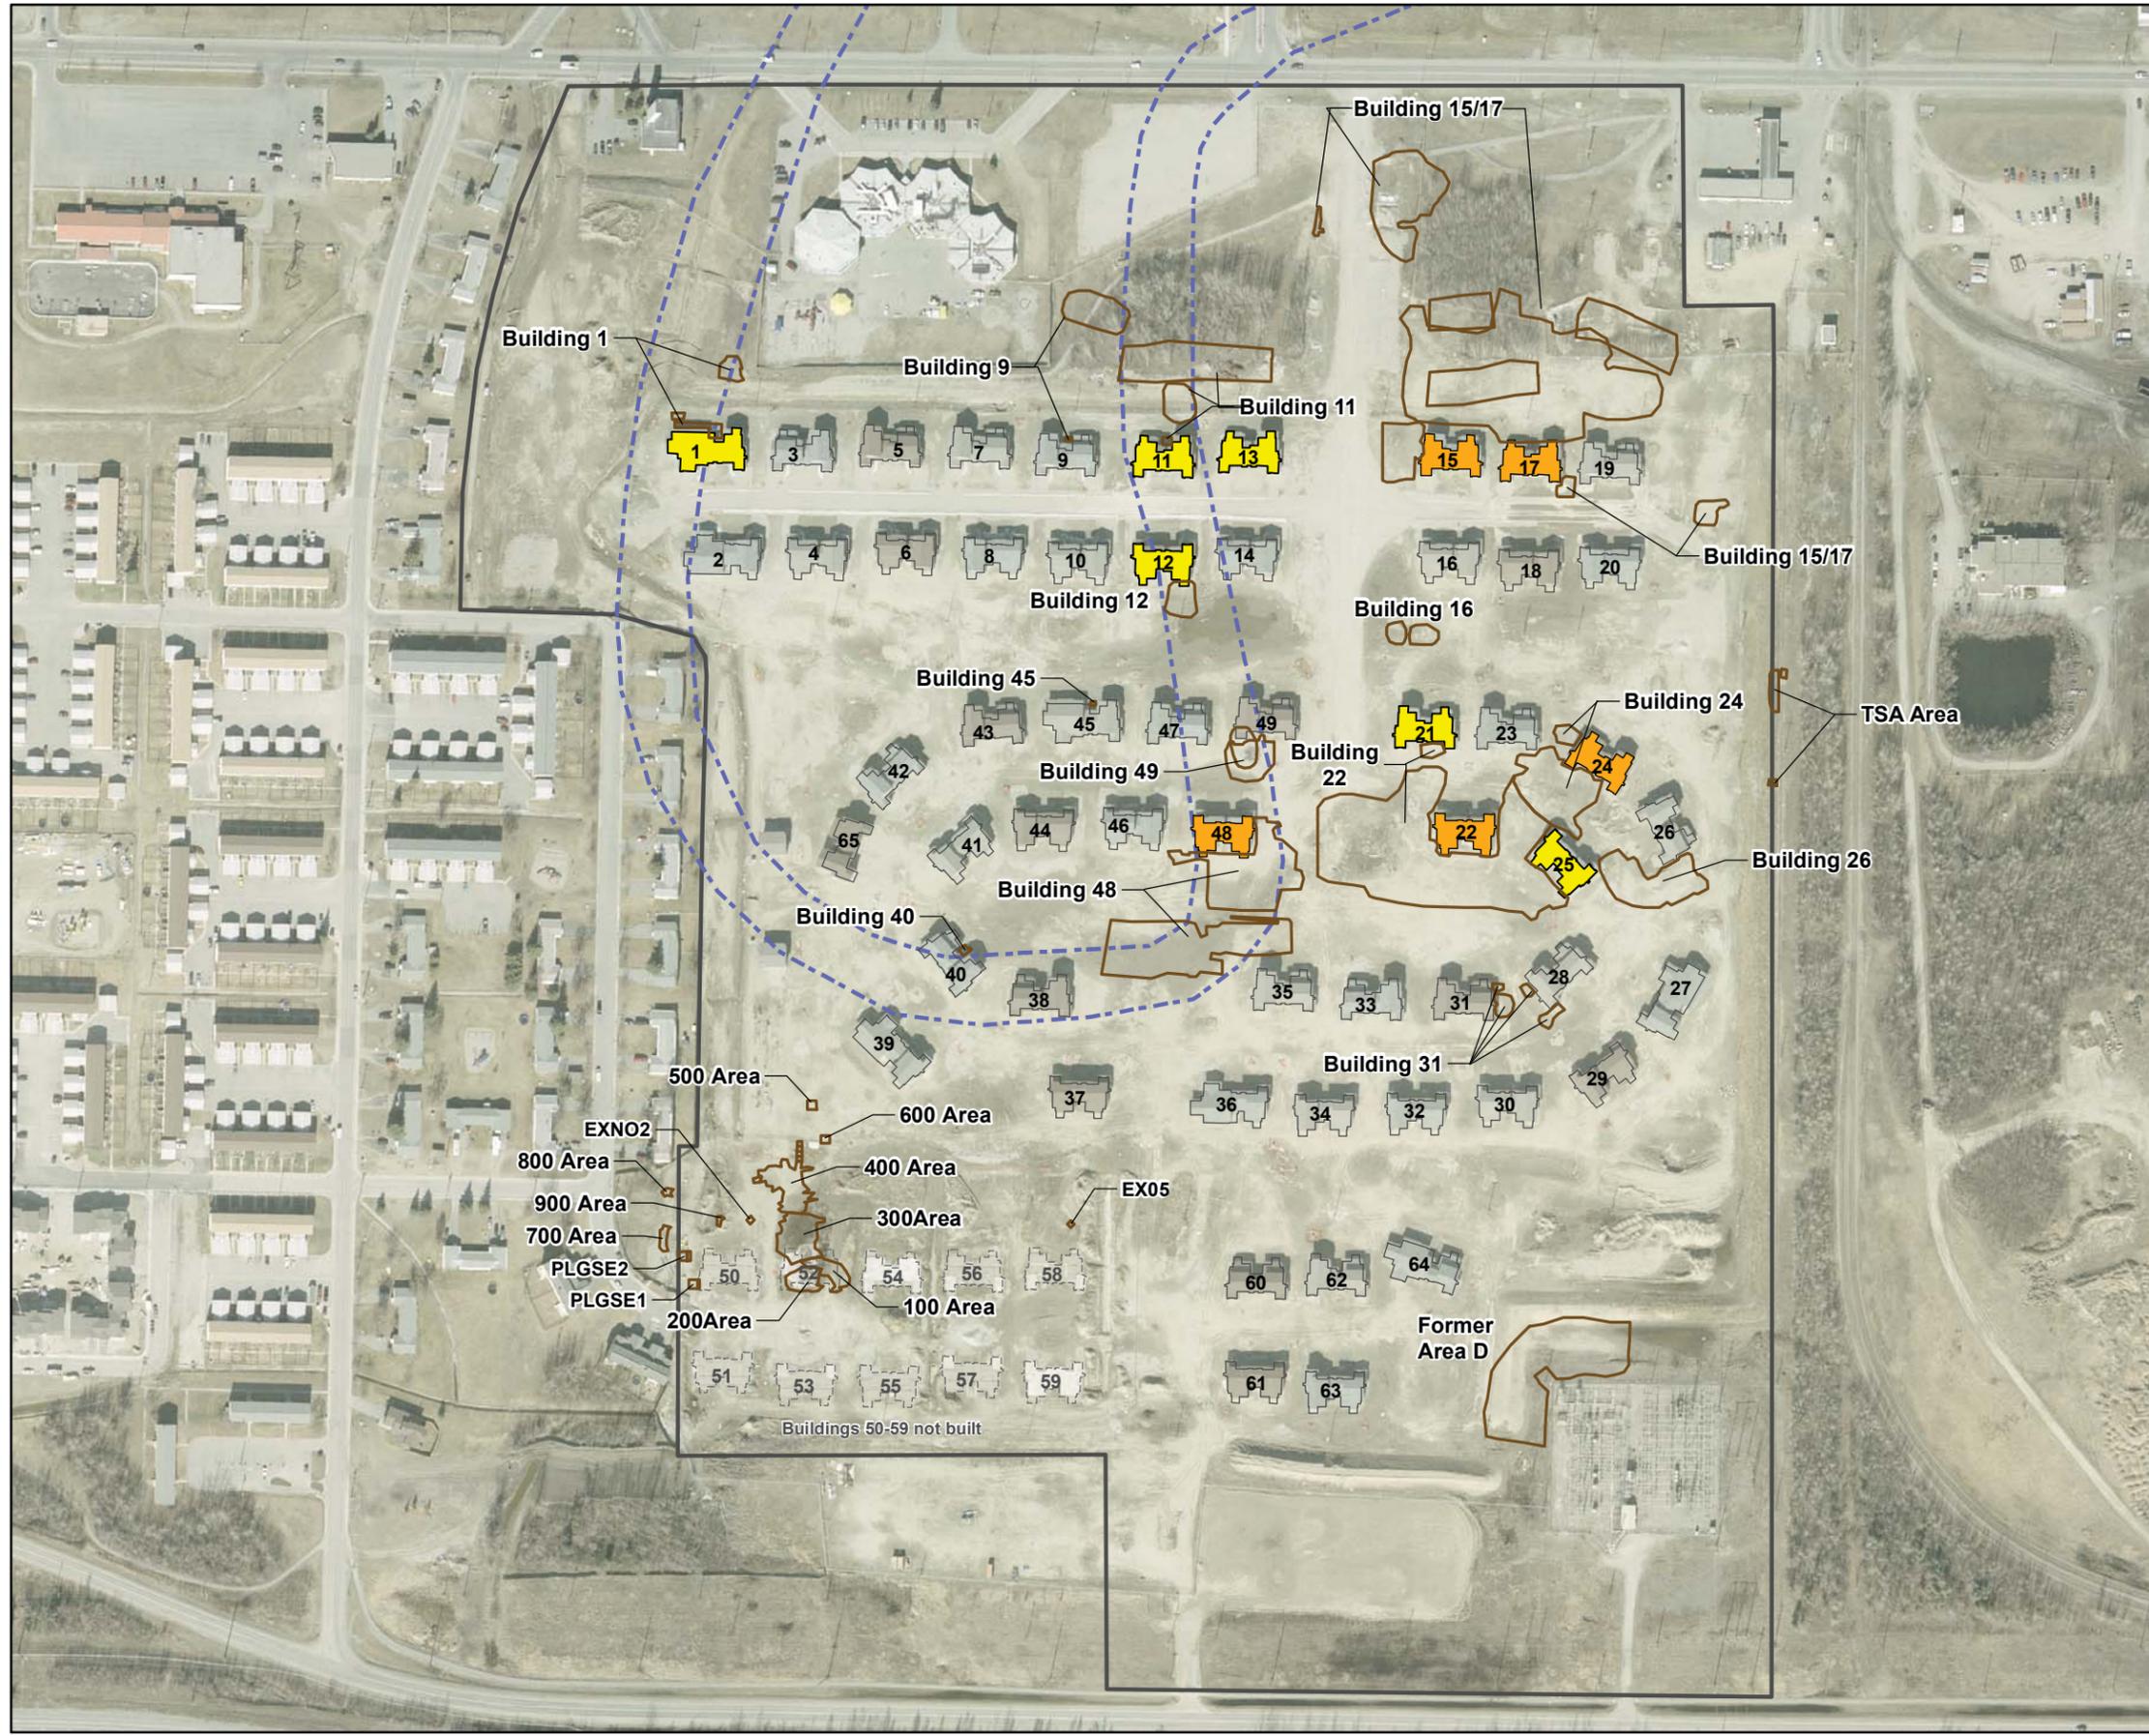
- LEGEND**
- Site Boundary
 - Former Hoppe's Slough
 - PCB and Exploratory Excavation Area
 - Building with Observed Debris Beneath Foundation
 - Building with Possible Debris Beneath Foundation

- **Potential for future releases from inaccessible debris beneath buildings:** Buried debris appears to extend beneath five buildings at the FCS and cannot be easily removed without compromising the structural integrity of the building foundations. The possibility that this residual debris might release volatile chemicals that could pose a potential for exposure to future building residents through the indoor air pathway is considered remote, given that 13 excavations targeting large and dense geophysical anomalies have been conducted at the FCS with the following relevant observations:

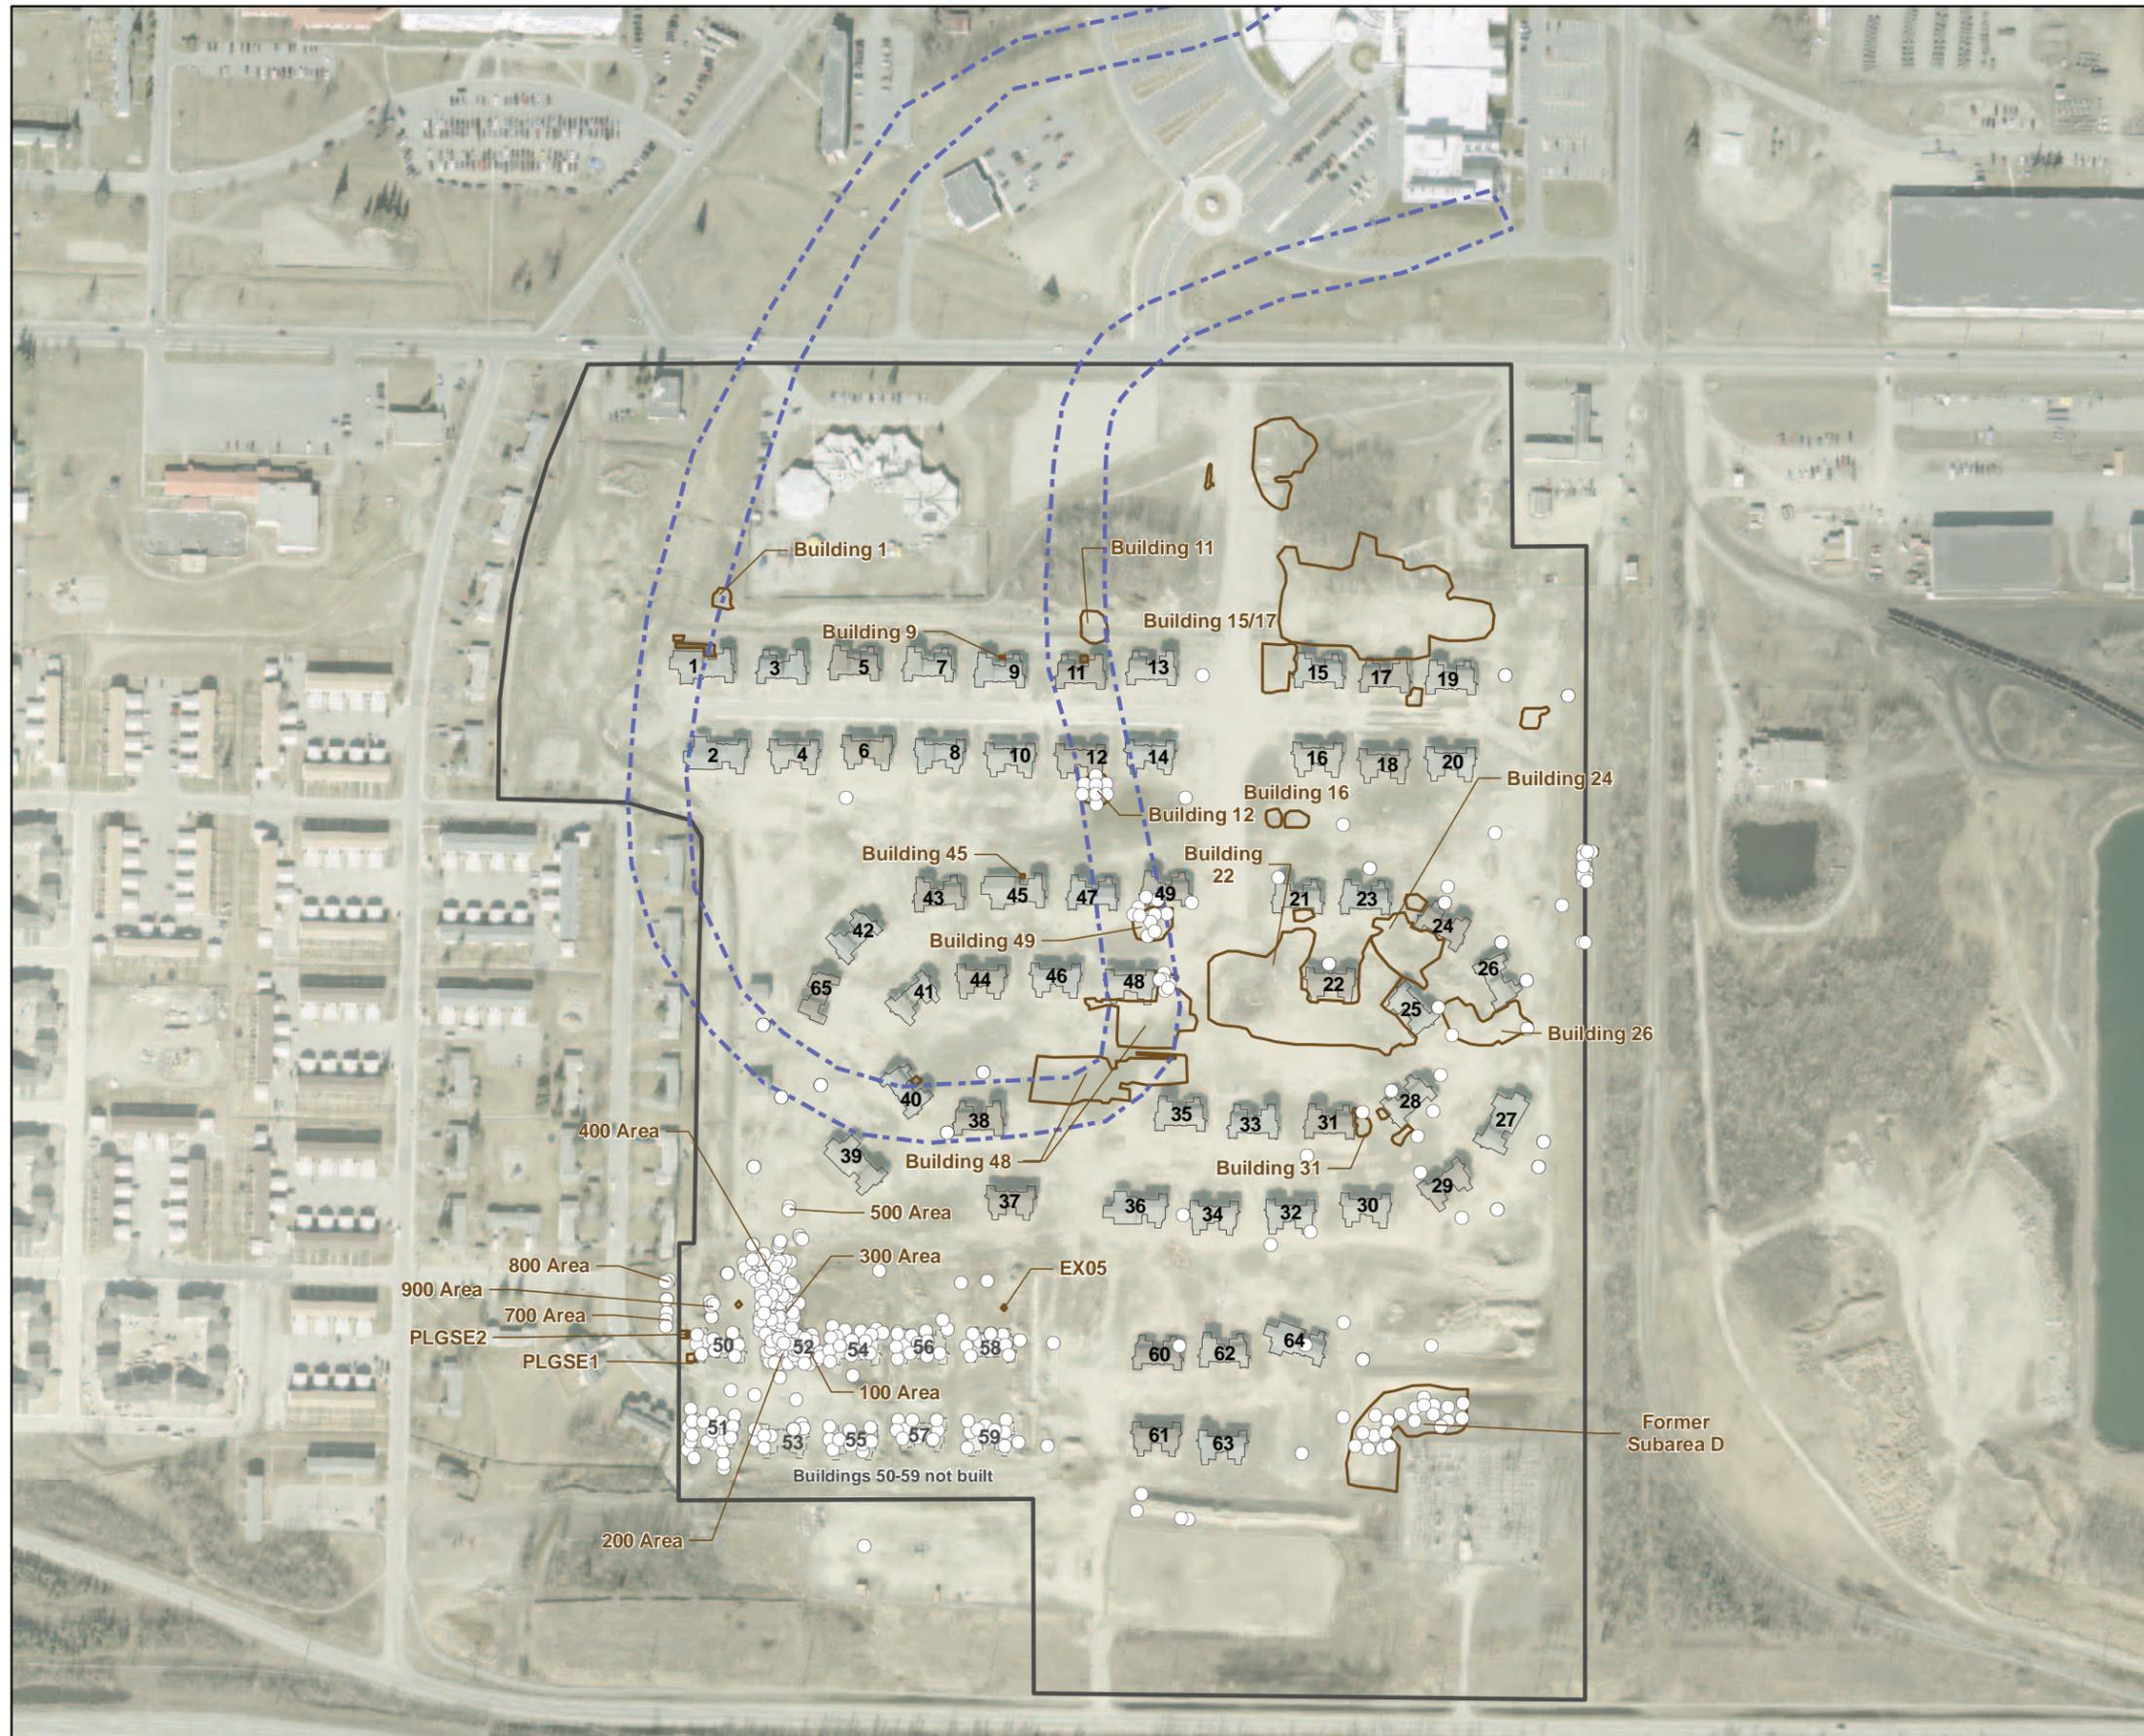
FIGURE 5-2
Distribution of PCB-1260 in Subsurface Soil
 Final Remedial Investigation Report
 Former Communications Site, Fort Wainwright, Alaska

Explanation of Results
 No detected exceedances of PSLs

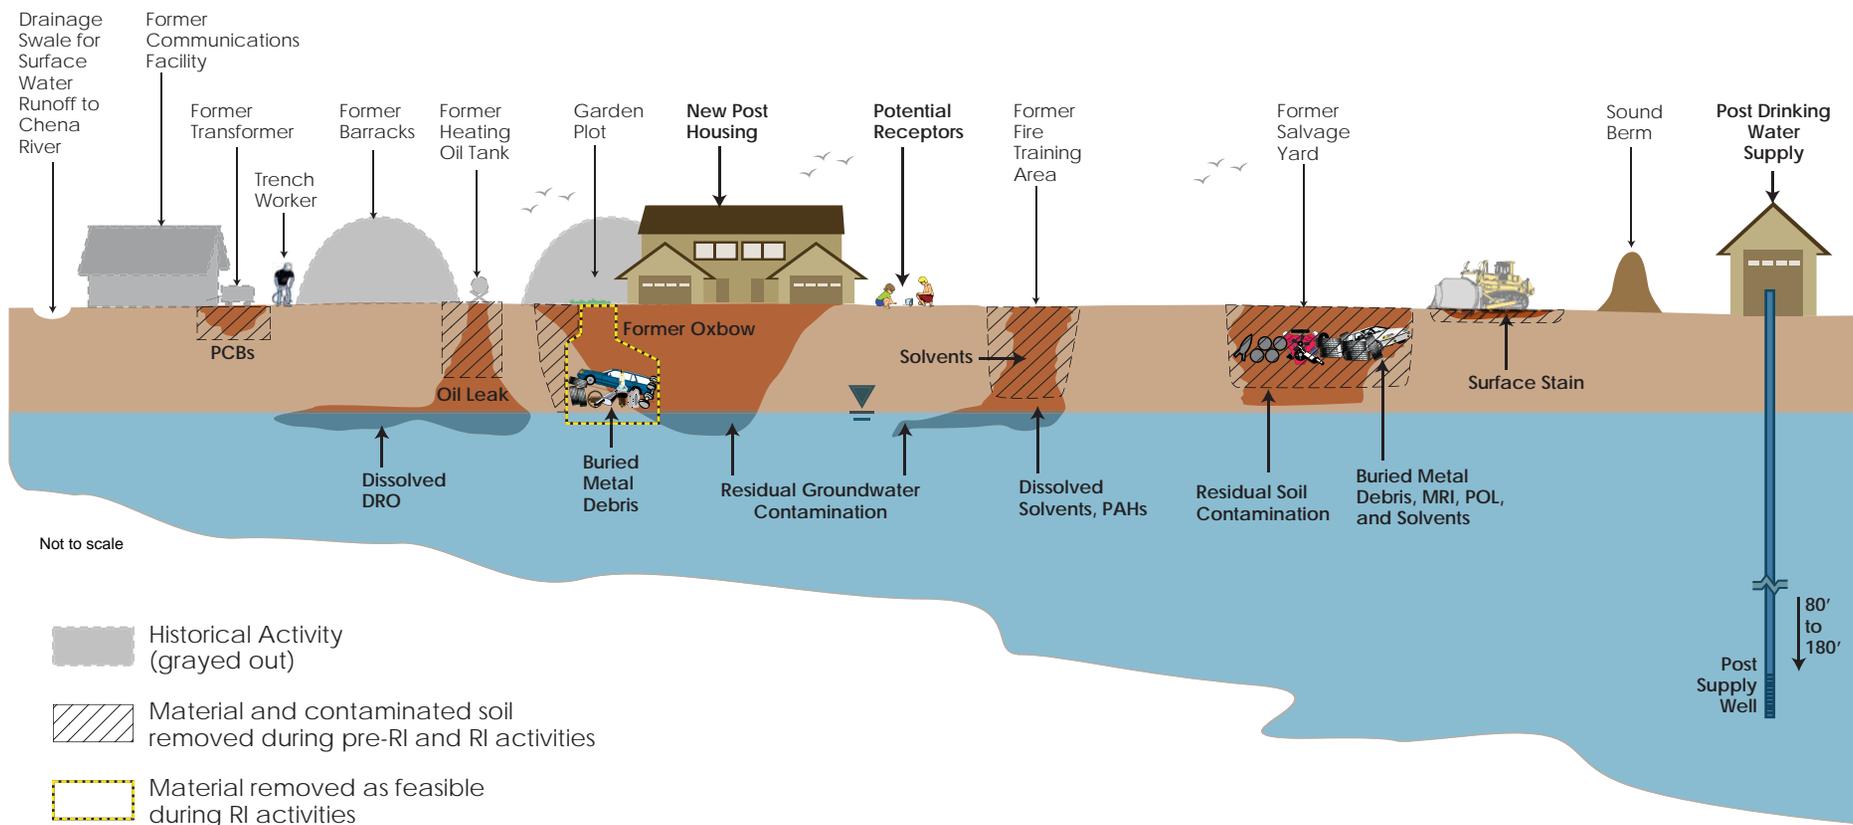
FIGURE 5-22

Conceptual Site Model
