Re: Building 3008 – Hanger 2 Structural Evaluation

Special Inspection

To:	Fort Wainwright Directorate of Public Works (DPW), File	Field Visit Date:	February 28, 2011
Date:	March 3, 2011	Location:	Hanger 2, Fort Wainwright
Time:	1330-1630	Weather:	-10°F, light wind, clear skies
Project:	FTWW Bldg. 3008 – Hanger 2 Structural Evaluation	Present at Site:	Michael Dean, Billy Brookins, Janet Matheson – Design Alaska; Scott Smith – FTW DPW; Shaw Contracting Crew

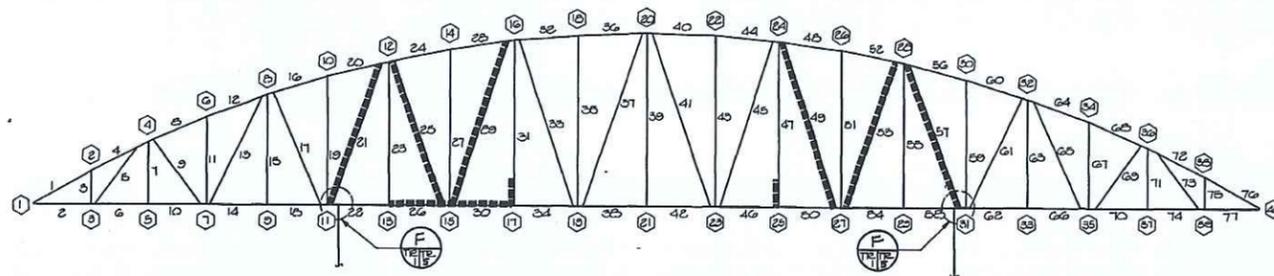
B1 TRUSS KEY - TRUSS 1

REPAIR AND ADDITIONS		HANGAR 2 TRUSS 1	
LOCATION	TYPE OF DISTRESS	REPAIR / MODIFICATION-TYPE	LOCATION / DETAIL REFERENCES
J7	STRUT MODERATE CHECK	REPLACE	TRUSS 1 TO TRUSS 2
M21	COMPRESSIVE OVERSTRESS	TYPE 4	DETAIL I-TR 7
M25	TENSION OVERSTRESS	TYPE 3	DETAIL K-TR 6, DETAIL G-TR 8 (OPP.)
M28, M30 EAST	SEVERE SPLIT	TYPE 2	JT. 13 / DETAIL F-TR 7 TO JT. 17 / DETAIL G-TR 7
M29	COMPRESSIVE OVERSTRESS	TYPE 4	DETAIL I-TR 7
M31	TENSION OVERSTRESS	TYPE 3	DETAIL K-TR 8
J15	STRUT SEVERE SPLIT	REPLACE	TRUSS 1 TO TRUSS 2
M47	TENSION OVERSTRESS	TYPE 3	DETAIL K-TR 8
M49	COMPRESSIVE OVERSTRESS	TYPE 4	DETAIL I-TR 7 (OPP.)
M53 EAST	SEVERE SPLIT, TENSION OVERSTRESS	TYPE 3	DETAIL K-TR 6 (OPP.), DETAIL G-TR 8
M57	COMPRESSIVE OVERSTRESS	TYPE 4	DETAIL I-TR 7 (OPP.)

Truss 1 has undergone significant fire damage along the center member 39 and the top chord. All members noted above need to be replaced with new material to ensure the truss remains capable of supporting the loads it was originally designed for. The original construction material was Douglas Fir #1 according to as-built documentations utilized during the inspection. All bolts not immediately affected by the fire, outside of joints listed or affected by repair work, need to be checked for proper tightening and thread exposure. All bolts affected by the above repair work should be replaced with new material and hardware due to adverse stresses imposed during the fire.
