CONDITION ASSESSMENT AND REHABILITATION PLANS, HANGARS 2 AND 3, LADD FIELD NATIONAL HISTORIC LANDMARK FORT WAINWRIGHT, ALASKA

*Final Submission
January 2008*

As part of a Cooperative Agreement with the United States Army Environmental Center (USAEC), The Louis Berger Group, Inc. (Berger) was tasked to produce a Condition Assessment and Rehabilitation Plan (CARP) for use by the Department of the Army to determine the feasibility and use of the World War II era hangars to meet current and future anticipated mission needs associated with the projected move of the Aviation Task Force at Fort Wainwright, Alaska.

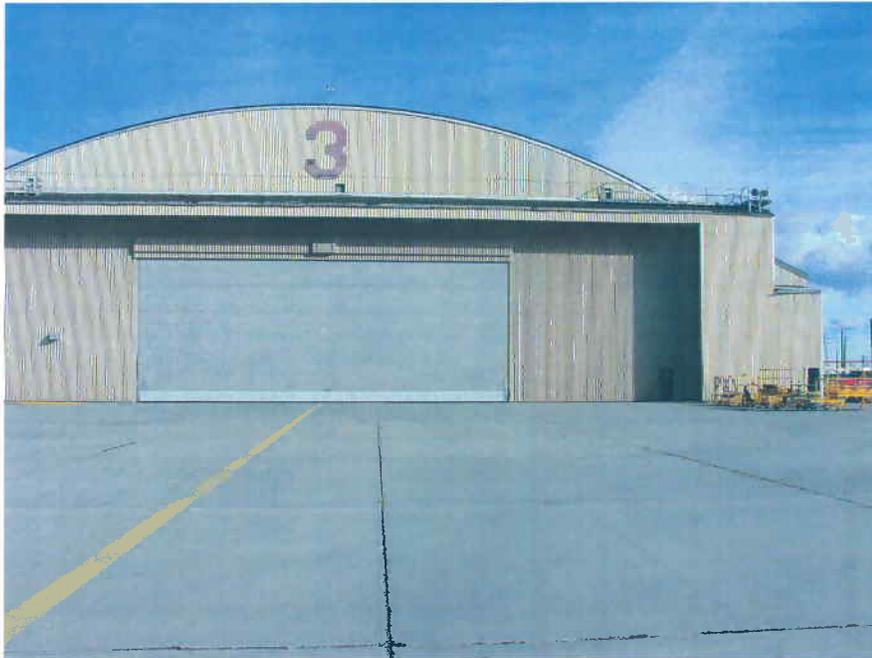
Figure 3.3 Exterior shot hangar with lean-south support bay - Hangar 3.

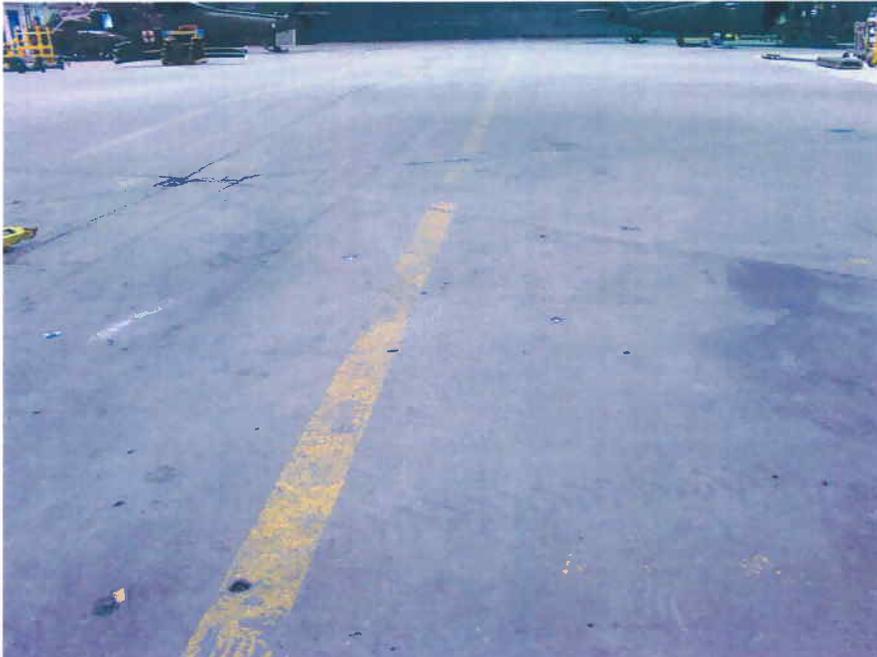
- Code and Standard Deficiencies:
 1. The sloped floor has settlement and cracking throughout the aircraft hangar bay which may impede service to the aircraft housed in the hangar (refer back to Fig. 3.4).
 2. Floors do not have proper slope, drains, ramps or curbs to contain flow of liquids (refer back to Figs. 3.35 and 3.36).
 3. Ramped transitions and foundation settlement at all doors are in violation of NFPA code requirements (see Figs. 3.60 and 3.61).
 4. Curb each side of exterior wall is in violation of NFPA (refer back to Figs. 3.23 and 3.27).
 5. All vinyl tile is out of date and failing throughout the building (see Figs. 3.55, 3.57 and 3.59).
 6. Concrete both painted and unpainted needs to be removed, clean, patched, repaired and repainted or resealed (see Fig. 3.56).

Figure 3.4 Hangar concrete floor slab at both Hangars 2 & 3.

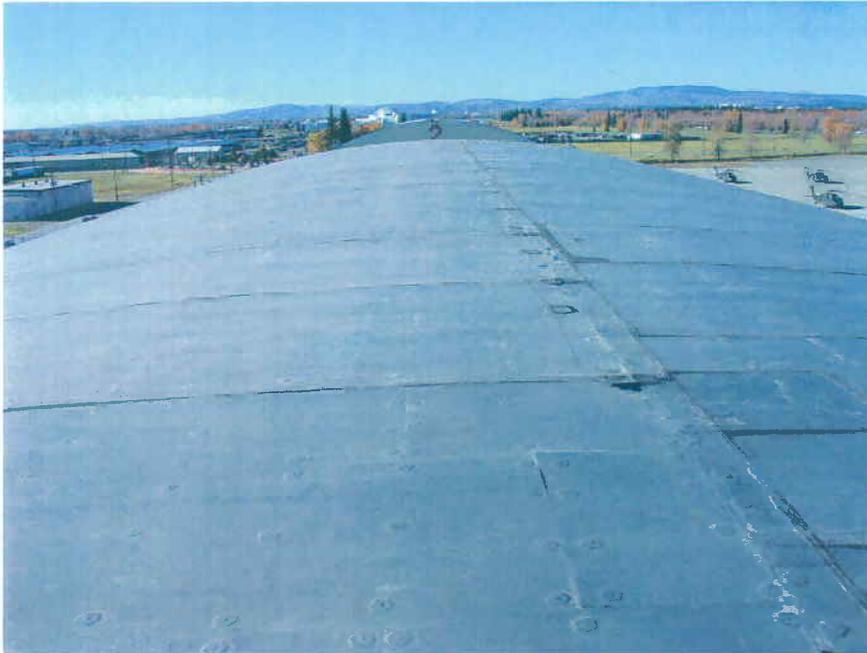
Figure 3.13 EPDM roofing - Hangars 2 & 3.

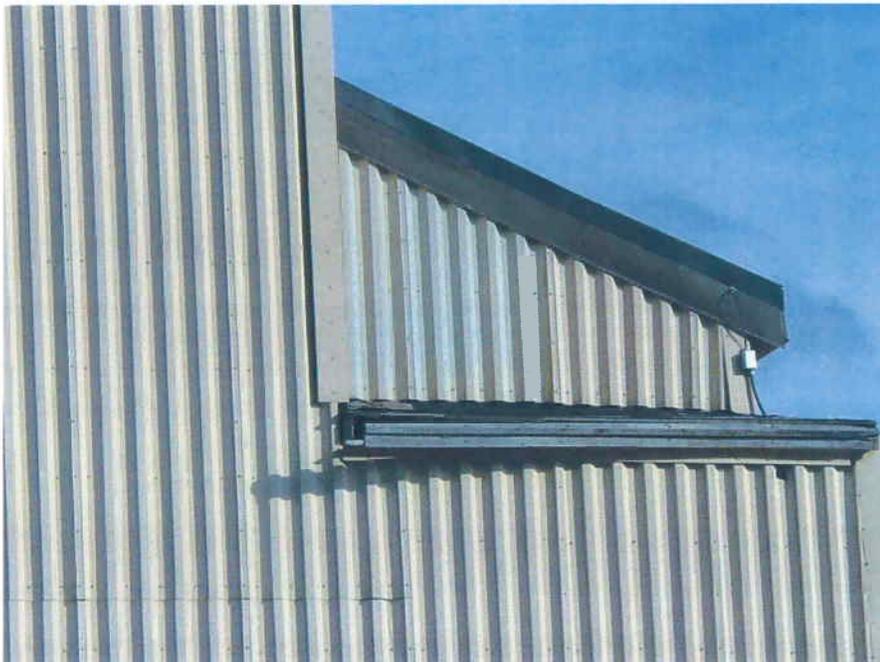
Figure 3.16 Rotten wood fascia trim - Hangars 2 & 3

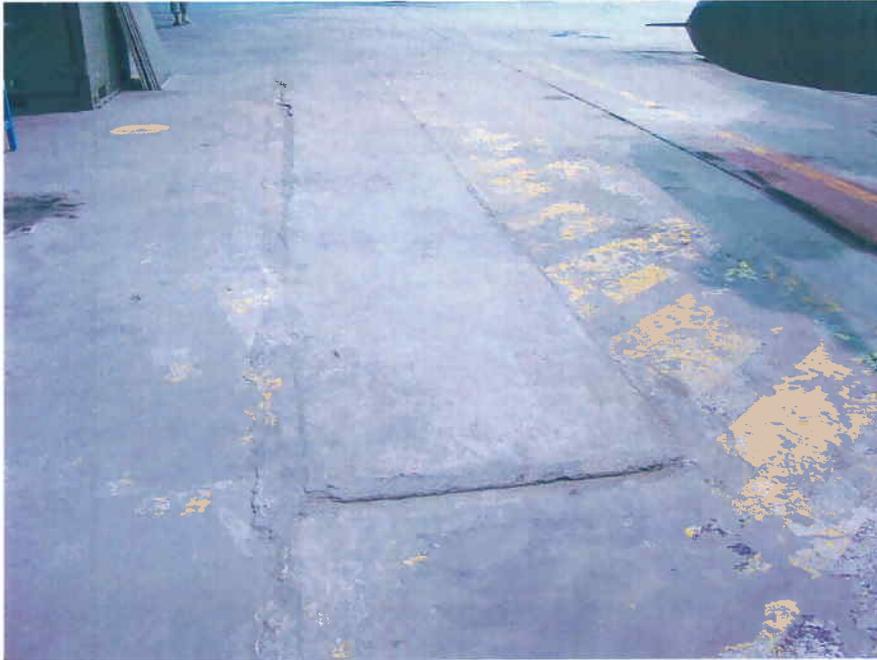
Figure 3.21 Concrete hangar floor slab - Hangars 2 & 3.

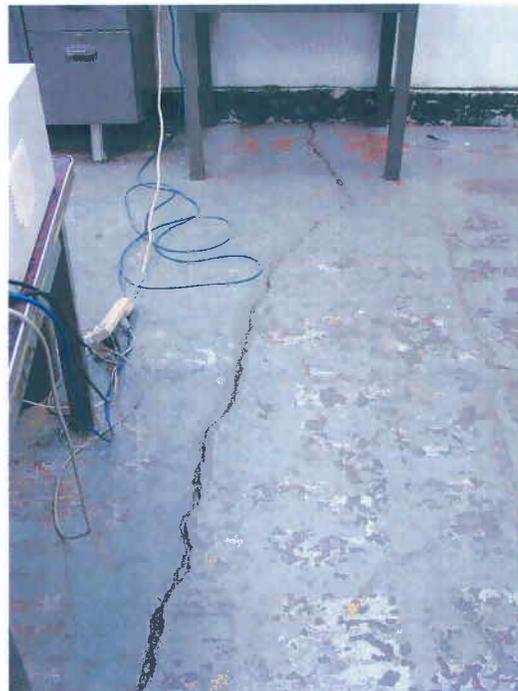
Figure 3.22 Concrete floor slab - support spaces
- Hangar 2 & 3.

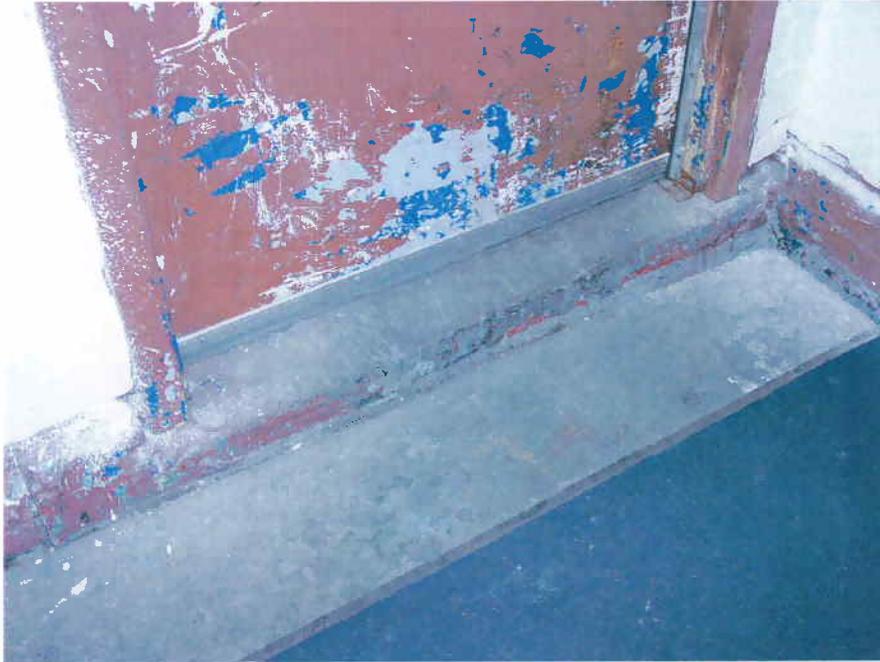
Figure 3.23 Concrete curb at exterior doors, typical - Hangars 2 & 3.

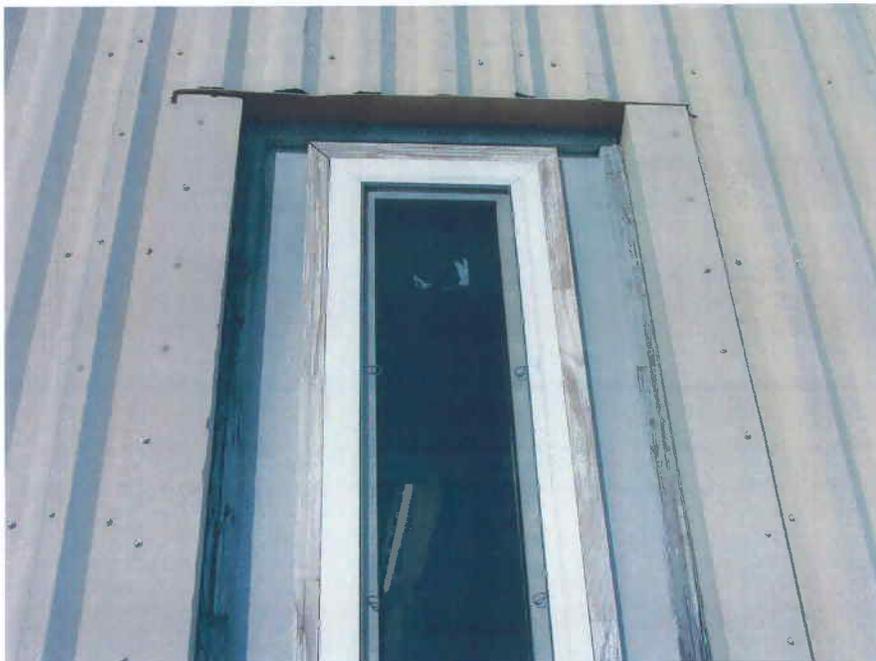
- Code and Standard Deficiencies:
 1. The wood infill and wood trim have reached the end of their useful life (see Fig. 3.26).
 2. Vapor barrier at all windows may be inadequate or nonexistent.

Figure 3.26 Typical vinyl windows shaving infill - Hangars 2 & 3.

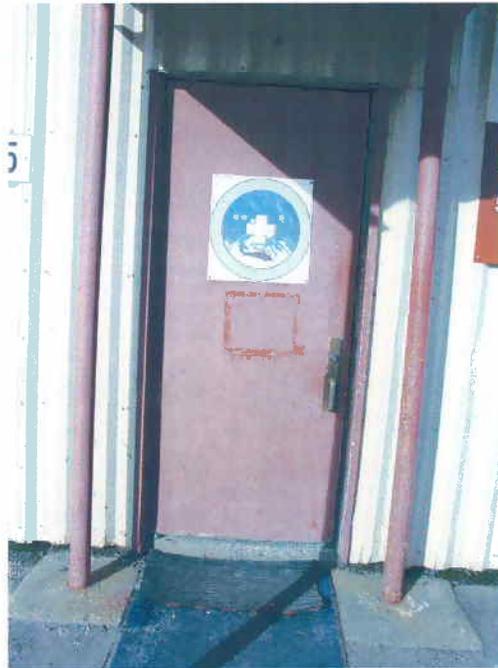
Exterior landings outside grade level exterior doors do not exist. Exterior landings at exterior door exits from the second floor stair towers are wood platforms (see Fig. 3.34; also refer back to Fig. 3.27).

Figure 3.27 Exterior door - at canopy - Hangars 2 & 3.

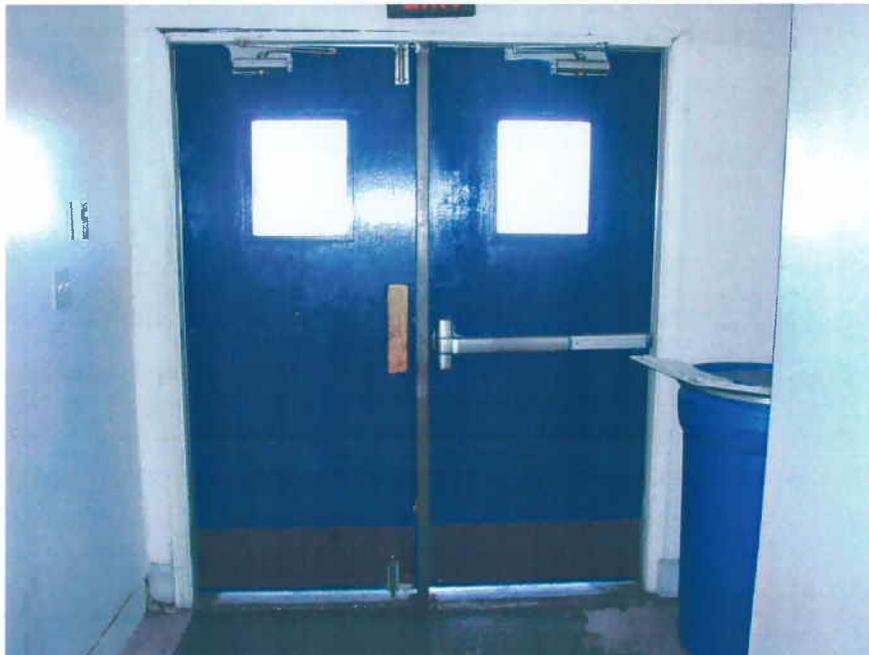
Figure 3.28 Exterior doors inside - Hangars 2 & 3.

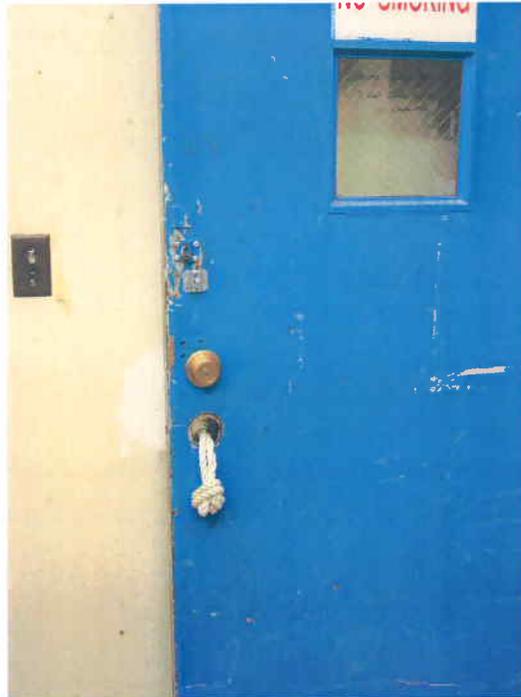
Interior doors and frames are uninsulated painted hollow metal (refer back to Figs. 3.29 and 3.30).

Figure 3.29 Interior door note: lack of lockset or pull - Hangars 2 & 3.

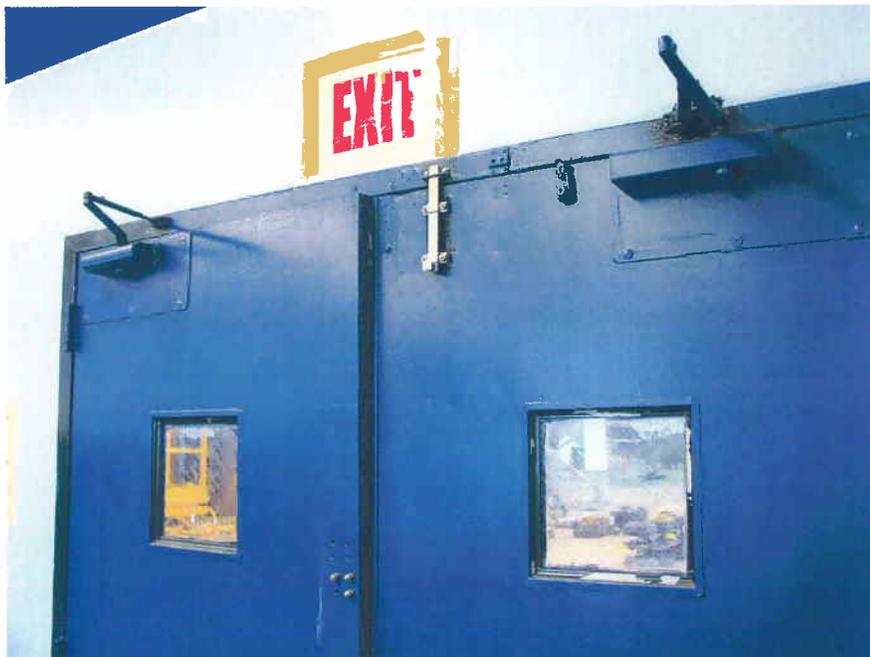
Figure 3.30 Interior doors with old hardware, inside - Hangars 2 & 3.

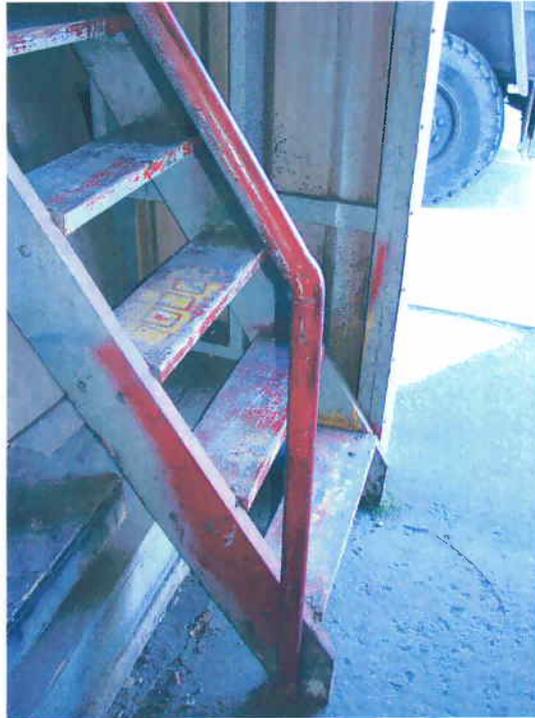
Figure 3.31 Exterior Stair tower, base of stairs - Hangars 2 & 3.

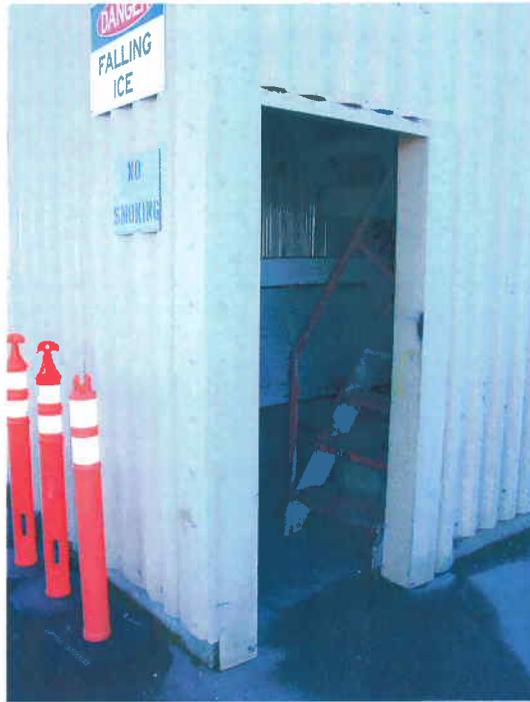
Figure 3.33 Exterior stair tower, opening - Hangars 2 & 3.

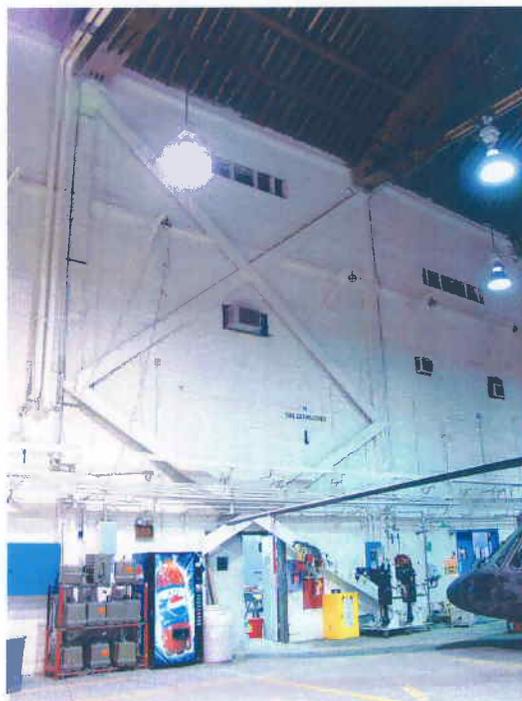
The hangar/support bay walls incorporate wood 12x12 columns. The condition of these columns is described in the structural section of this report. The hangar side of the walls is finished with 1x6 horizontal wood siding over a layer of gypsum board over 1x6 board sheathing applied diagonally to the supporting studs on the hangar side face. The supporting studs are 2x6 wood studs @ 16 inches o.c. The support bay side of these walls has gypsum board and 1x horizontal siding. In the office areas, the 1x horizontal siding has been furred out with a gypsum board finish (see Figs. 3.38 through 3.41; also refer back to Fig. 3.19).

- Code and Standard Deficiencies:
 1. Many of the finishes currently installed throughout the hangar are not durable, low maintenance materials that are easy to clean or designed for workmen doing aircraft repair. Much of the horizontal wood siding on the hangar walls is old and reaching the end of its useful life. Much of the siding has been cut and patched so many times it is un-repairable (refer back to Figs. 3.38 through 3.41).

Figure 3.38 Hangar support bay walls - Hangars 2 & 3.

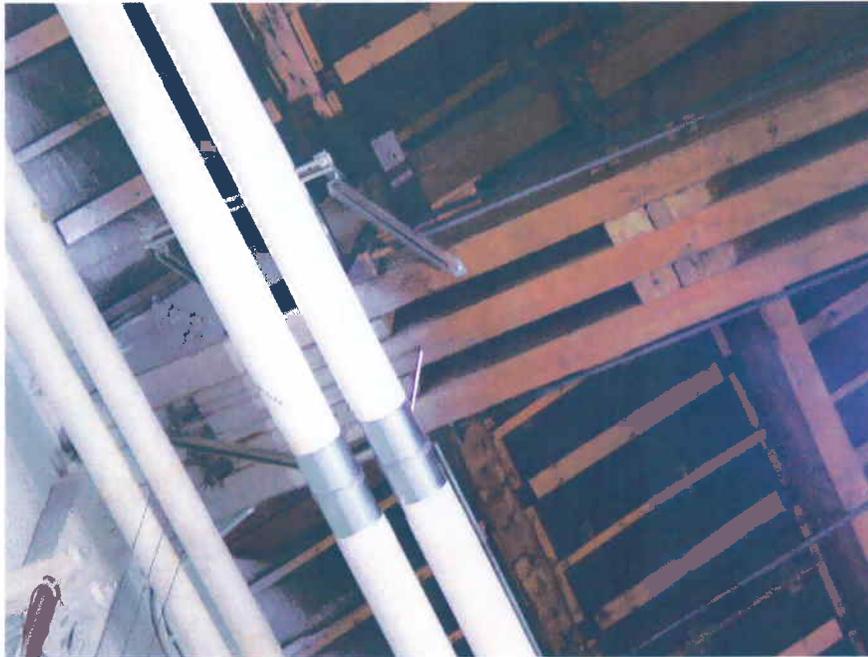
Figure 3.39 Top of column to truss connection at hangar/support bay walls - Hangars 2 & 3.

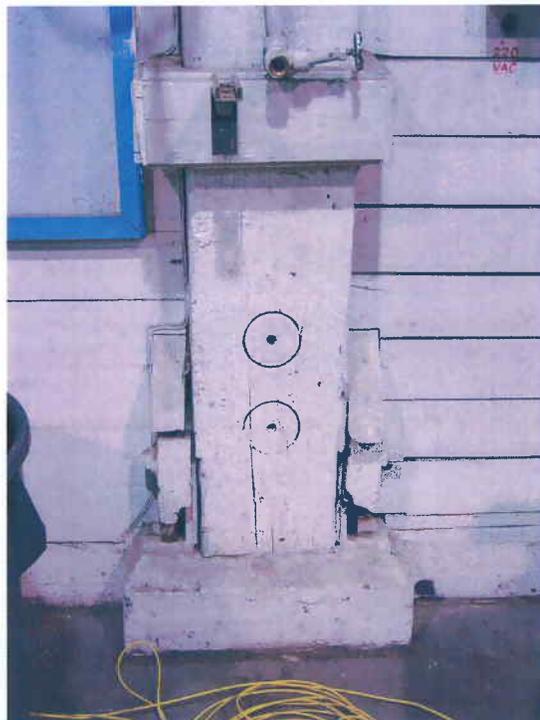
Figure 3.40 Column base at hangar/support bay walls - Hangars 2 & 3.

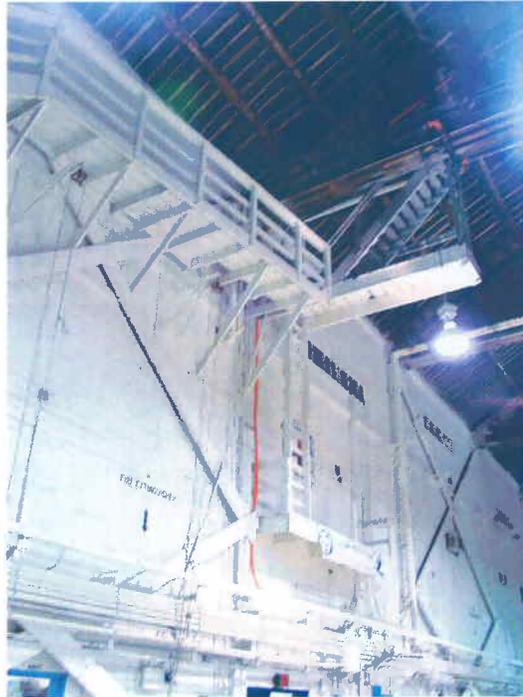
The catwalks typically extend from the east end of a hangar to the west down the middle of each hangar. At the east and west end, the catwalk extends from the north to the south wall along the inside bottom chord of the end truss. Approximately centered between the east and west end walls is another section of catwalk running from the north wall to the south wall. The catwalk is typically accessed by ladder or stair central to the north or south wall up the face of the wall to the central section of catwalk. The framing is generally light lumber framing, 2x4 and 2x6 members with plywood sheathing over the walking platform. The catwalks are suspended from the trusses or bear on the truss bottom chord or truss stabilizing struts (see Figs. 3.68 through 3.72, and also refer back to Fig. 3.41).

Figure 3.41 Upper hangar/support bay walls
- Hangars 2 & 3.

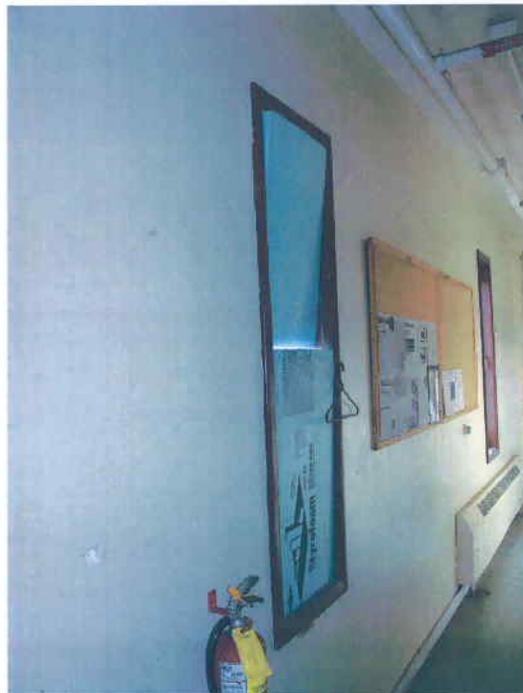
The support bay walls consist of indeterminate thickness plywood over 1x6 horizontal wood siding over 1x8 diagonal wood sheathing applied to the face of the 2x6 wall studs @ 16 inches o.c., and painted gypsum board (see Figs. 3.42 and 3.43).

Figure 3.42 Inside of exterior of wall at corridor
- Hangars 2 & 3.

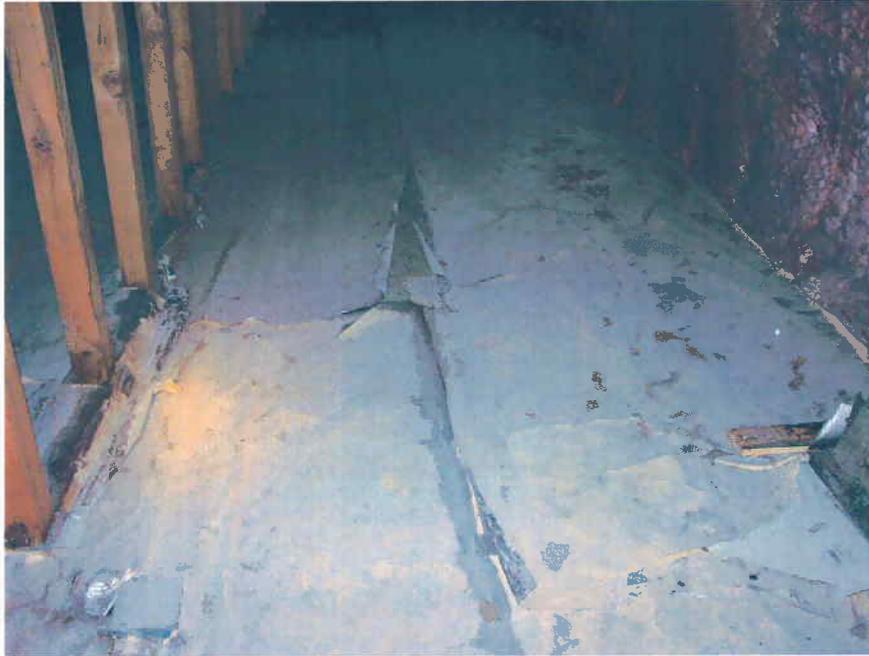
The support bays' original flat roof is constructed of a foil backed paper exposed as a walking surface over tar or asphalt coating substrate over indeterminate thickness plywood over joists, with (1) layer of painted gypsum board below (see Figs. 3.46 and 3.47).

Figure 3.47 Floor/ceiling support and bay cavity at cavity at top ceiling - Hangars 2 & 3.

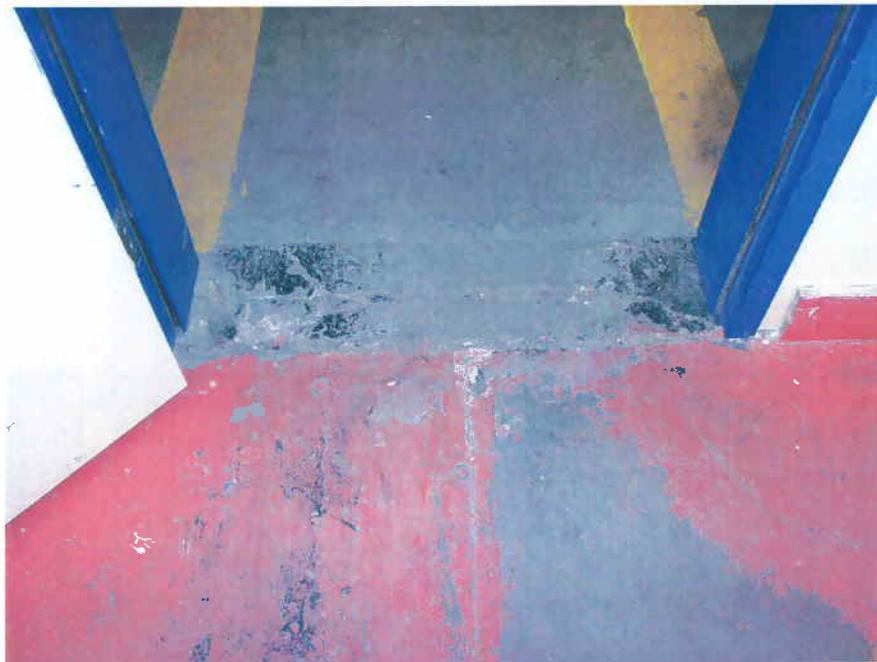
- Code and Standard Deficiencies:
 1. Throughout the facility, carpet is worn, torn, damaged, soiled, stained and fraying (see Fig. 3.63).
 2. Vinyl tile is a mismatch assortment to different types. All are showing age, cracking, chipping, damage, staining, scraped and missing. All vinyl tile is out of date and failing throughout the building (refer back to Figs. 3.55, 3.57 and 3.59).
 3. Treads and risers in stairs are showing wear and tear. Landings are also missing detectable warnings at stairs (see Fig. 3.64).
 4. Transitions at all doors are coming apart, do not exist, are out of date or do not meet code.
 5. Concrete both painted and unpainted needs to be cleaned, patched, repaired and repainted or resealed (refer back to Fig. 3.56).

Figures 3.56 Floor finish at doors - Hangars 2 & 3

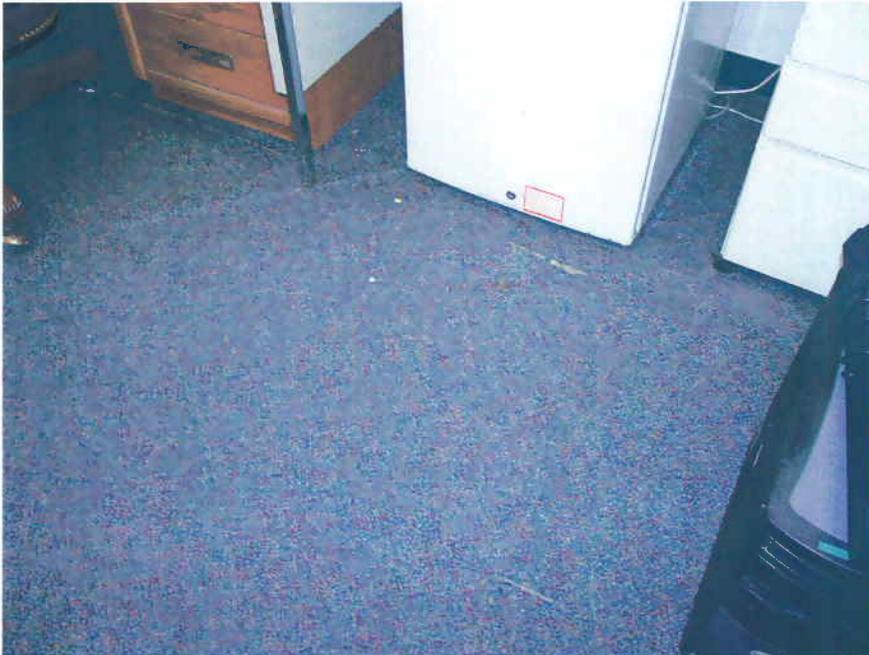
Figure 3.63 Carpet floor finishes - Hangars 2 & 3.

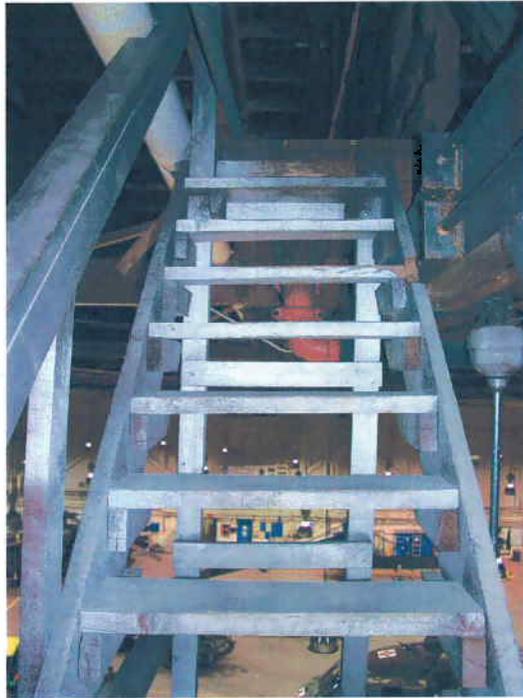
Figure 3.68 Catwalk walking surface temporary patch - Hangar 3.

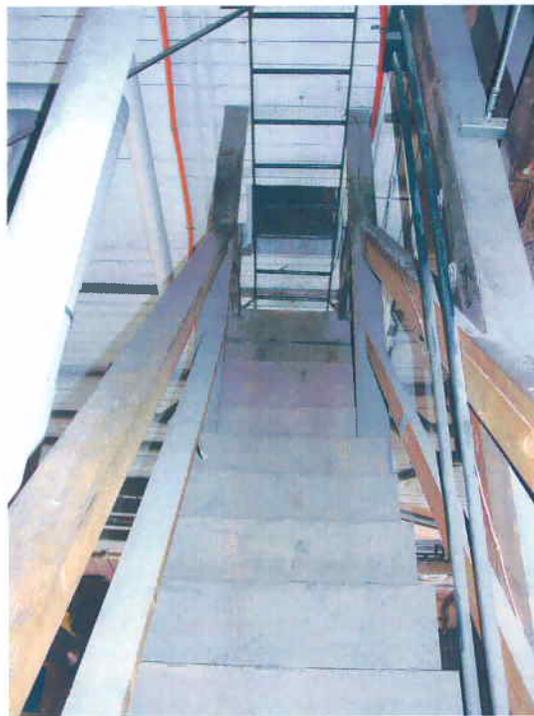
Figure 3.69 Catwalk access stair up - Hangar 3.

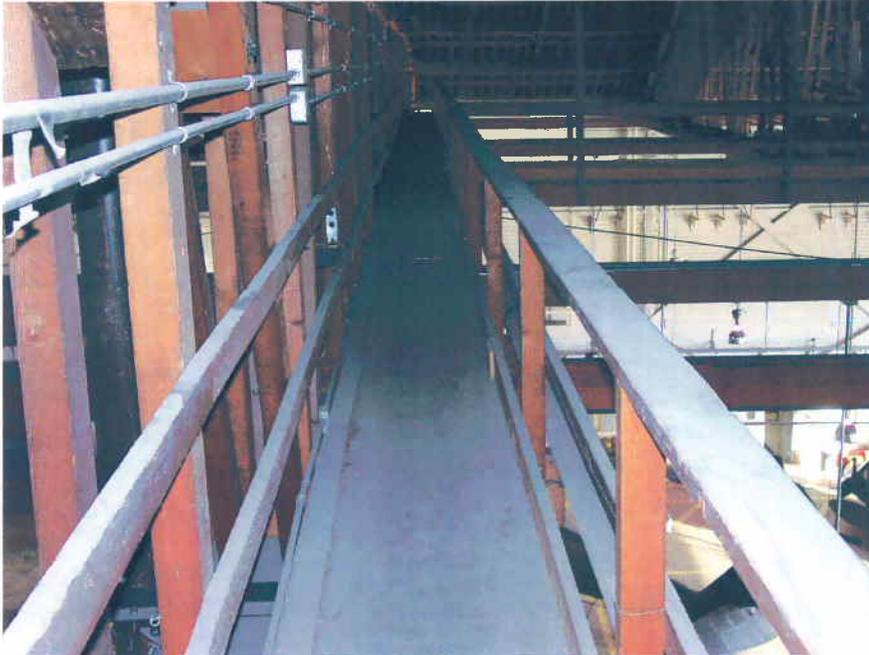
Figure 3.70 Catwalk access stair down - Hangar 3.

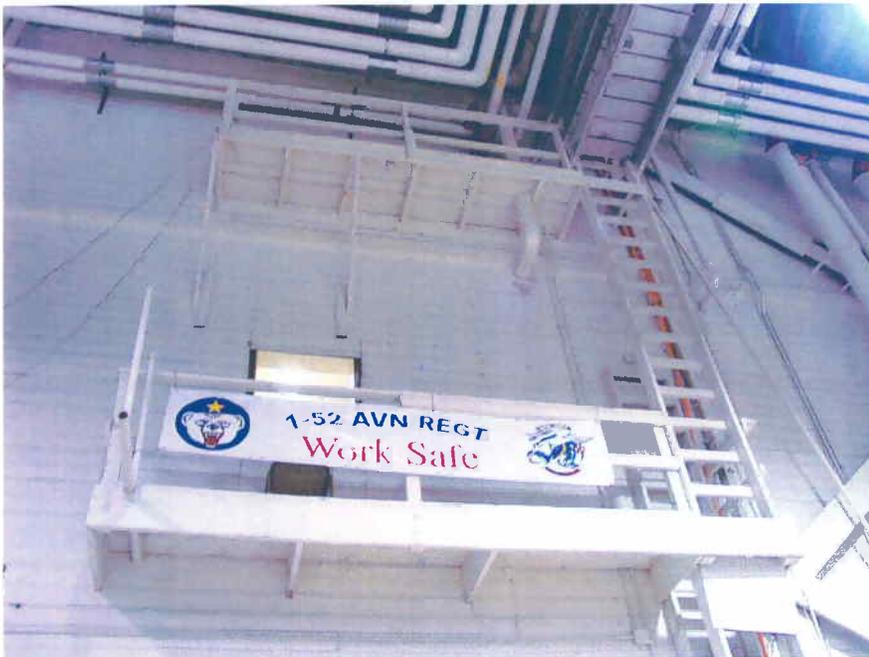
Figure 71 Catwalk - Typical - Hangars 2 & 3.

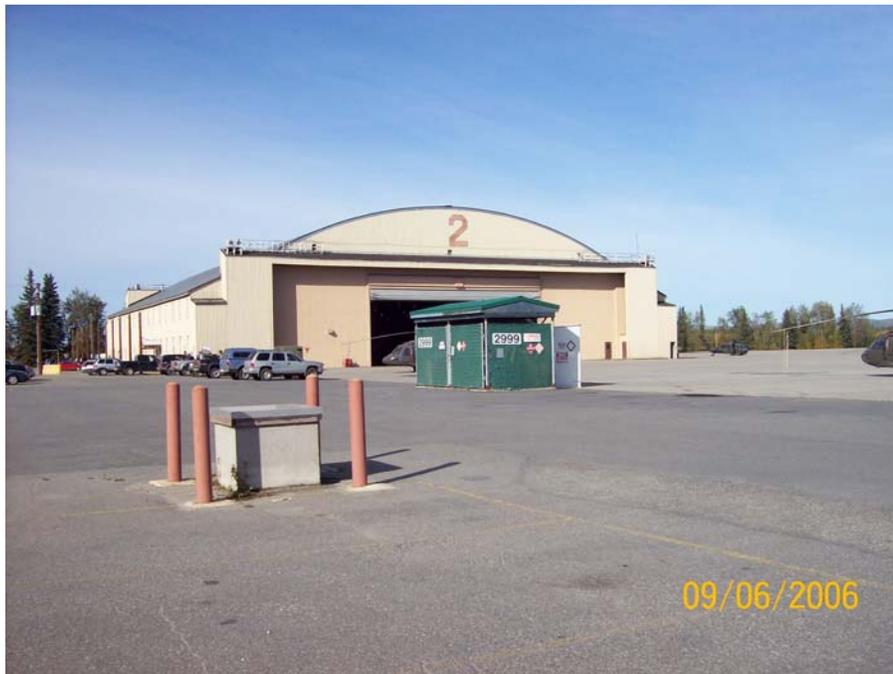
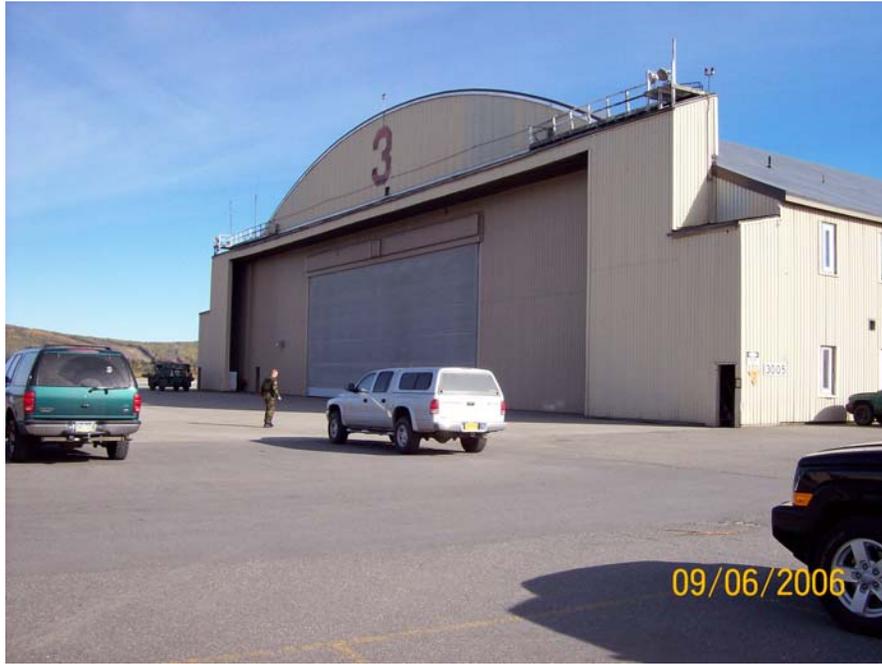
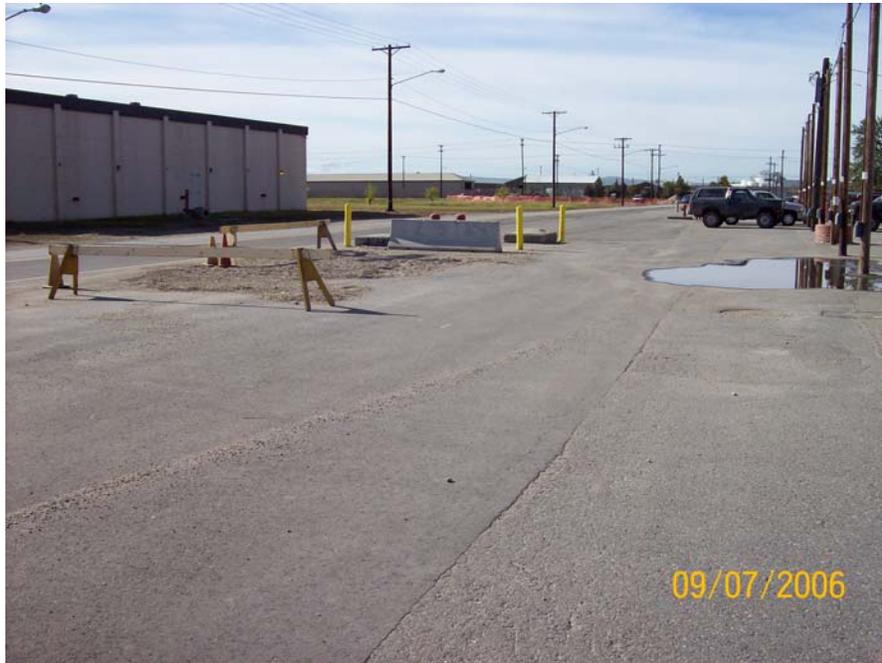
The asphalt parking lot has had multiple resurfacing and patch repairs done in the past. Many large cracks and puddles were observed on the parking surface. The parking spaces paint lines are faded and nonexistent in many locations. There is no curb separating the parking lot and Montgomery Road (see Figs. 4.1, 4.2 and 4.3).

- Re-grade, resurface and repaint the parking lot
- Add more fire hydrants around the buildings so that all exterior areas of both hangars will be within 150 feet of a fire hydrant as required by UFC 3-600-01.
- Construct a six foot chain link fence around both hangars with three gates. The gates would allow government vehicles access to the hangars. Different types of barriers could be considered to fulfill the force protection requirements.
- The fence would run 25 meters south of both hangars for about 1000 feet. The fence will run under the sides of each building about 100 feet (25 meter west of Hanger 2 and 25 meter east of Hanger 2). There will be a gate at each end of the hangars and one in the middle.

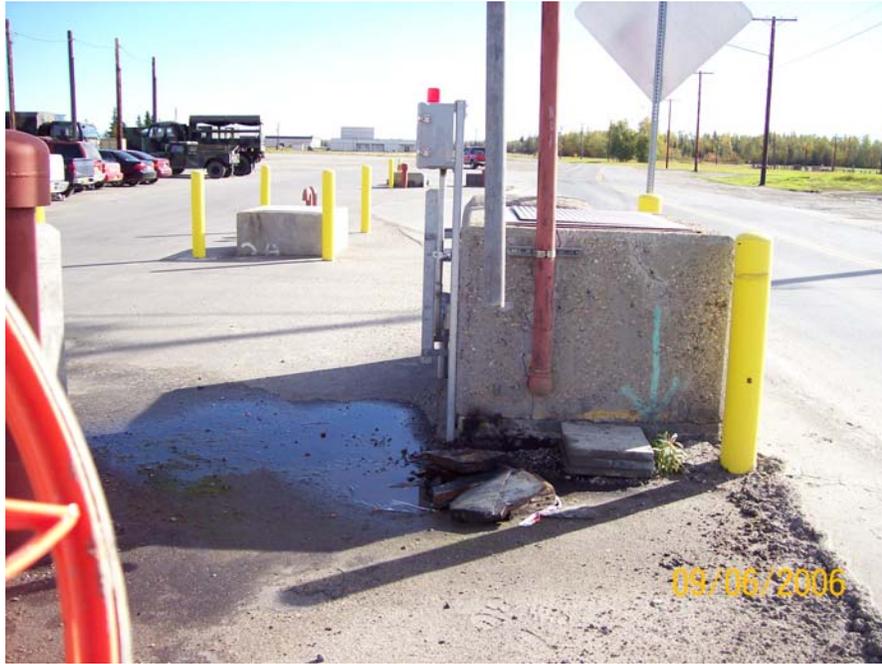
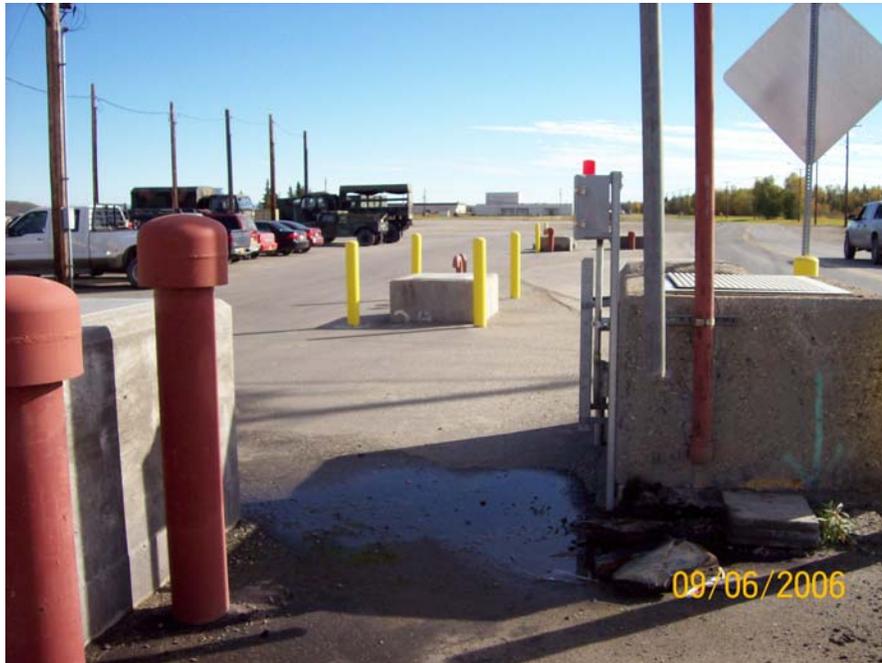
A utilidor runs parallel to Montgomery Street on the north side of the street. The utilidor was replaced in 2005 (see Figs. 4.4 and 4.5). The Utilidor contains the following utilities:

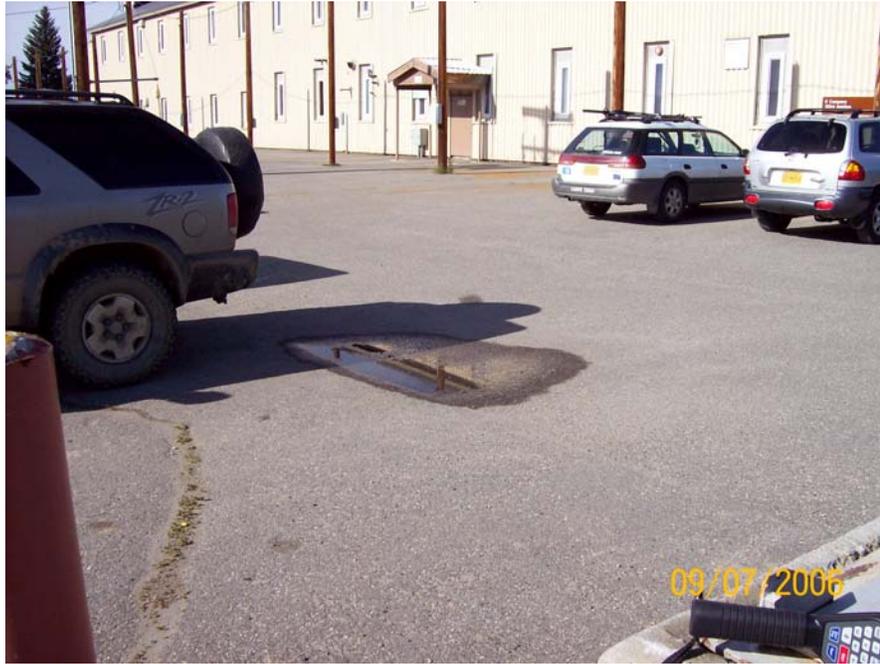
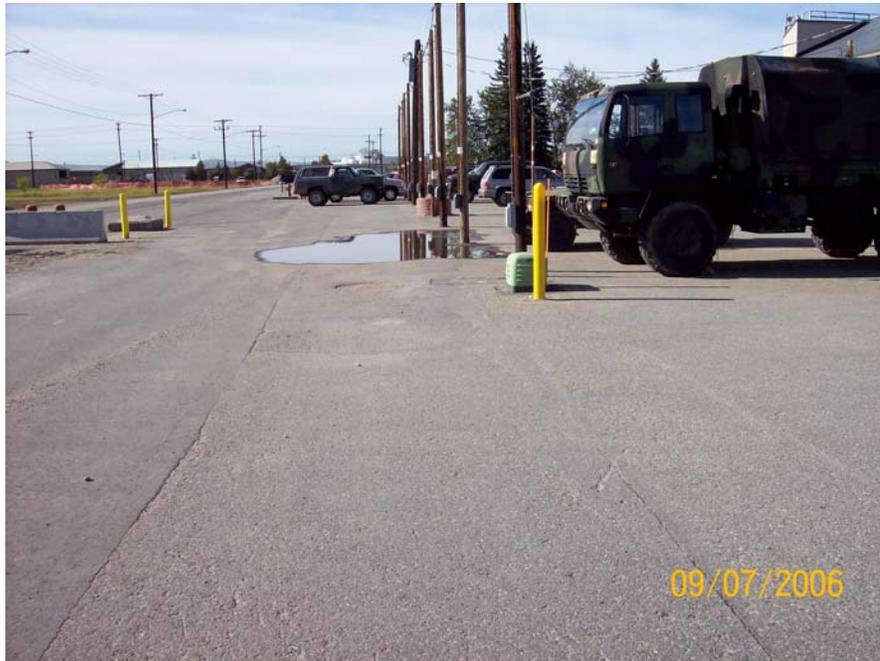
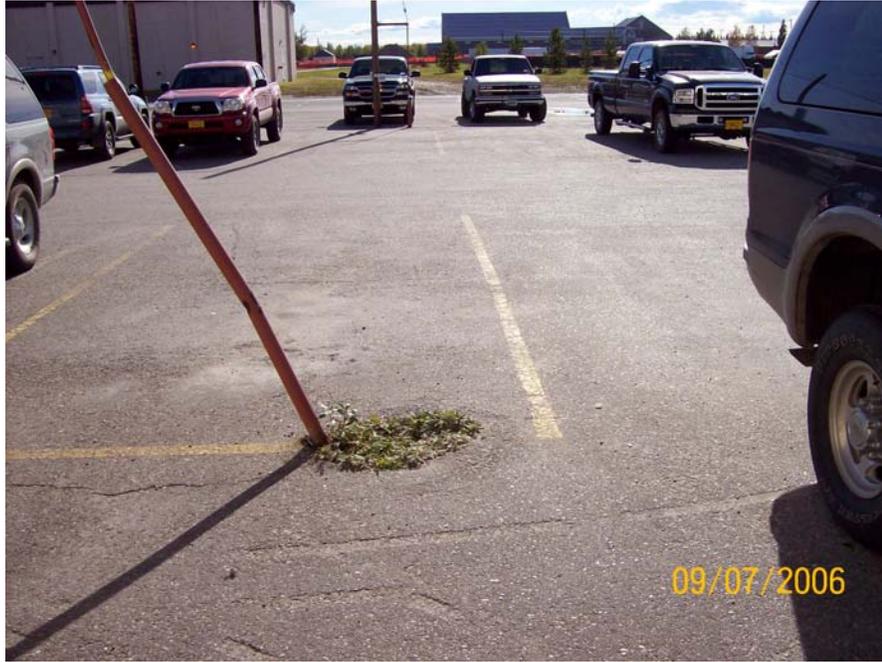
- Parking lots contains many potholes and cracks (see Figs. 4.6 through 4.9).
- The parking spaces paint lines are faded and almost nonexistent (see Figs. 4.10 and 4.11).
- Number and distances of fire hydrants do not meet the UFC 3-600-01 requirements (see Fig. 4.12).
- Barrier needed to comply with Force Protection.

Figure 4.6 Pothole

Figure 4.7 Looking West

Figure 4.8 Potholes

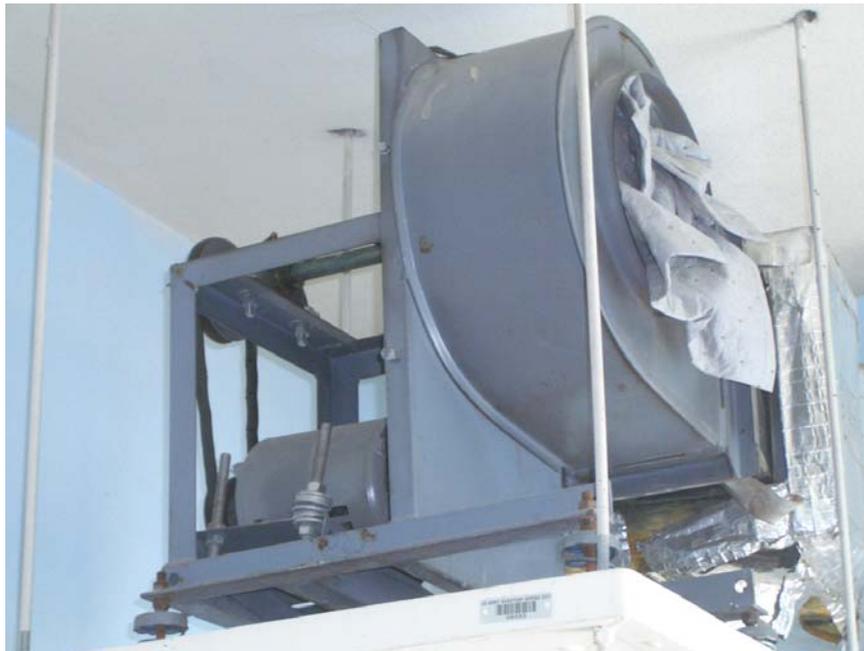
Both Hangars 2 and 3 suffer from poor maintenance. Except for the fire suppression system it appears that maintenance on these facilities is work order driven and not subject to a periodic preventive maintenance program. It appears that unless mechanical equipment failure significantly impacts the larger mission of maintaining helicopters it is ignored. For example restroom fans that have been covered with plastic to block winter back drafts with this plastic remaining well into the fall of the next season (see Fig. 6.1). The fire suppression system is maintained and tested on a regular basis.

Figure 6.1 Bathroom Exhaust Made Non-Operable at Hangar 2

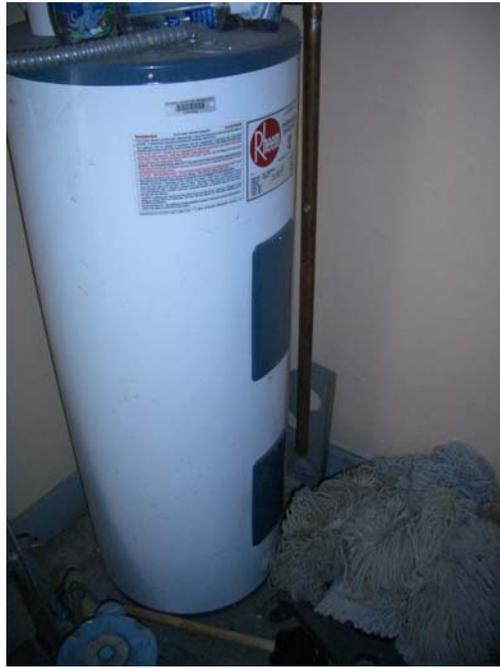
1. Electric water heaters are not seismically braced (see Fig. 6.2).
2. Emergency eyewash and showers are not equipped with mixing valve and do not meet current ANSI standards (see Fig. 6.3). Hangar 3 is equipped with 4 emergency showers spaced evenly throughout the hangar. Hangar 2 has only one emergency shower.

Figure 6.2 Electric Water Heater w/o Seismic Bracing - Hangar 2

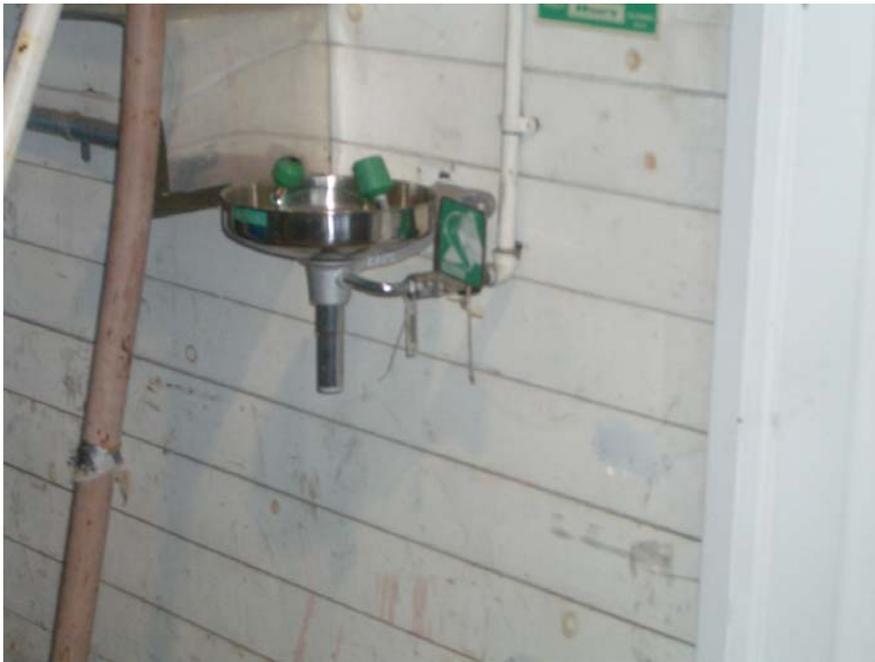
Figure 6.3 Emergency Eye Wash w/o Tempering Valve Hangar 2

1. Address indicated deficiencies including the addition of 4 emergency showers in Hangar 2.
2. Cap abandoned services to service pits. Fill in service pits (see Fig. 6.9).
3. Replace domestic water, compressed air, waste, and vent piping throughout the facility to provide an additional 30 year service life. Our estimate includes fixture replacement since fixtures must be removed to perform plumbing modifications. In addition a trench drain must be added to the hangar bay to meet current ETL requirements for fire suppression. See Tab 8 for further discussion. Our estimate shows replacement of the entire waste piping system. If it was determined that the age of the waste piping was on the order of 40 years rather than 60 years, we would not recommend its replacement

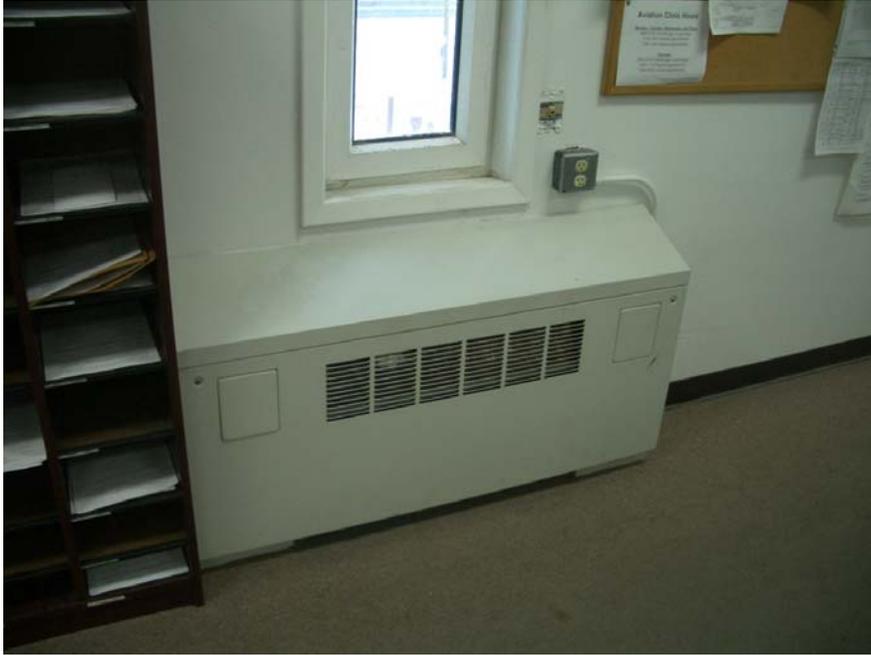
There are many places within the office and shop spaces that do not provide adequate heat. In Hangar 2 in the second floor office area on both sides of the hangar bay every other original finned tube cabinet has been replaced with a cabinet unit heater (see Fig. 6.4). The cabinet unit heaters are sized so that they are able to provide significant heat despite the low available flow. In Hangar 3 this conversion has not occurred. There is however a steam unit heater that has been installed on the second floor above the existing mechanical room.

Figure 6.4 Cabinet Unit Heater at Hangar 2

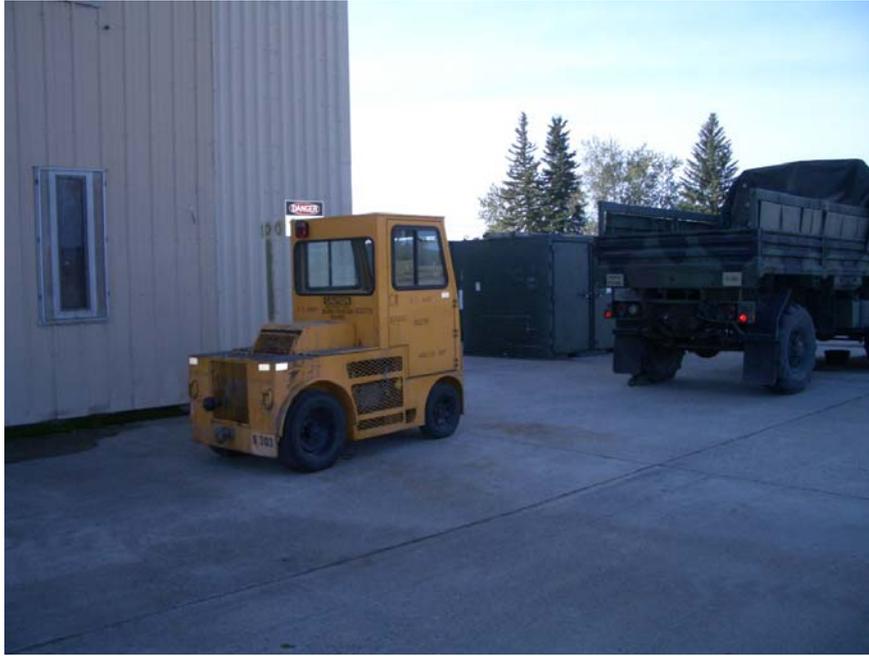
The hangar bays are not ventilated. During a November inspection, the air within Hangar 2 was noticeably foul. Small diesel tractors are used to move the helicopters and small gasoline powered ATV carts are used to transport supplies throughout the bay and apron area (see Figs. 6.6 and 6.7).

Figure 6.6. Diesel Tug Used at Hangars 2 & 3
