CONDITION ASSESSMENT AND REHABILITATION PLANS, HANGARS 2 AND 3, LADD FIELD NATIONAL HISTORIC LANDMARK FORT WAINWRIGHT, ALASKA

*Final Submission
January 2008*

As part of a Cooperative Agreement with the United States Army Environmental Center (USAEC), The Louis Berger Group, Inc. (Berger) was tasked to produce a Condition Assessment and Rehabilitation Plan (CARP) for use by the Department of the Army to determine the feasibility and use of the World War II era hangars to meet current and future anticipated mission needs associated with the projected move of the Aviation Task Force at Fort Wainwright, Alaska.

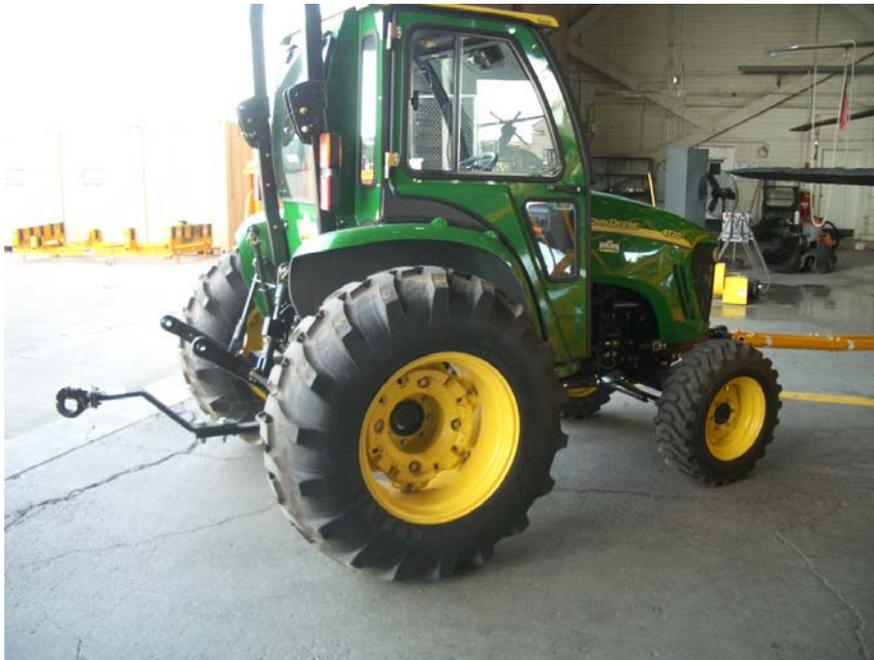
The hangar bays are not ventilated. During a November inspection, the air within Hangar 2 was noticeably foul. Small diesel tractors are used to move the helicopters and small gasoline powered ATV carts are used to transport supplies throughout the bay and apron area (see Figs. 6.6 and 6.7).

Figure 6.7 Diesel Tractor Used at Both Hangars 2 & 3

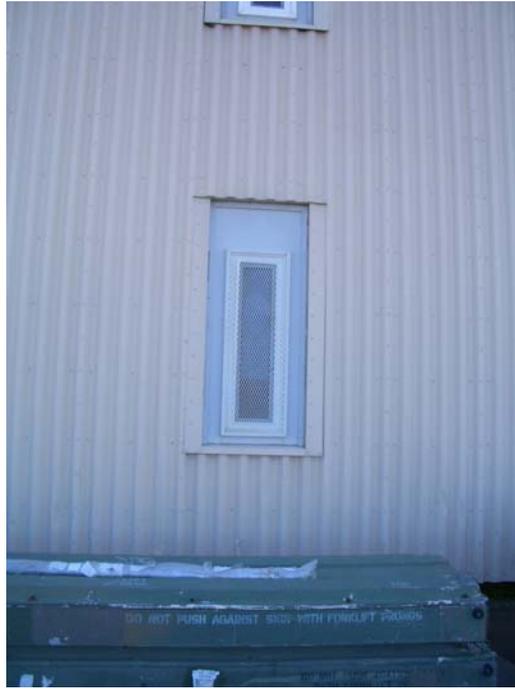
ventilation upgrades are performed such as air to air heat recovery. These measures were not included in the our estimate or course system design as we believe they would not be economically viable due to only intermittent use of high volumes of outside air. Reference the architectural section of this report for further discussion on the building envelope (see Fig. 6.8).

Figure 6.8 Window Reduced in Size Both Hangar 2 & 3

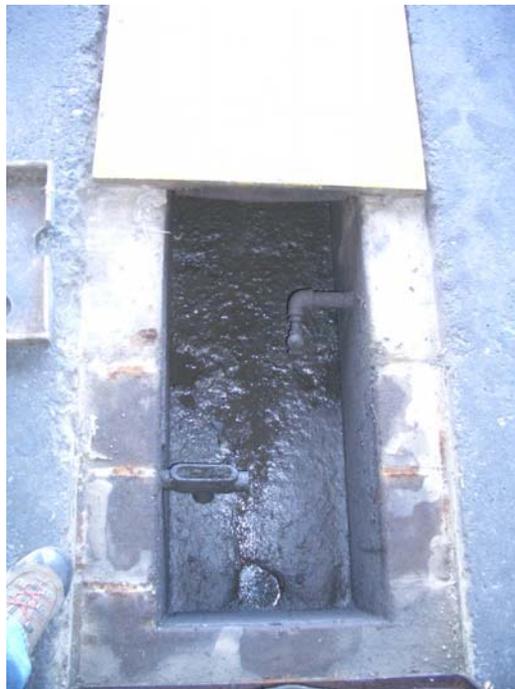
Figure 6.9 Abandoned Services Pit, Hangar 2

1. Address indicated deficiencies including the addition of 4 emergency showers in Hangar 2.
2. Cap abandoned services to service pits. Fill in service pits (see Fig. 6.9).
3. Replace domestic water, compressed air, waste, and vent piping throughout the facility to provide an additional 30 year service life. Our estimate includes fixture replacement since fixtures must be removed to perform plumbing modifications. In addition a trench drain must be added to the hangar bay to meet current ETL requirements for fire suppression. See Tab 8 for further discussion. Our estimate shows replacement of the entire waste piping system. If it was determined that the age of the waste piping was on the order of 40 years rather than 60 years, we would not recommend its replacement

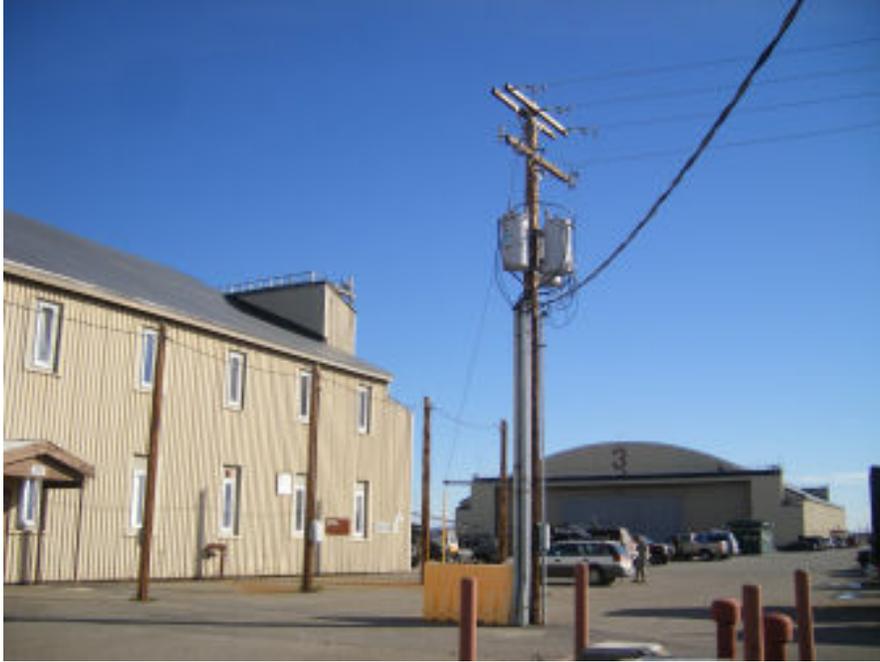
Hangars 2 and 3 are fed by pole mounted transformers in the parking lot (see Fig. 7.1). Secondary service entrance conductors run underground from the service pole to a 1600 ampere, 208Y/120 volt switchboard in an electrical room inside the building. Some of the service feeders on the pole have been hit by a vehicle and are damaged (see Fig. 7.2). Feeders from the main switchboards to panelboards distributed through the hangars have a mixture of primarily thermoplastic and cross-linked polyethylene, but some braided cloth insulation still exists. There are some original panelboards still in operation. Panelboard manufacturers range from Fouch Electric Mfg Co., I.T.E. Imperial Corporation, General Electric, and Square D. The first two listed manufacturers do not exist anymore.

Figure 7.1 General view of transformer service pole.

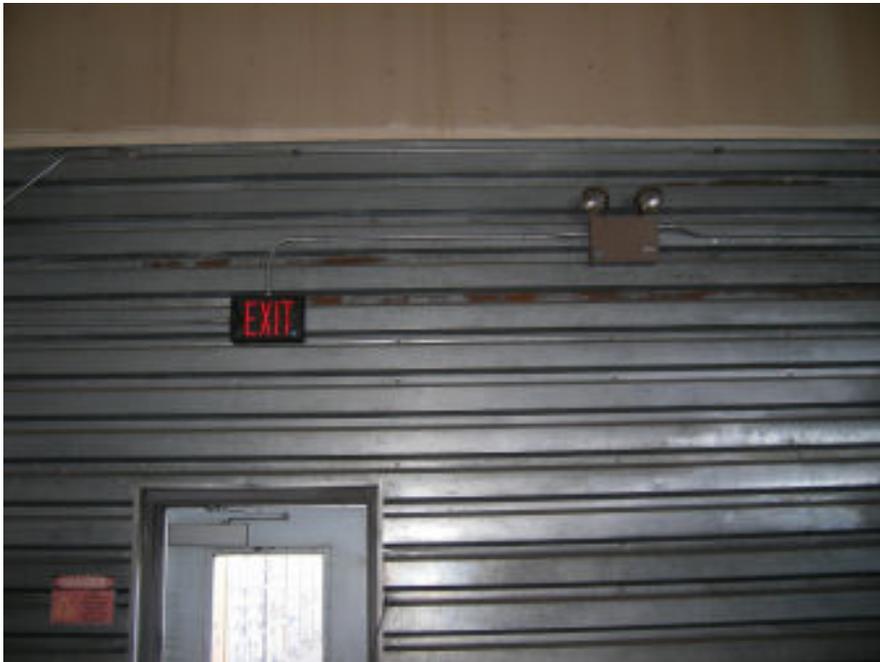
Emergency egress lighting consists of battery operated emergency lighting units. The units are sparsely placed (see Figs. 7.3 and 7.4). Exit signs vary widely. Some are red, some are green, some flash on loss of power, and some remain steady burning. One of the exit signs in Hangar 3 was inoperative.

Figure 7.4. Typical sparsely placed unit emergency lighting and exit signs.

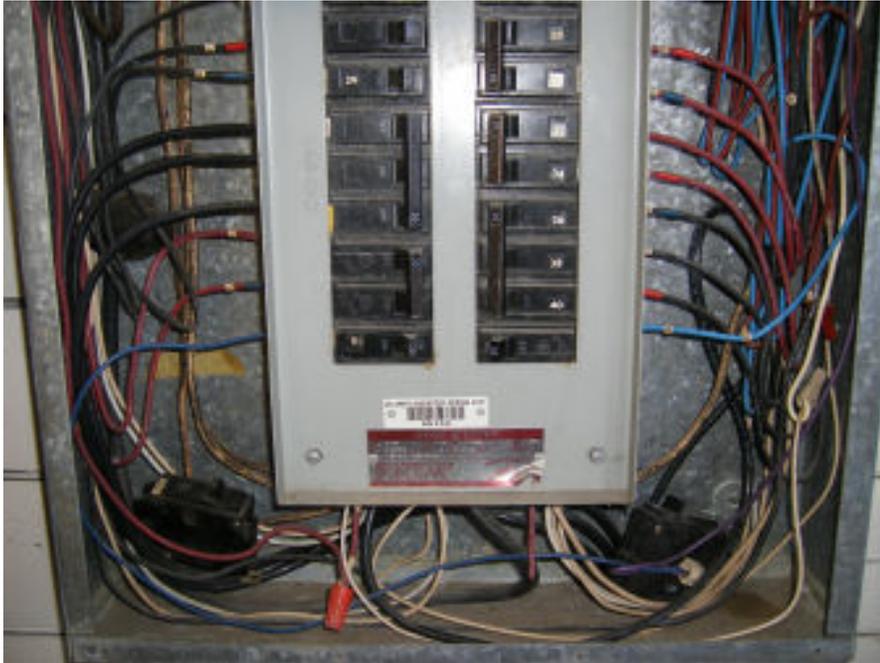
A number of the wiring devices are old and worn out (see Figs. 7.5 and 7.6). Many have been painted over and the paint is peeling. Spot testing (open ground, open neutral, open hot, hot and ground reversed, hot and neutral reversed) of the power receptacles was performed with no deficiencies found.

Figure 7.5 Typical panelboard wiring with mixture of braided cloth and thermoplastic insulated conductors.

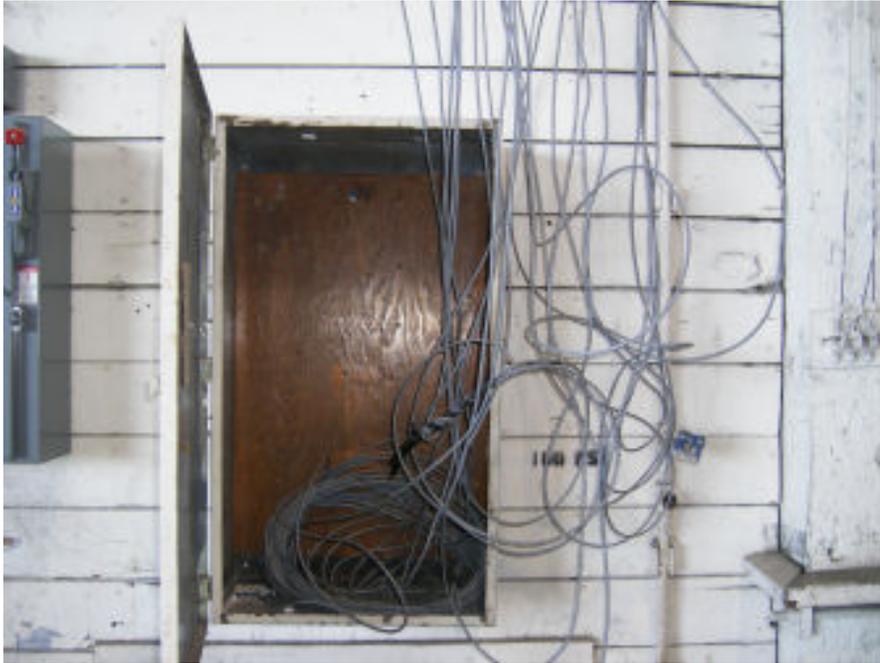
Data system cabling has been added to the hangars in recent years. Cabling is a mixture of Category 5 and 5e. Some communications cabinets have coils of unconnected cables spilling out of the enclosures. Cabinets are located in common use areas such as open hangar spaces or in break rooms (see Figs. 7.7 through 7.9).

Figure 7.7 Communications cabinet with coils of unconnected cables spilling out of the enclosure.

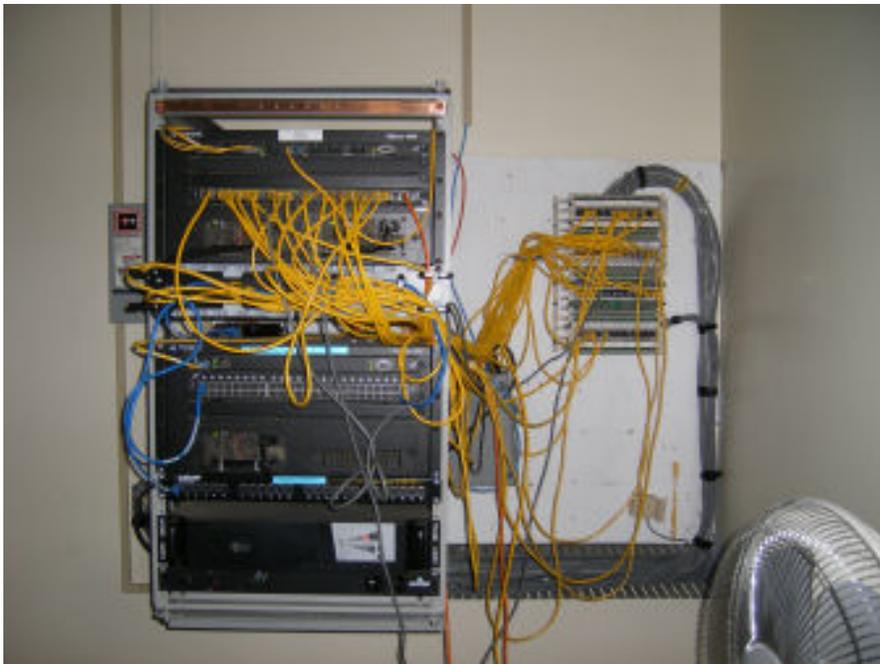
Figure 7.8 Communications cabinet located in break room: A common use area.

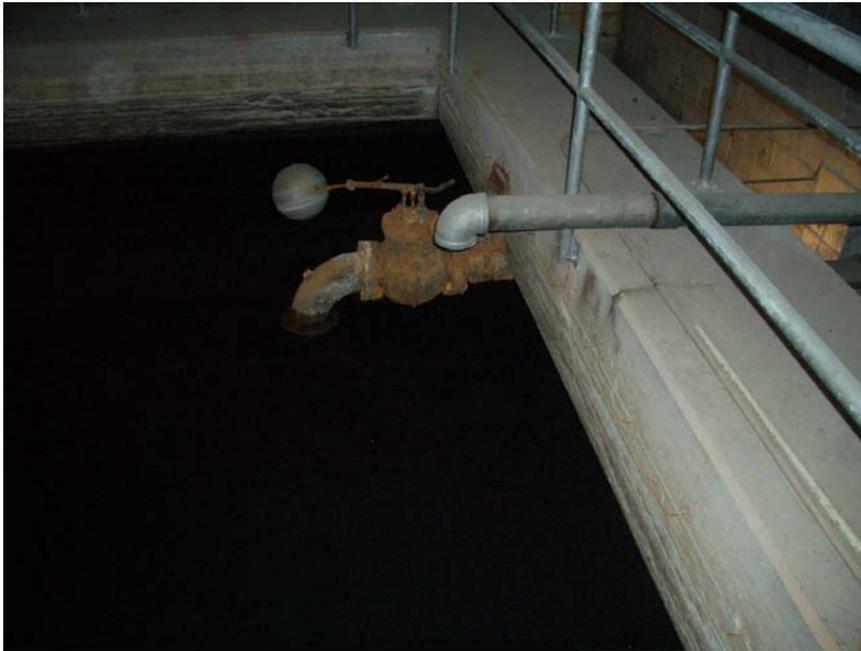
Fire water is provided from a remote building named Building 3011 located across the street from the hangars. This building provides fire water for both Hangar 2 and Hangar 3 through a 16" water main. The storage tank is manually filled from the base utility domestic water system. After the fire tank the systems are independent of each other. Four diesel fired pumps rated at 2000 gpm at 103 psi are used to provide fire water flow in the event of a loss of pressure in the deluge system. These pumps have a date code indicating a manufacture date of 1977. A single electric and gasoline fired pump also exist within building 3011. These two pumps were replaced by the four pump set (see Figs. 8.1 through 8.4).

Figure 8.2 Defunct make Up Valve at Bldg 3011.
Tank in now filled manually.
