Hangar 2 (Building 3005) After Fire Structural Inspection Report

Jason L. Webb P.E.

FT. WAINWRIGHT-DPW

11/22/11

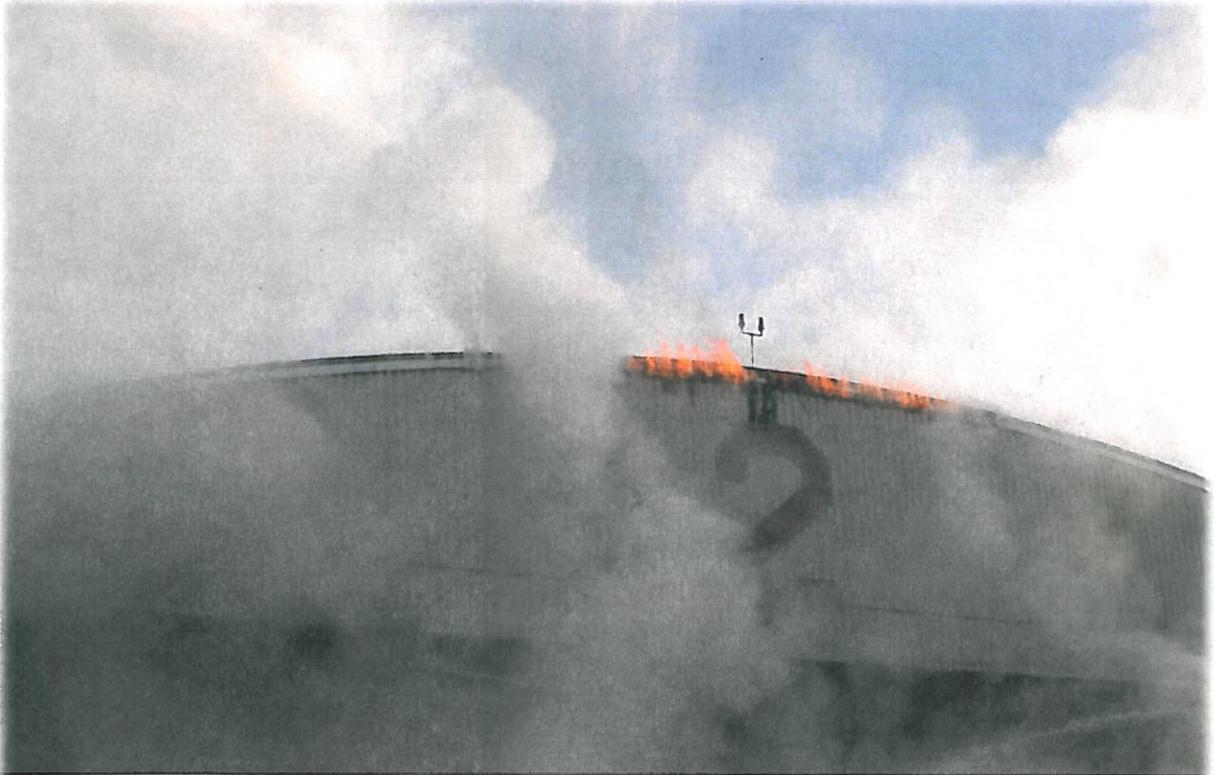
At approximately 11:45 on Thursday February 17th a fire was reported by employees of Tatitlek Inc. who were working on removing the door overhangs. Due to deployments no soldiers or helicopters were present in Hangar 2(Building 3005). Firefighters from Fort Wainwright, Fairbanks and North Star departments worked to extinguish the blaze.

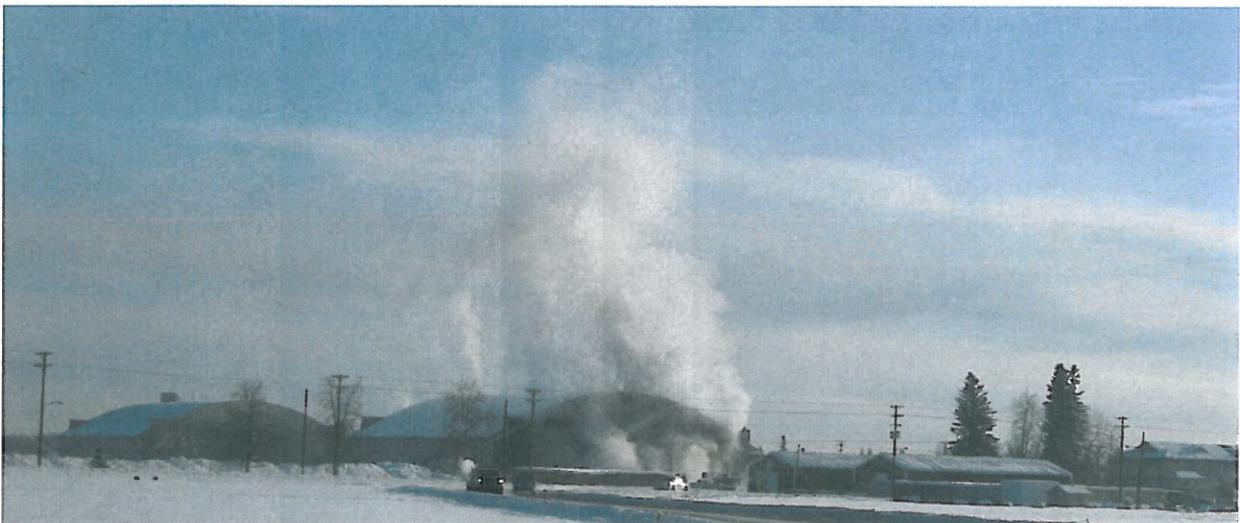
The fire was extinguished about 2 p.m. and the building was cleared for entry by the fire chief about 4 p.m.
