BUILDING # 1560

GARAGE AND MAINTENANCE BUILDING

FORT WAINWRIGHT ■ NORTH STAR BOROUGH ■ ALASKA

HISTORIC AMERICAN
BUILDINGS SURVEY
SHEET 1 OF 4

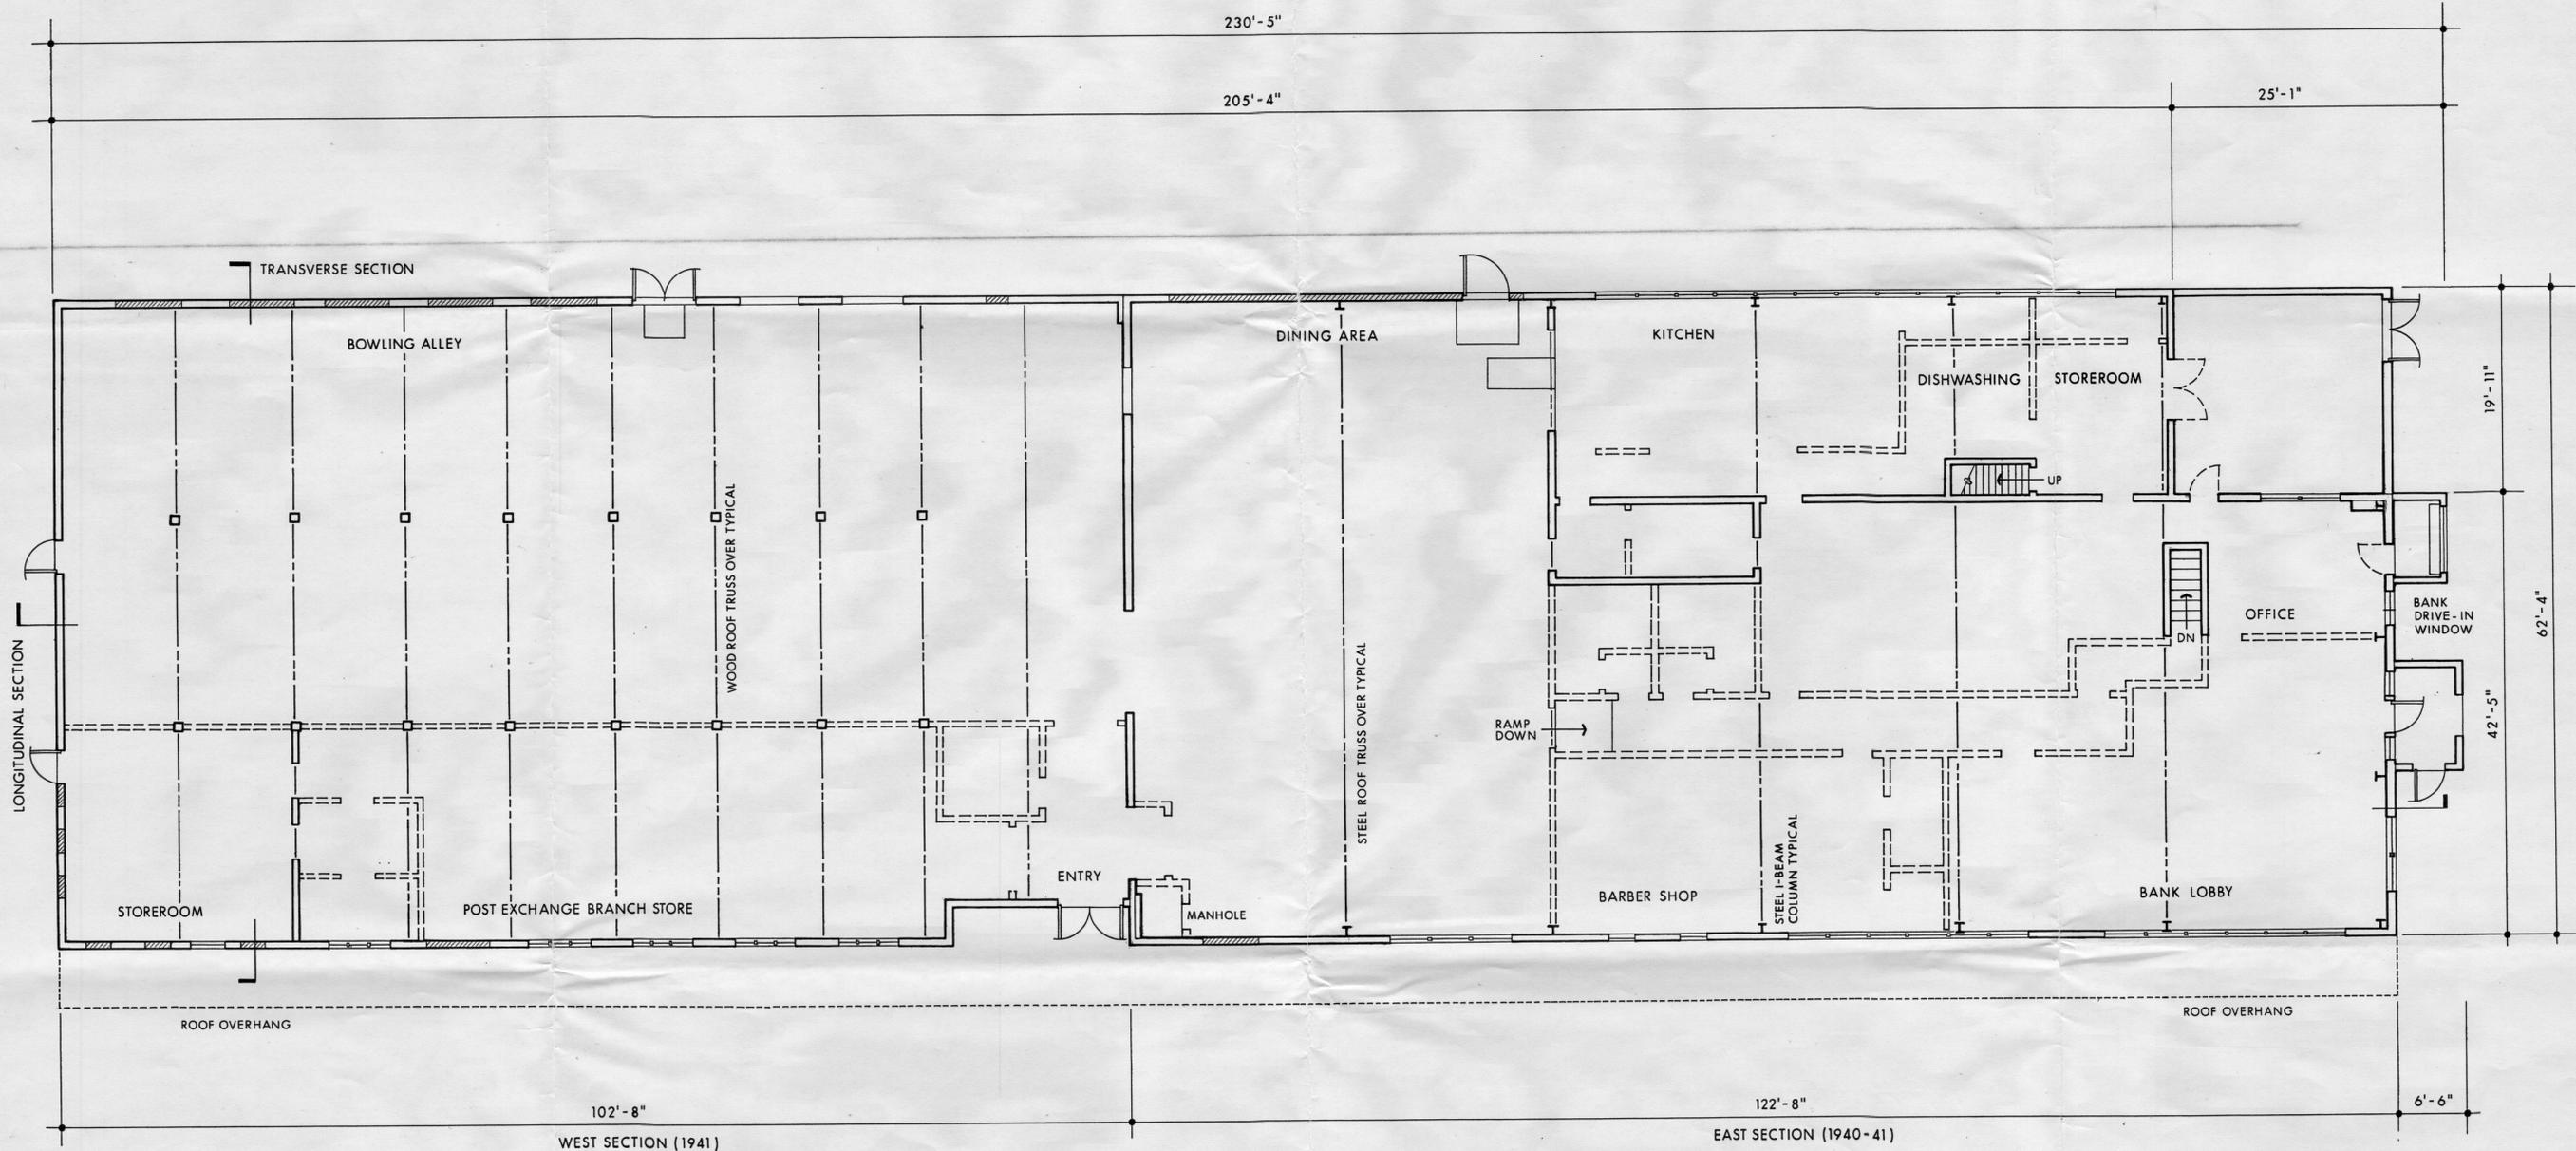
FLOOR PLAN

- STRUCTURE: CONCRETE FOUNDATIONS; WOOD FRAME WALLS; STEEL (EAST SECTION) OR WOOD (WEST SECTION) ROOF TRUSSES
- FLOOR: CONCRETE SLAB WITH FINISH FLOORS (WOOD, CARPET AND VINYL-ASBESTOS TILE) REMOVED
- WALLS: WOOD STUD WALLS WITH SHEETROCK SHEATHING
- CEILINGS: REMOVED

NOTE: THE DRAWINGS SHOW A BUILDING THAT IS PLUMB AND TRUE, NOT REFLECTIVE OF ITS CONDITION. THE DRAWINGS ARE A GRAPHIC REPRESENTATION OF THE EXISTING BUILDING, NOT HOW IT WAS CONSTRUCTED.

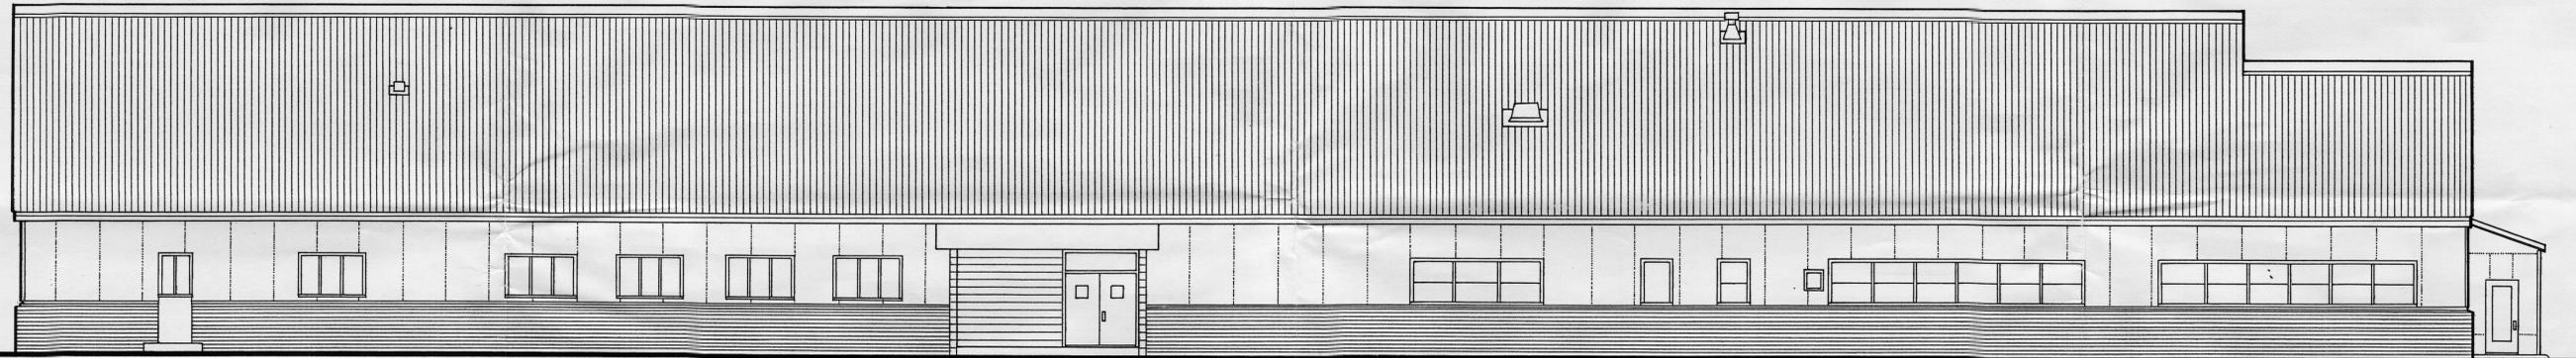
SOUTH ELEVATION

MATERIALS
 WALLS: PREFINISHED ALUMINUM SIDING OVER CORRUGATED STEEL WITH ROMAN BRICK VENEER
 ROOF: RIBBED ALUMINUM ROOF OVER ORIGINAL PLYWOOD ROOF DECKING
 DOORS: PLYWOOD- OR METAL-SIDED REPLACEMENT DOORS IN WOODEN FRAMES
 WINDOWS: ORIGINAL STEEL TWO-LIGHT CASEMENTS; REPLACEMENT WOODEN ONE-LIGHT CASEMENTS

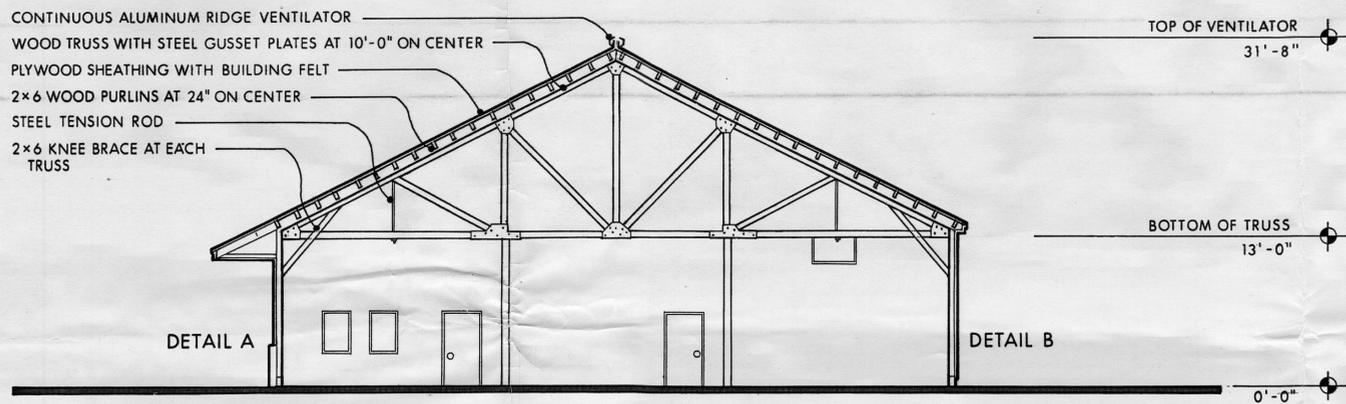
TRANSVERSE SECTION

NOTE: INDIVIDUAL STUDS AND GIRTS IN BACKWALL NOT SHOWN FOR CLARITY

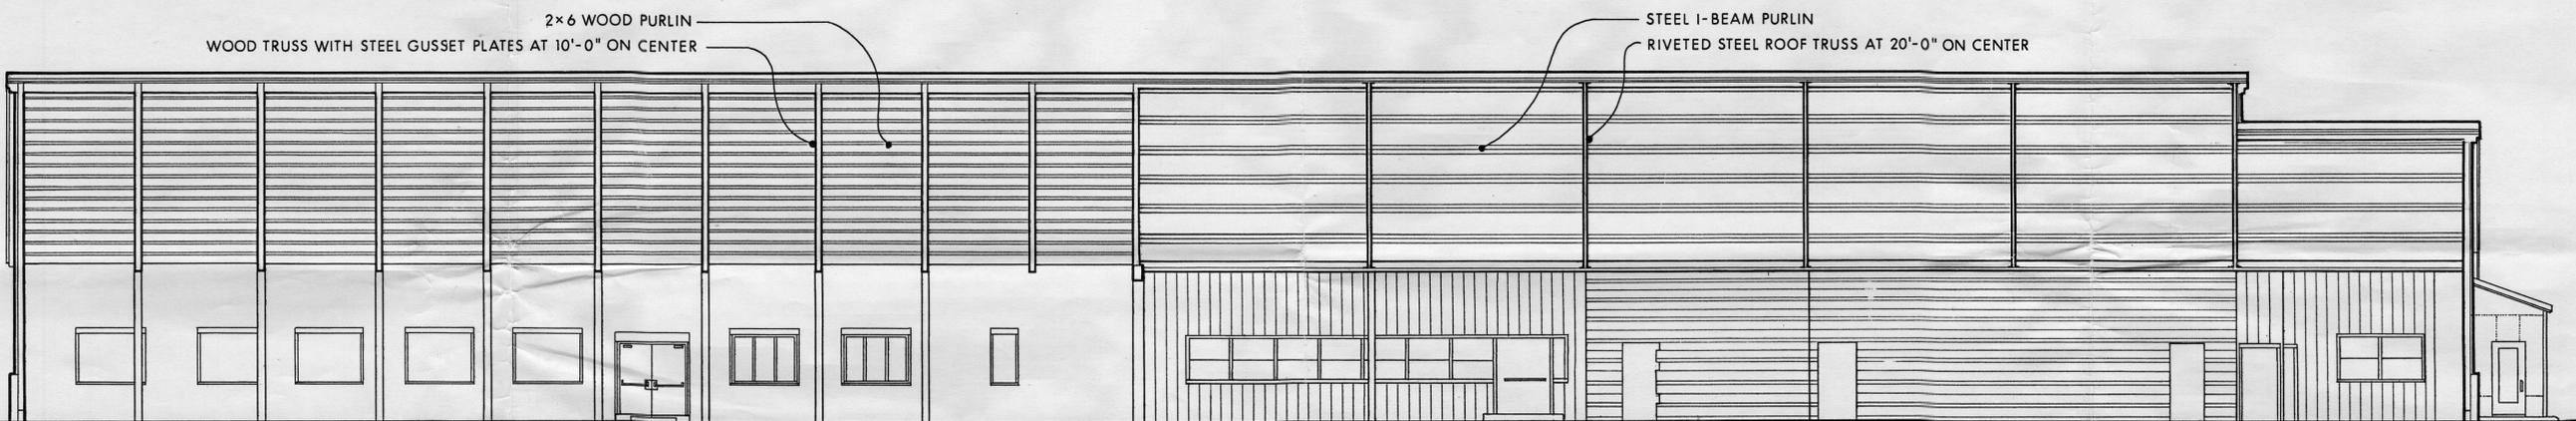
LONGITUDINAL SECTION

NOTE: INDIVIDUAL STUDS AND GIRTS IN BACKWALL OF WEST SECTION NOT SHOWN FOR CLARITY
